# HISTORY OF CONSTRUCTION FOR EXISTING CCR SURFACE IMPOUNDMENT REVISION 1 PLANT MCMANUS ASH POND A (AP-1) 40 CFR 257.73(c)(1)(i)-(xii)

Site Name: Clifford B. McManus Power Plant

CCR Impoundment Name: Plant McManus Ash Pond A (AP-1)

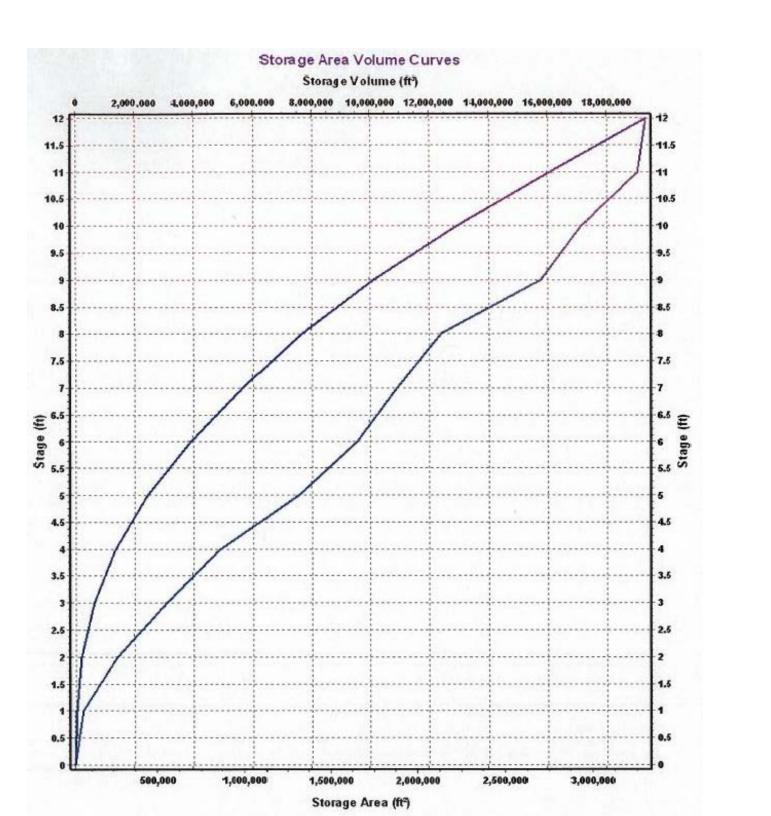
# **Appendix B**

See Appendix B for Stage Storage Curve
