# LIMITED HYDROGEOLOGICAL ASSESSMENT REPORT FOR INACTIVE CCR LANDFILL

FORMER PLANT ARKWRIGHT – AP1 LANDFILL  
MACON-BIBB COUNTY, GEORGIA  
FOR

# Georgia Power

November 2018

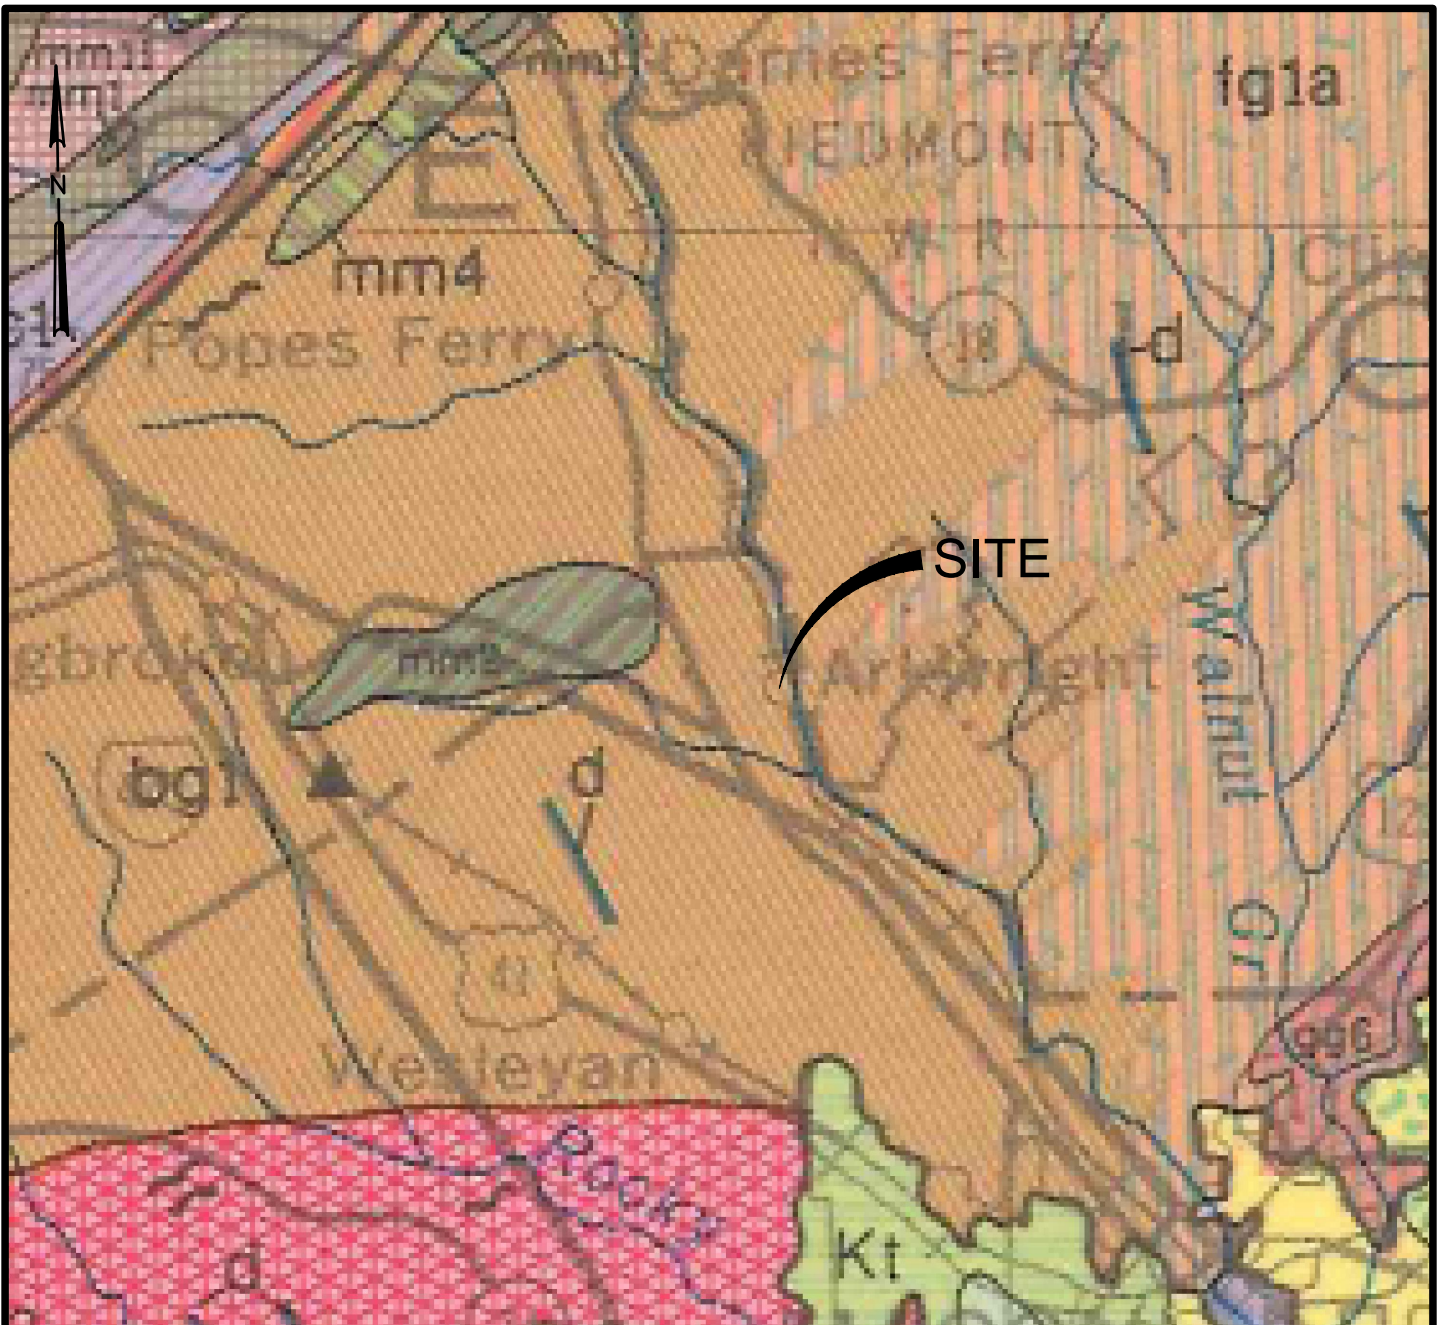
<b>JACOBS</b>	Former Plant Arkwright AP1 Landfill	PROJECT NO.: 35DK9206 DATE: November 2018 SCALE: AS SHOWN
	Geologic Map of General Area	SHEET NO.: <b>Figure 2</b>

Geological Map of Georgia  
 Atlanta  
 1976  
 Reprinted 1997  
 Georgia Department of Natural Resources

Former Plant Arkwright is in the northern part of Bibb County, which is in the Piedmont province of the Appalachian Highland Physiographic District. The Piedmont Plateau occupies the northern half of Bibb County. The topography is rolling to hilly and the highest parts rise to about 800 feet above sea level. The main streams, having adjusted their courses to the structure of the underlying crystalline rocks, flow eastward to join the through-flowing Ocmulgee River, which receives the entire drainage of the county. Regionally, igneous and metamorphic rocks are exposed in the extreme northern part of Bibb County where the site is located. Many of them are granitic, being true granite, biotite-granite gneiss, or a granite component in a diorite injection complex. All these rocks are highly weathered and where exposed are generally soft and friable (LeGrand, 1962). A geologic map of the area is included as Figure 2 in Appendix A.

The general geology of the site consists of unconsolidated riverine deposits such as clays, silty and sandy clays, silty sands, sandy silts, and minor gravel. More consolidated materials encountered at lower elevations consist of silty sand saprolite and bedrock. Recent and historic borings indicate the soils are underlain by extremely weathered quartzofeldspathic gneiss, hornblende gneiss, and schist.

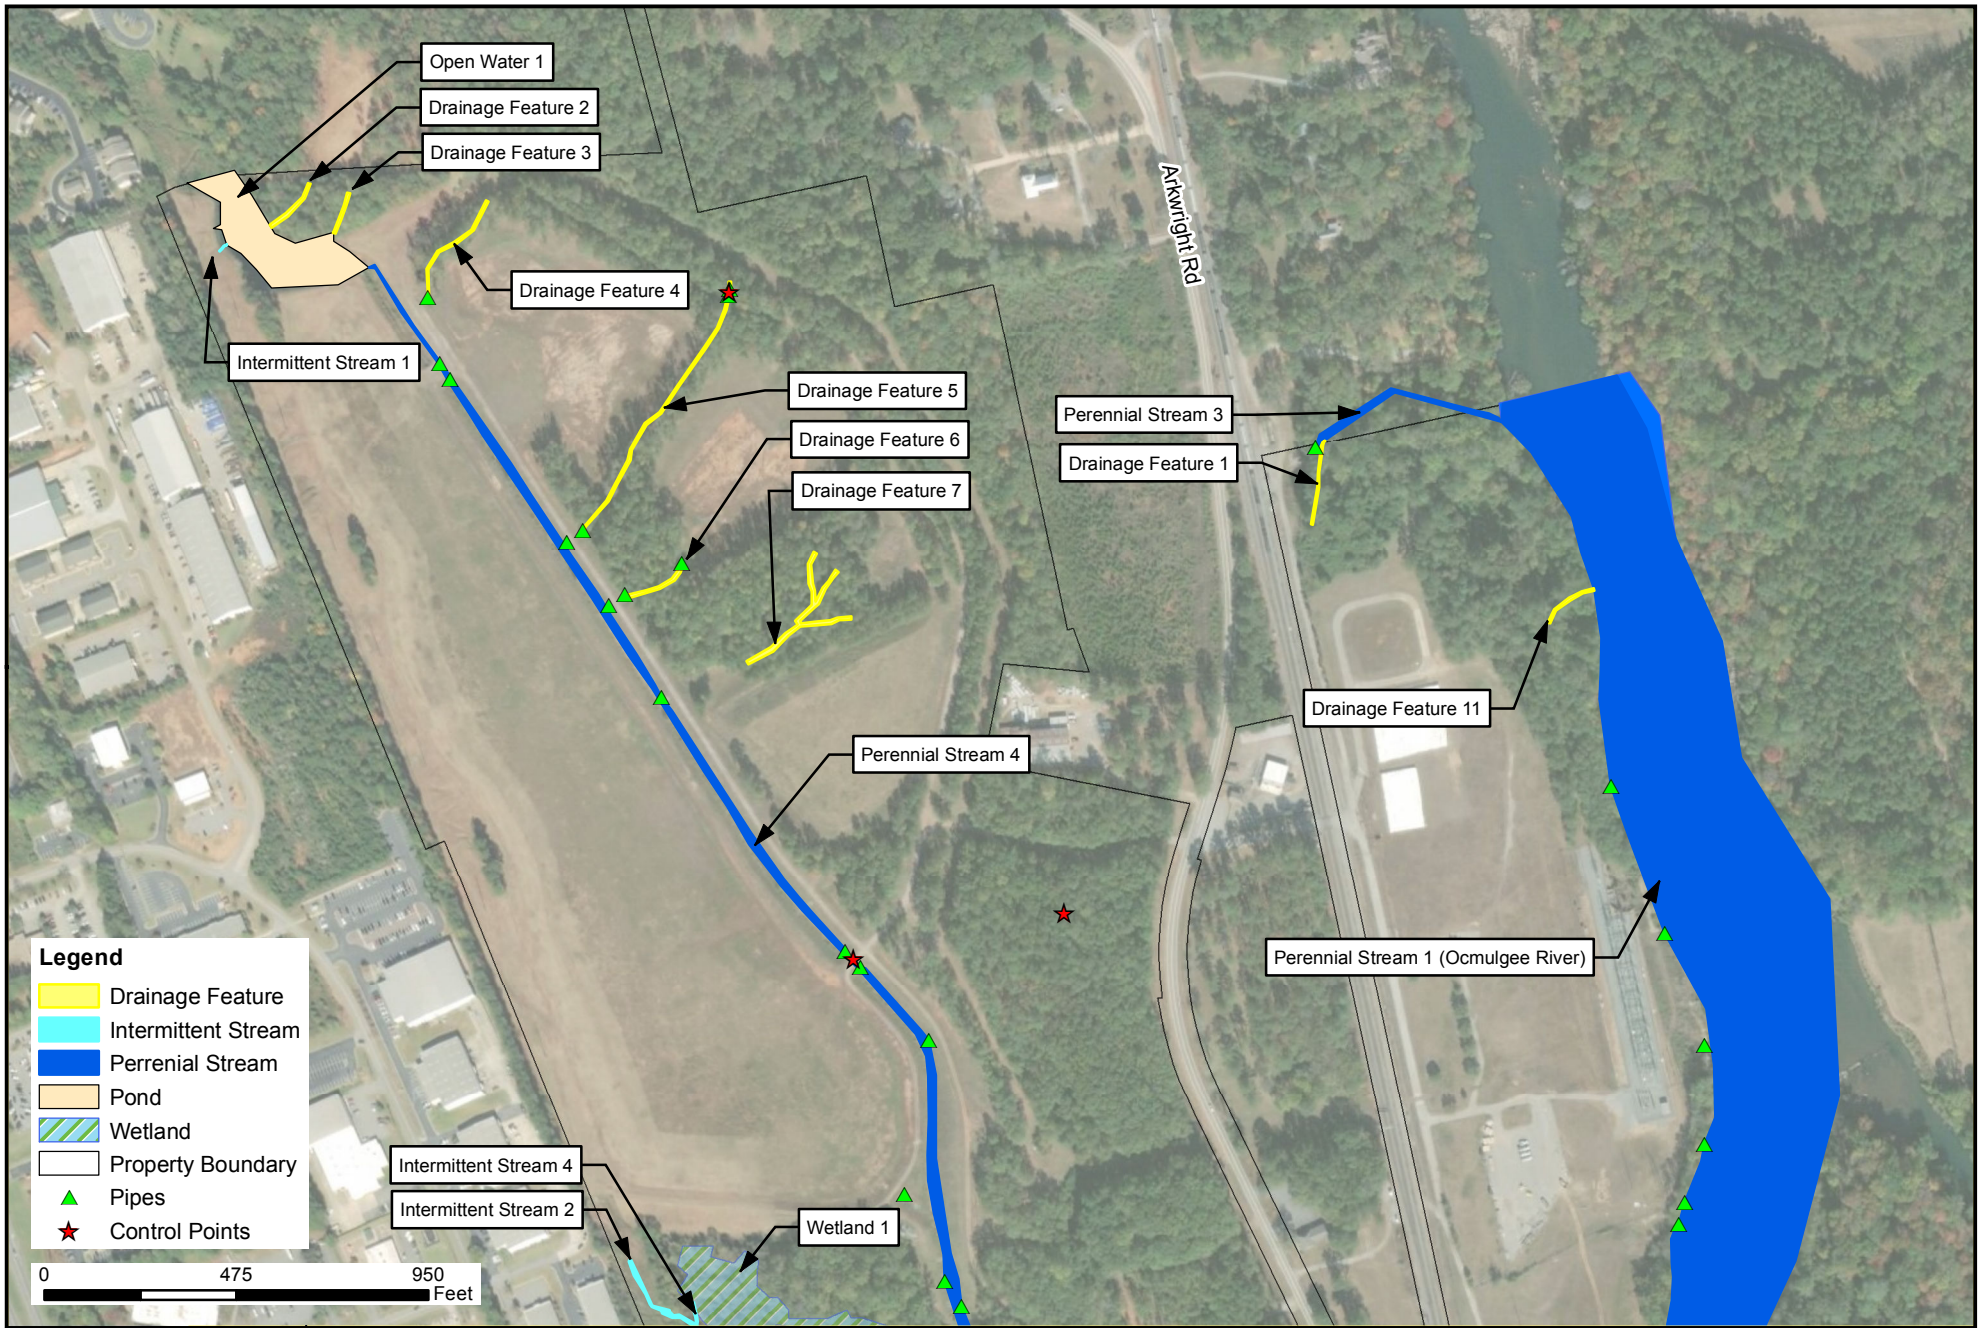
N  
 Date: Oct. 2018  
 Scale: 1" = 475'  
 Figure 1A

Federal and State Waters Map

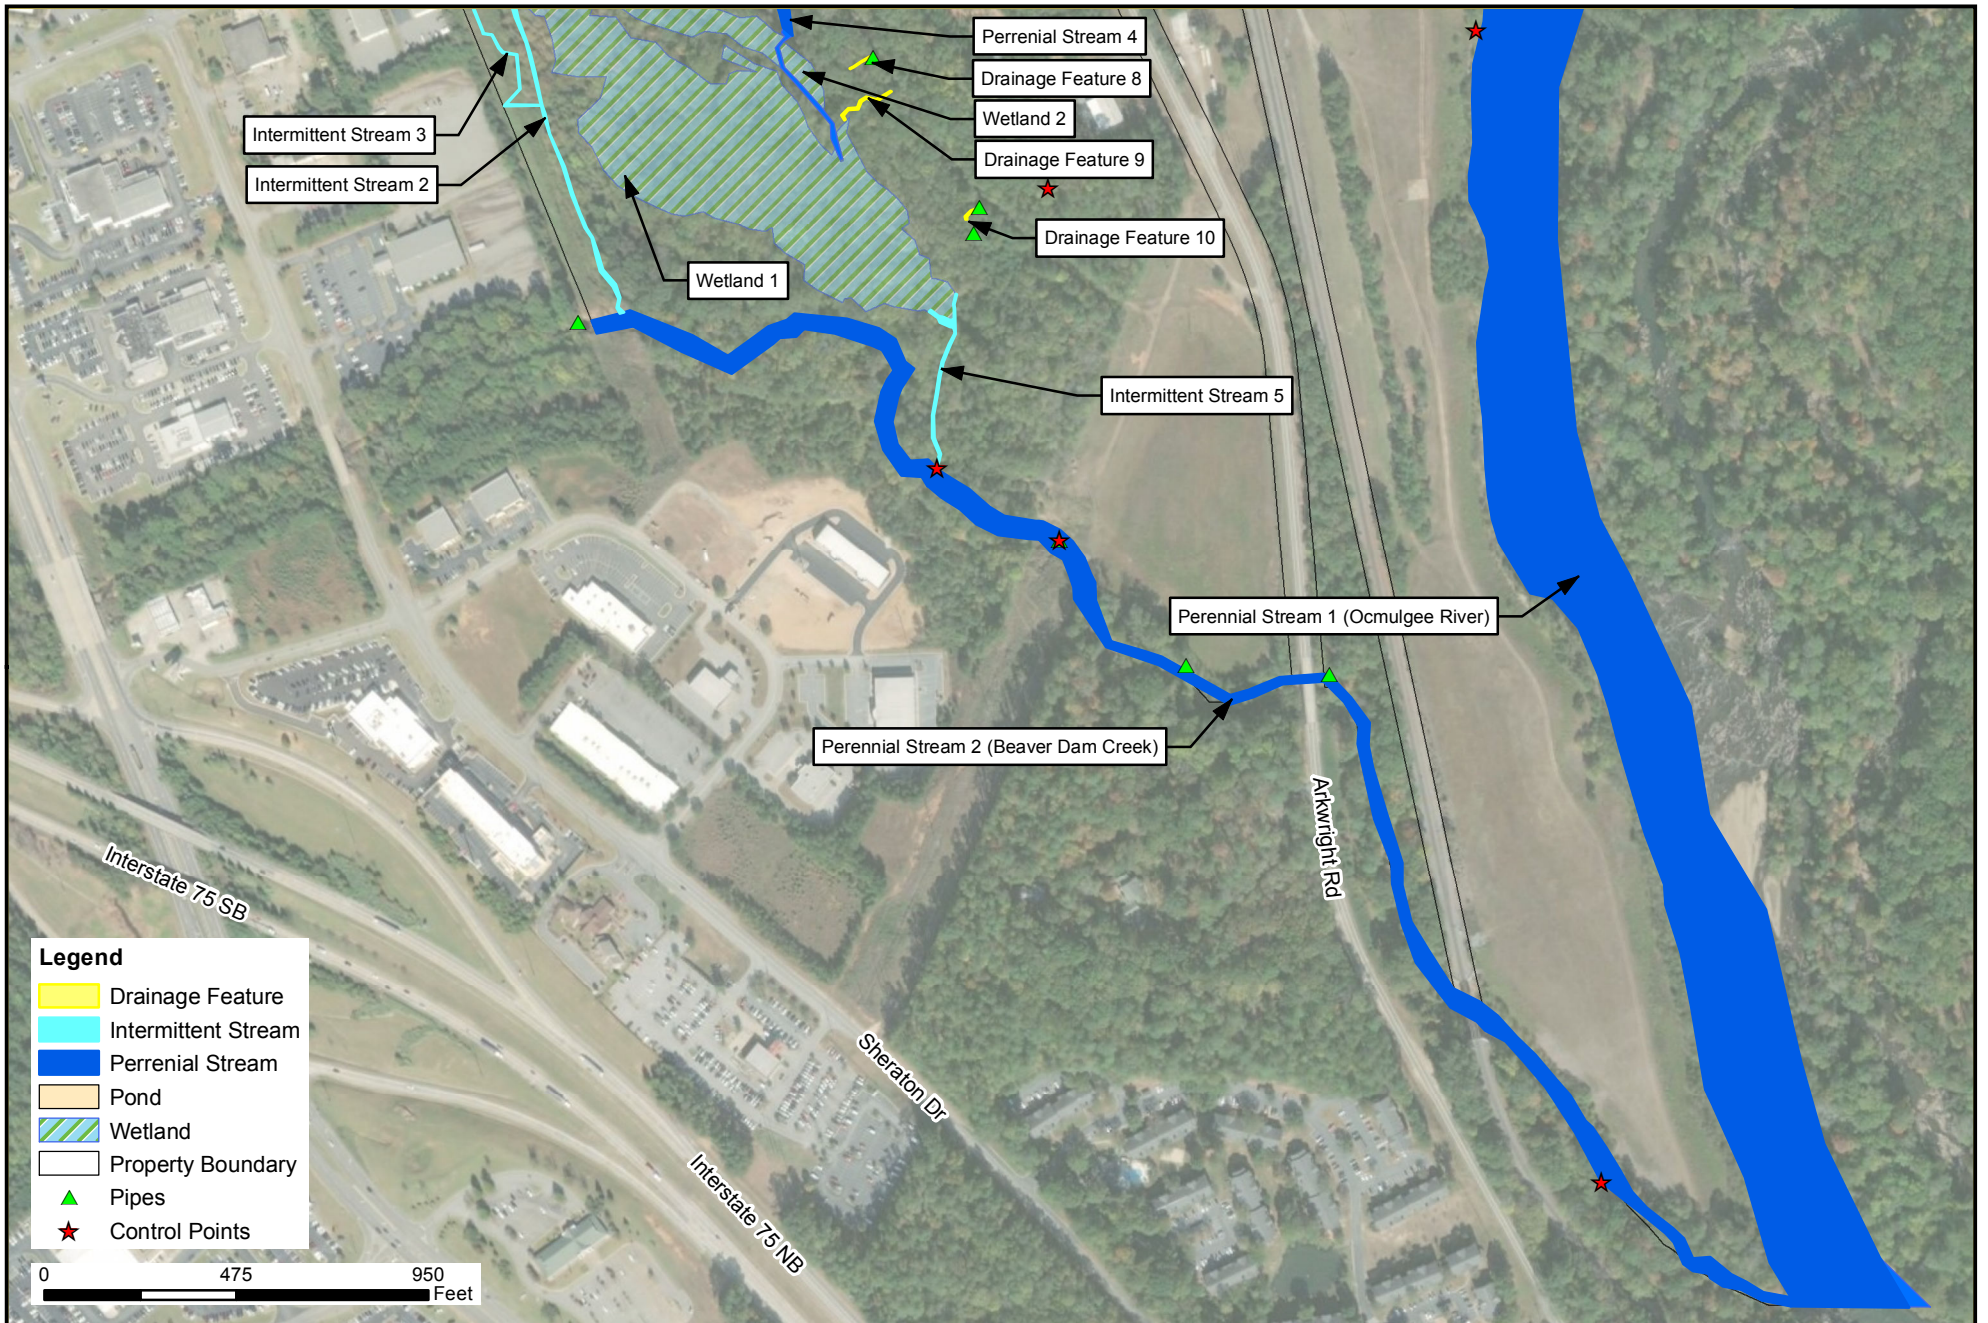
N  
 Date: Oct. 2018  
 Scale: 1" = 475'  
 Figure 1B

Federal and State Waters Map
