FINAL HYDRAULIC AND HYDROLOGIC MODELING REPORT

(Volume II of III)

LANGDALE PROJECT (FERC No. 2341)
AND
RIVERVIEW PROJECT (FERC No. 2350)

APPENDIX C USGS FLOW MEASUREMENTS

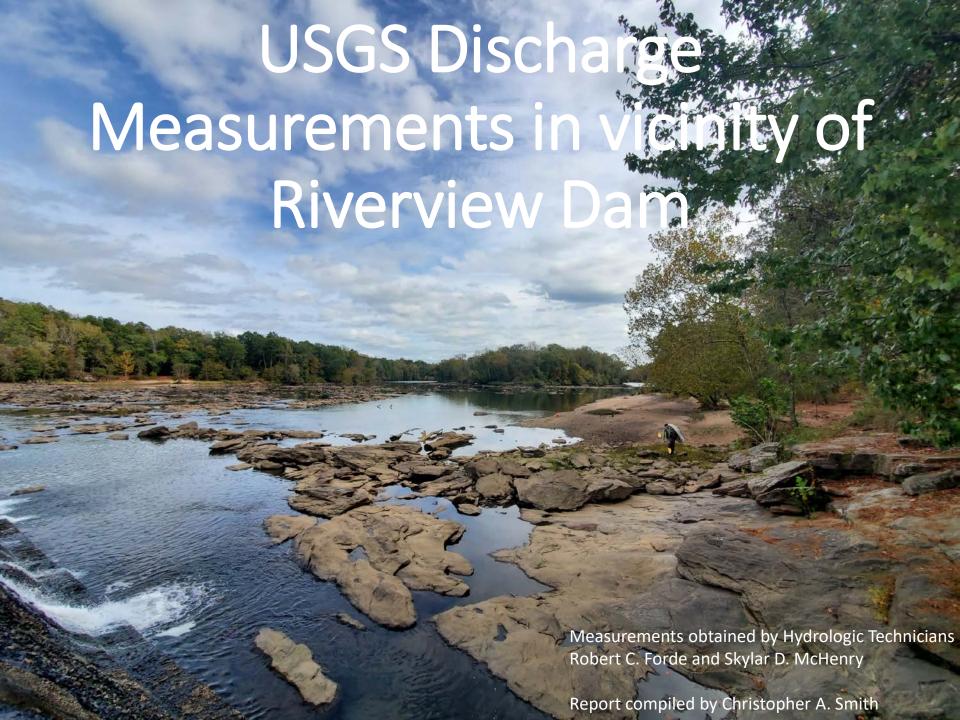
Langdale and Riverview Flow measurements and water surface elevation measurements at all locations except BF WSElev, which is just a water surface elevation measurement. Lang-B Lang-C Crow-A Crow-B Crow-C 💠 River-A Crow-D River-B • BF WSElev Map provided by Georgia Power

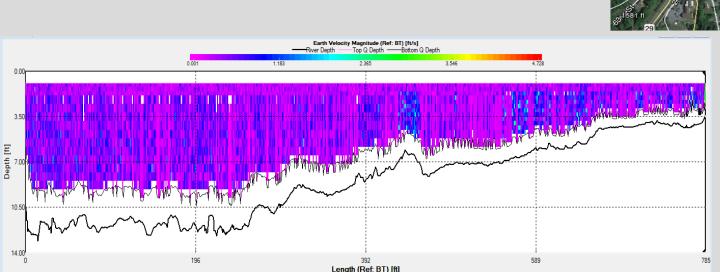
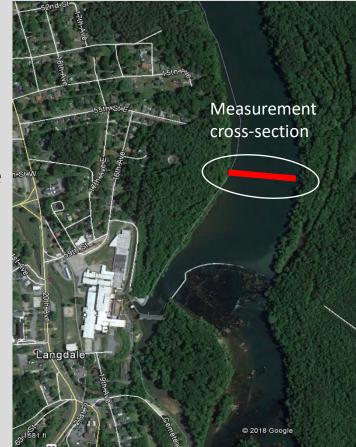
Discharge measurement above Langdale Dam

- Location of cross-section identified as Lang-A on map provided.
- Discharge measurement made above the influence of the dam on the cross section. This location chosen due to channel conditions.
- Velocity in this section was low but fairly uniform throughout the cross section.
- W/S = 550.4 feet. GPS accuracy of +/- 0.30 feet.

- 800 feet wide
- 0.15 ft/s mean velocity
- 6,300 ft² area
- Total $Q = 859 \text{ ft}^3/\text{s}$
- Sandy, rocky bottom

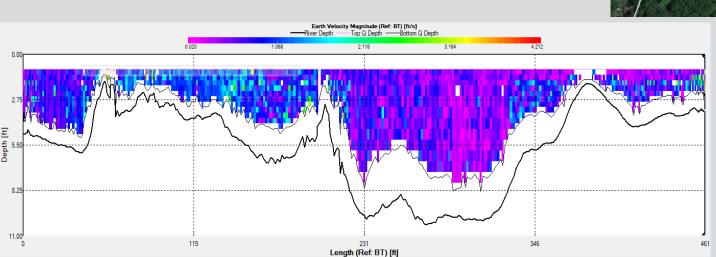
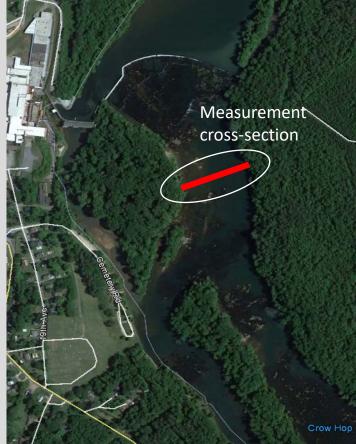
Discharge measurement below Langdale Dam

- Location of cross-section identified as **Lang-B** on map provided.
- Discharge measurement made below the influence of the dam on the cross section. This location is between two large shoals.
- Velocity in this section was low and not uniform throughout the majority of the cross section.
- W/S = 534.6 feet. GPS accuracy of +/- 0.30 feet.

- 610 feet wide
- 0.31 ft/s mean velocity
- 2,720 ft² area
- Total $Q = 840 \text{ ft}^3/\text{s}$
- Sandy and rock boulder bottom

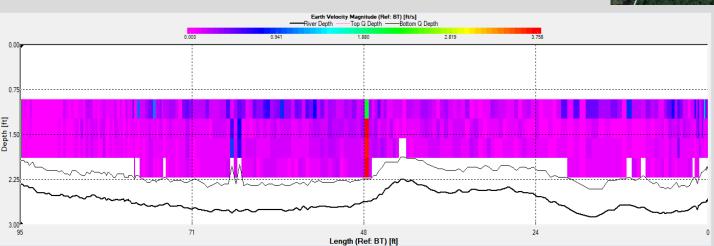
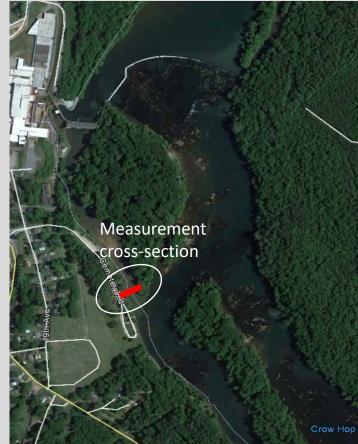
Discharge measurement below Langdale Dam

- Location of cross-section identified as **Lang-C** on map provided.
- Discharge measurement made below the influence of the dam on the cross section. This location is downstream of suggested location but provided best channel conditions for measurement.
- Velocity in this section was extremely low fairly uniform throughout the cross section.
- W/S = 534.6 feet. GPS accuracy of +/- 0.30 feet.

- 126 feet wide
- 0.10 ft/s mean velocity
- 255 ft² area
- Total $Q = 16 \text{ ft}^3/\text{s}$
- Measurement quality is POOR.

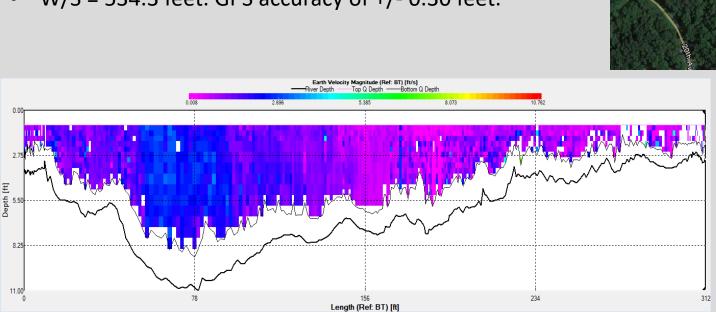
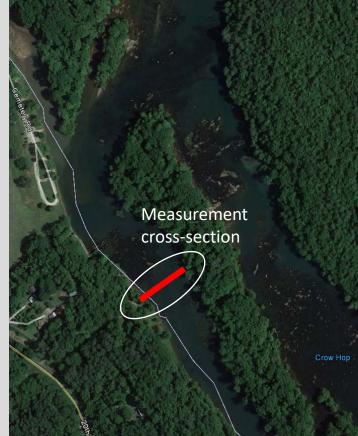
- Location of cross-section identified as **Crow-A** on map provided.
- Discharge measurement location is at suggested location.
- Velocity in this section was fairly uniform throughout the cross section.
- Channel bottom is composed of sand and large boulders.
- W/S = 534.3 feet. GPS accuracy of +/- 0.30 feet.

- 322 feet wide
- 0.71 ft/s mean velocity
- 1,730 ft² area
- Total $Q = 838 \text{ ft}^3/\text{s}$
- Measurement quality is POOR.

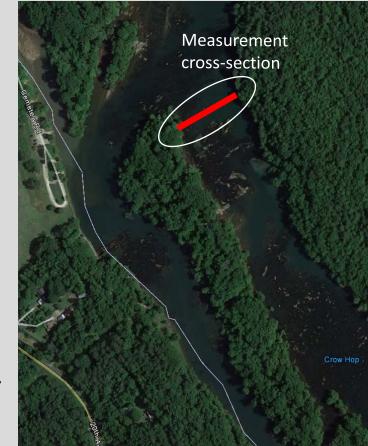
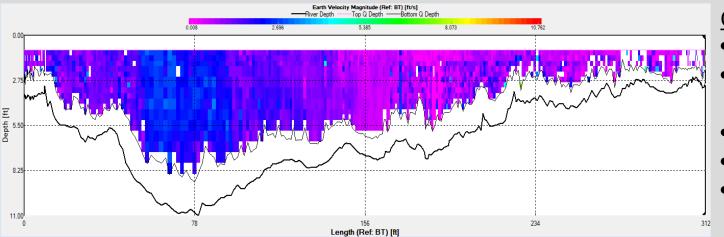
- Location of cross-section identified as **Crow-B** on map provided.
- Discharge measurement location is upstream of suggested location but provided best channel conditions for measurement.
- Velocity in this section was fairly uniform throughout the cross section.
- Channel bottom is composed of sand and large boulders.

- 353 feet wide
- 0.03 ft/s mean velocity
- 1,730 ft² area
- Total $Q = 39 \text{ ft}^3/\text{s}$
- Measurement quality is POOR.

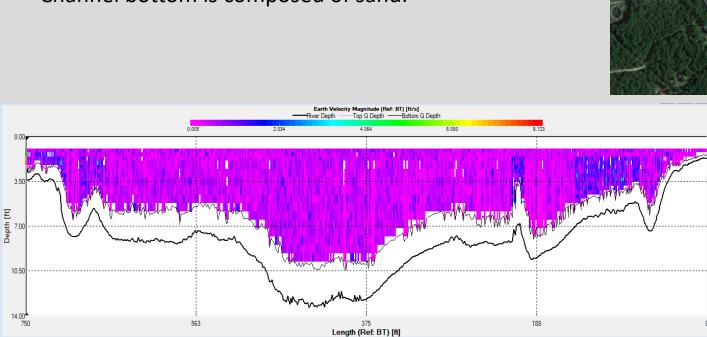
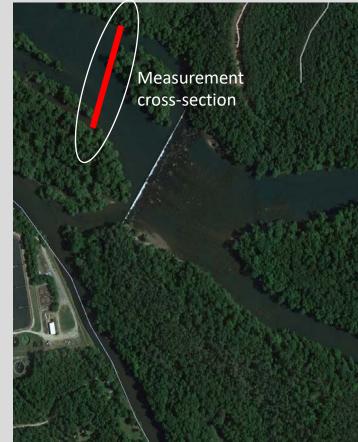
- Location of cross-section identified as Crow-C on map provided.
- Discharge measurement location is near suggested location.
- Velocity in this section was extremely sluggish but uniform throughout the cross section.
- Channel bottom is composed of sand.

- 808 feet wide
- 0.08 ft/s mean vel.
- 5,880 ft² area
 - Total $Q = 233 \text{ ft}^3/\text{s}$
- Measurement quality is extremely POOR.

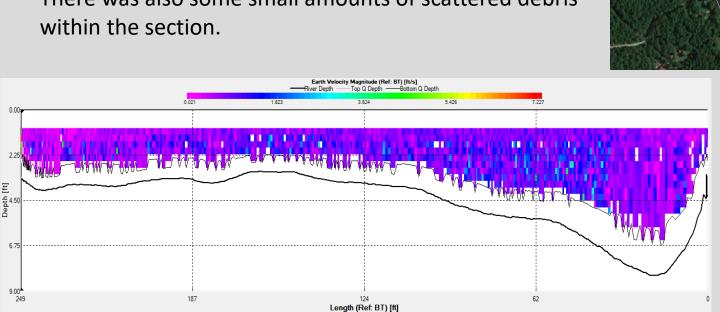
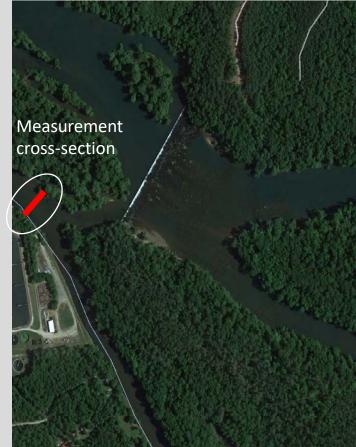
- Location of cross-section identified as River-A on map provided.
- Discharge measurement location is near suggested location.
- Velocity in this section was good and fairly uniform throughout the cross section.
- Channel bottom is composed of sand and boulders.
 There was also some small amounts of scattered debris within the section.

- 260 feet wide
- 0.56 ft/s mean vel.
- 1,090 ft² area
- Total $Q = 612 \text{ ft}^3/\text{s}$
- Measurement quality is FAIR.

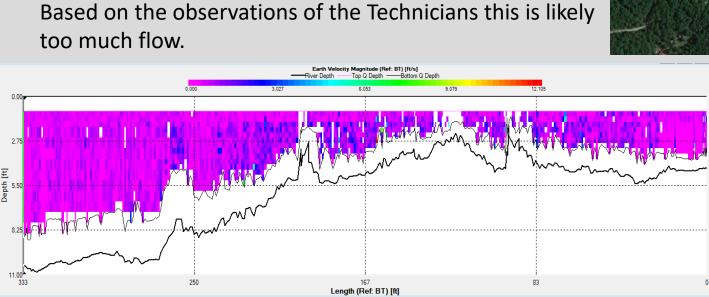
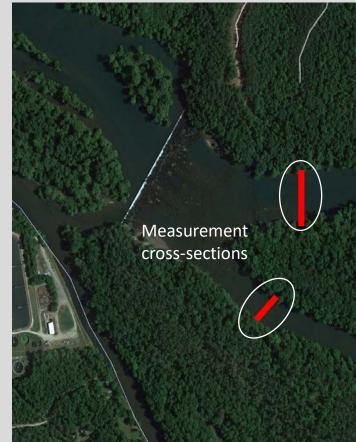
- Location of cross-section identified as Crow-D on map provided.
- Discharge measurement location is downstream of suggested section. River divides into two channels upstream. Cross-section included both channels. Channel characteristics listed are sum of two channels.
- Numerous sections were attempted as it was difficult to obtain a measurement in the right branch of the divided channel. The total flow for this branch measured 71 ft³/s. Based on the observations of the Technicians this is likely too much flow.

- 635 feet wide
- 0.08 ft/s mean vel.
- 2,680 ft² area
 - Total $Q = 189 \text{ ft}^3/\text{s}$
- Measurement quality is extremely POOR.

- The USGS crew is thankful for the opportunity to explore the area requested by Georgia Power.
- Obtaining discharge measurements near the three dams is extremely challenging. The USGS crew spent considerable time scouting measurement sections. The area below Crow Hop in the natural river channel is particularly difficult and it was necessary to split the measurement into two channels, as noted.

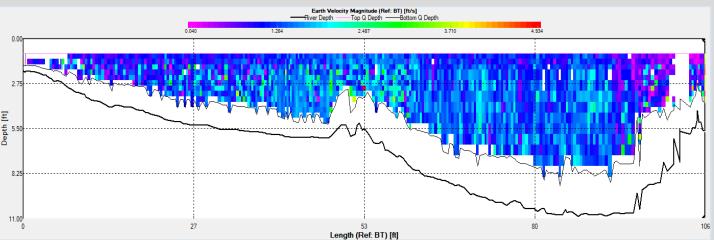
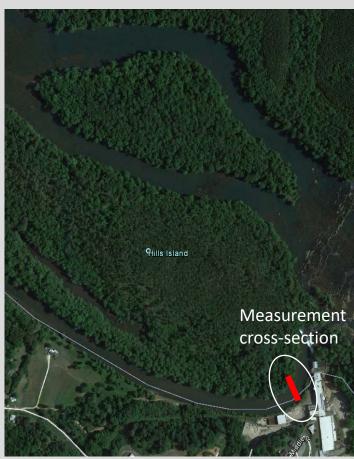
Discharge measurement above Riverview Dam

- Location of cross-section identified as River-B on map provided.
- Discharge measurement location is near suggested location.
- Velocity in this section was good and fairly uniform throughout the cross section.
- Channel bottom is composed of sand. There was some small amounts of scattered debris near the right bank.
- W/S = 533.6 feet. GPS accuracy of +/- 0.30 feet.

- 160 feet wide
- 1.13 ft/s mean vel.
- 735 ft² area
- Total $Q = 717 \text{ ft}^3/\text{s}$
- Measurement quality is GOOD.

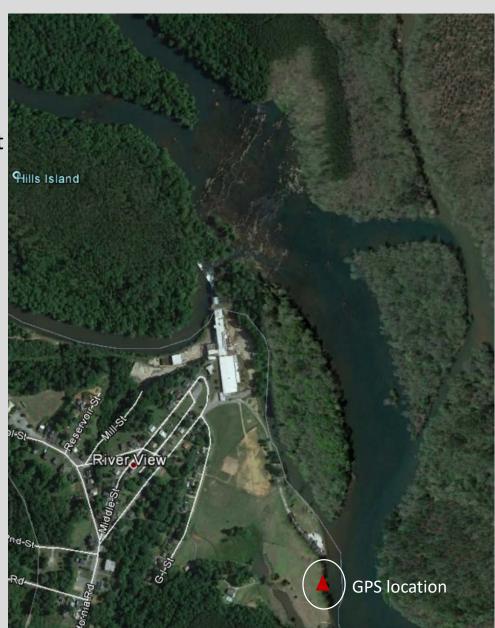
Water-level measurement below

- Location of cross-section identified as BF-WSElev on map provided.
- No discharge measurement was obtained at this location.
- W/S = 515.2 feet. GPS accuracy of +/- 0.30 feet.
