Langdale and Riverview Hydroelectric Projects FERC Nos. 2350 and 2341

Langdale and Riverview Hydroelectric Projects FERC Nos. 2341 and 2350

Public Meeting Hydrologic and Hydraulic (H&H) Modeling Study

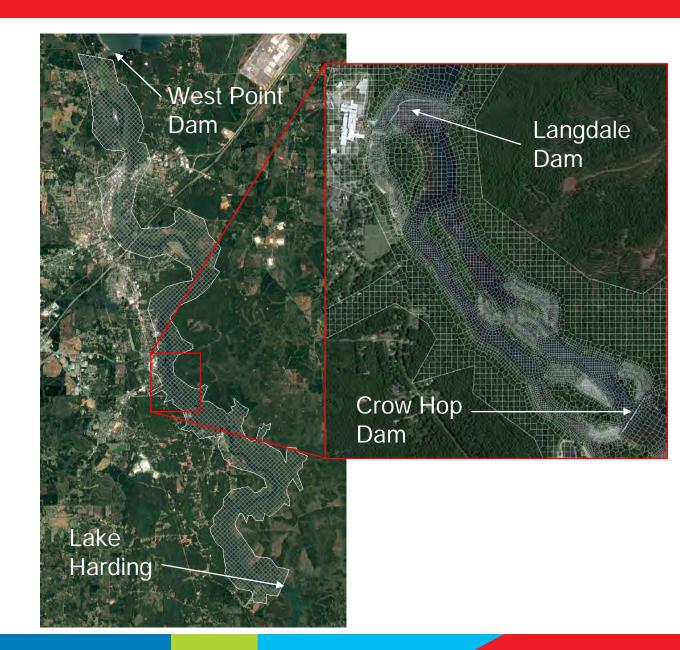
Methods and Data – Terrain Data

- Model extent from West Point Dam to Lake Harding (Bartletts Ferry Project, FERC No. 485)
- 2D mesh with cells varying from 10 feet to 100 feet in size
 - Model computes flow moving from one cell to another
 - Finer cell sizes in areas requiring better resolution data
- Upstream boundary = inflow to Chattahoochee from West Point
- Downstream boundary = water surface elevation dictated by Lake Harding elevation

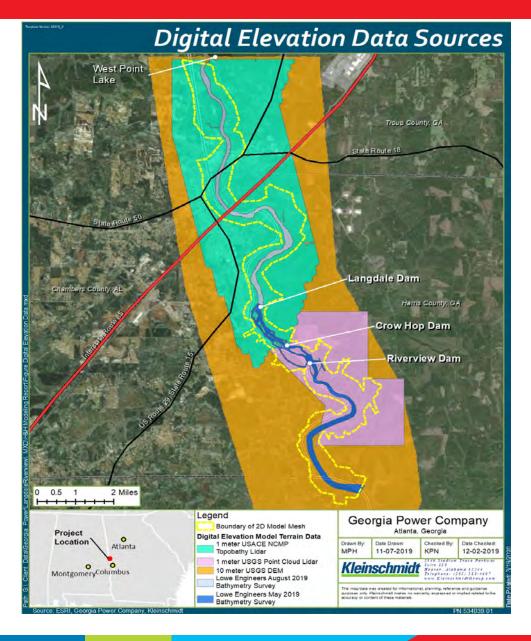
Methods and Data – Elevation Data

- Topographic Data
 - 1/3 arc-second (10-meter) digital elevation model (DEM) from the U.S. Geological Survey (USGS) National Elevation Dataset
 - 1-meter DEM developed from 2010 USGS
 LiDAR (Light Detection and Point Ranging)
 point cloud data for Harris County, Georgia
 - 1-meter DEM from 2015 USACE NCMP Topobathy LiDAR: West Point Lake, Georgia
- Bathymetry (collected by Georgia Power)
 - Lowe Engineers May 2019 Survey
 - Lowe Engineers August 2019 Survey

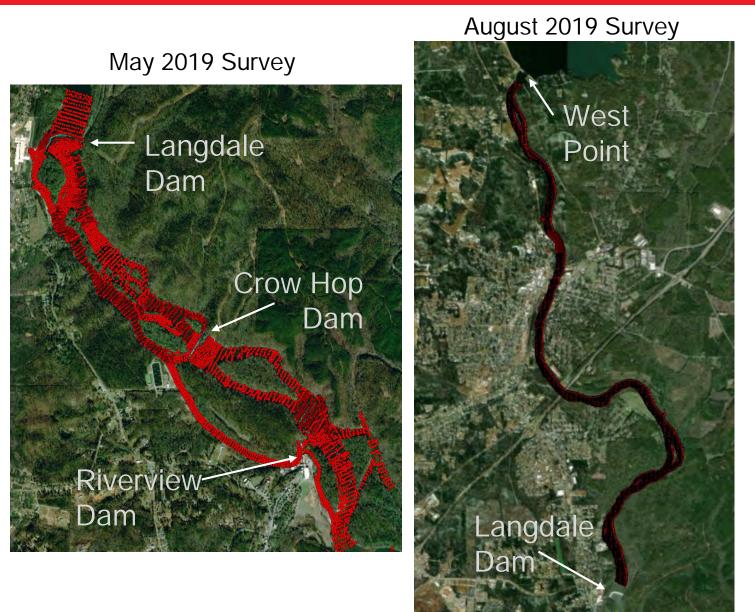
Methods and Data – Elevation Data

- Over 214,000 points collected along river bottom from West Point Dam to Langdale Dam
- Bathymetric points converted into a terrain surface

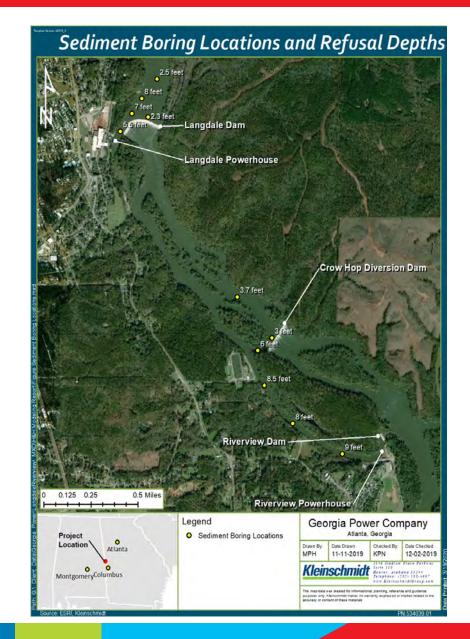
Methods and Data – Sediment Borings

- Geotechnical & Environmental Consultants (GEC)
 - Collected 11 sediment borings
 - 5 upstream of Langdale Dam
 - 3 upstream of Crow Hop Dam
 - 3 upstream of Riverview Dam
- Borings provided grain size distributions and estimated sediment depths
- Sediment data used in modeling to evaluate possible changes assuming natural riverchannel migration after dams' removal

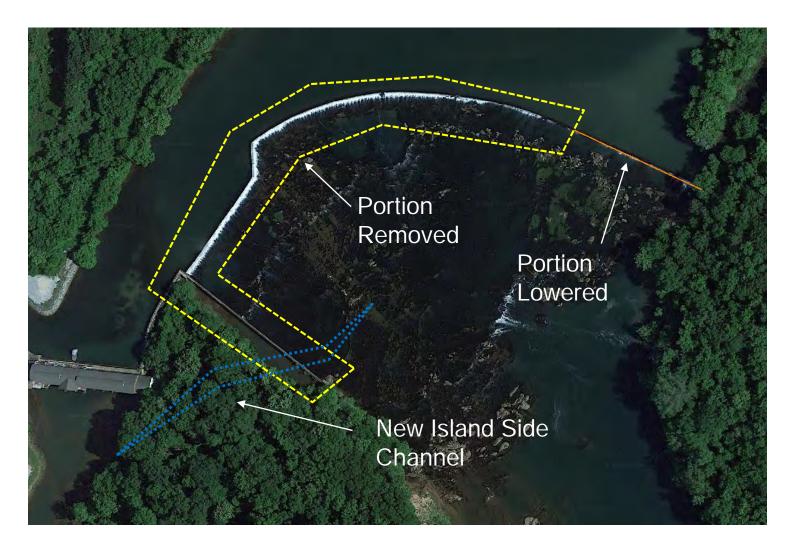
Scenarios Analyzed – Proposed Removals / Modifications

- Langdale
 - Majority of dam removed from western (AL) side
 - ~300 ft portion lowered on eastern (GA) side (to decrease velocity and spread flow across the river)
 - Powerhouse remains
- New Island Side Channel
 - To provide water to powerhouse tailrace

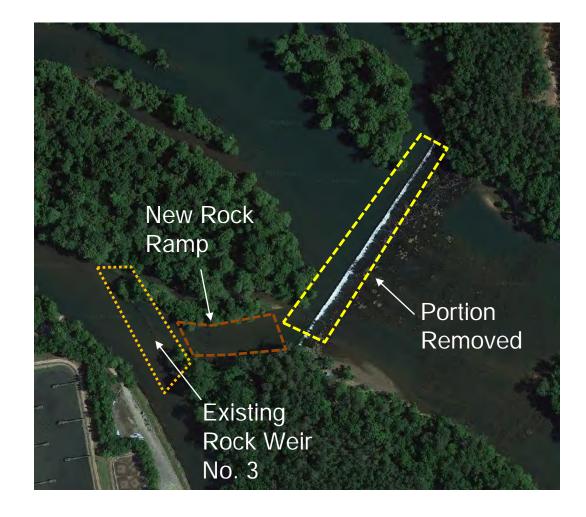
Scenarios Analyzed – Proposed Removals / Modifications

- Crow Hop Dam
 - Nearly fully removed
 - 10 ft abutment sections left at banks of river
- Rock Ramp adjacent to Crow Hop
 - will help maintain rock weir upstream of Riverview channel entrance

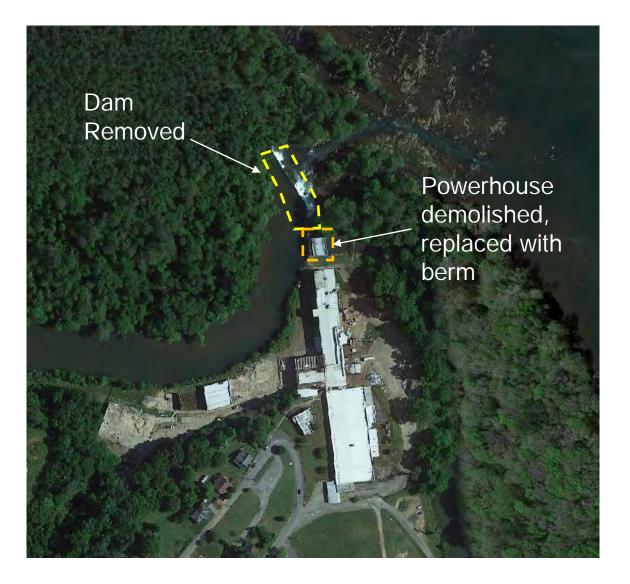
Scenarios Analyzed – Proposed Removals / Modifications

- Riverview
 - Dam nearly fully removed
 - 10 ft abutment sections left at banks of river
 - Powerhouse demolished replaced with berm to constrain flow to Riverview Channel

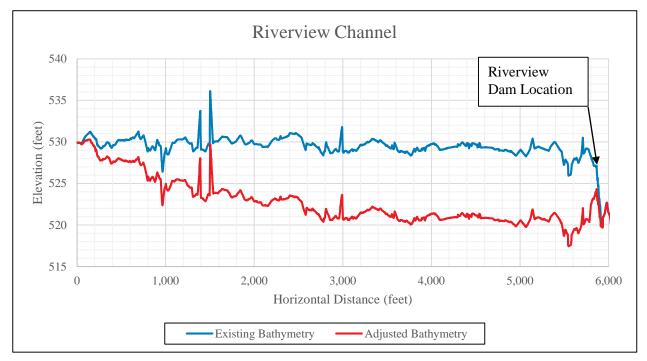
Scenarios Analyzed – River Sediment Assumptions

- Existing Conditions
- Dams Removed Existing Bathymetry
- Dams Removed Adjusted Bathymetry
- Existing Bathymetry assumes surface of river bottom unchanged post-removal of dams
- Adjusted Bathymetry assumes natural sediment migration to refusal depth post-removal of dams (conservative estimate)
 - <u>Note</u>: adjustments made upstream of Langdale and Riverview Dams
- Likely post-dam removal will be somewhere in between these two scenarios

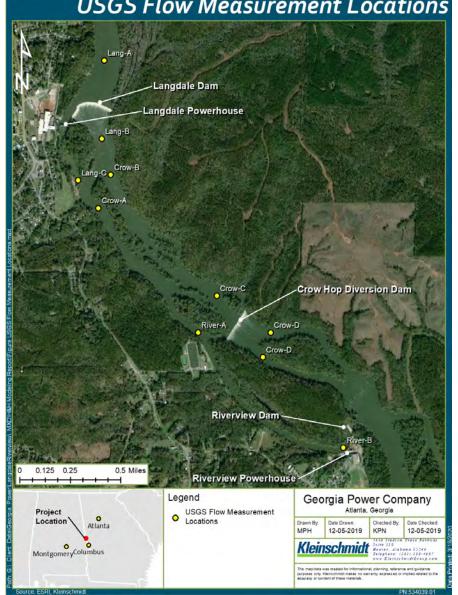
USGS Flow Measurement Locations

- No historic water levels available for Langdale and Riverview powerhouses
- Georgia Power contracted USGS to measure flow in the river
- Model compared well with USGS data

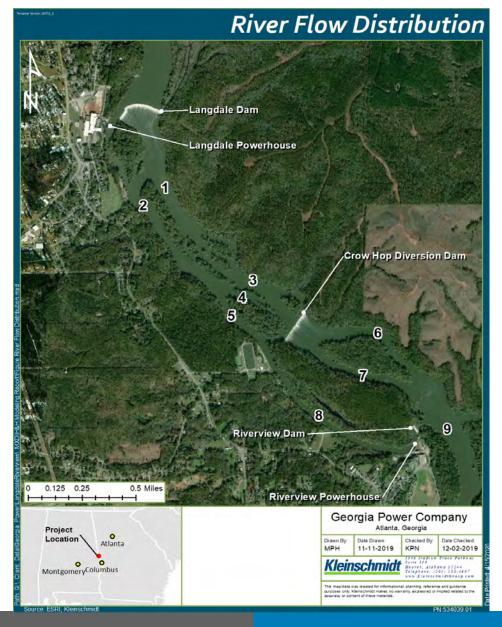
Results – River Flow Distribution – Dams Removed: Existing Bathymetry

West Point Minimum Flow (670 cfs)

- No change in total flow in river, just redistributed
- No changes in river flow distribution downstream from Riverview Dam

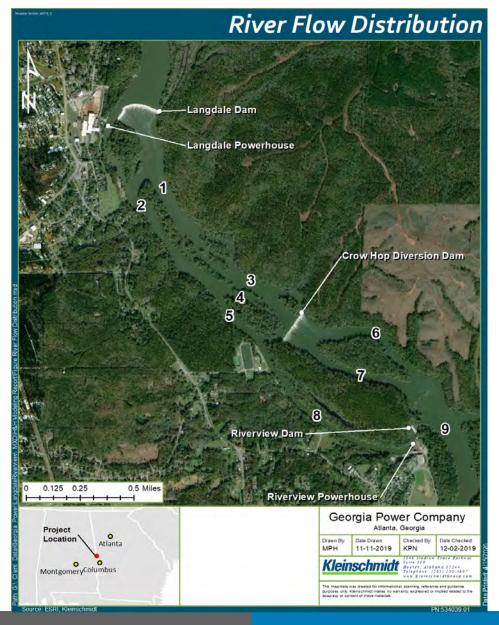
Results – River Flow Distribution – Dams Removed: Existing Bathymetry

West Point Minimum Flow +2 Generating Units (15,875 cfs)

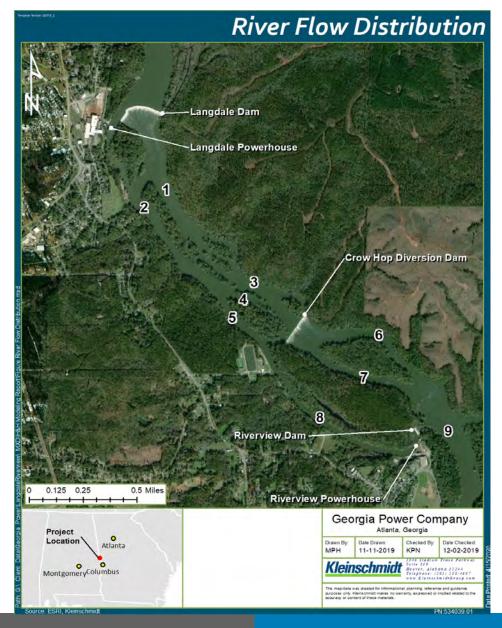
Results – River Flow Distribution – Dams Removed: Adjusted Bathymetry

West Point Minimum Flow (670 cfs)

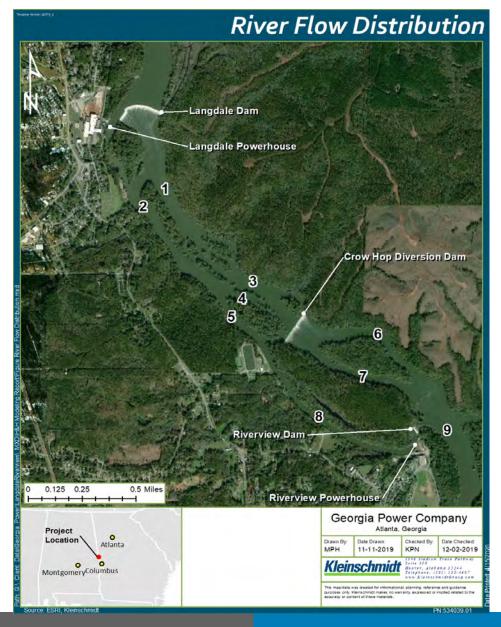
Results – River Flow Distribution – Dams Removed: Adjusted Bathymetry

West Point Minimum Flow +2 Generating Units (15,875 cfs)

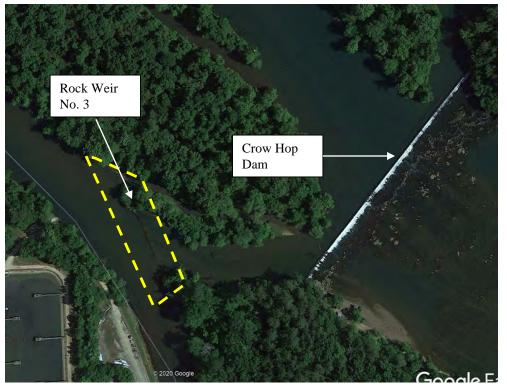
Results – Depth Changes in Riverview Channel

- Adjusted bathymetry simulations show more water entering Riverview Channel
- Despite greater amount of water, water surface elevation decreases due to the removal of the dam and migration of sediment

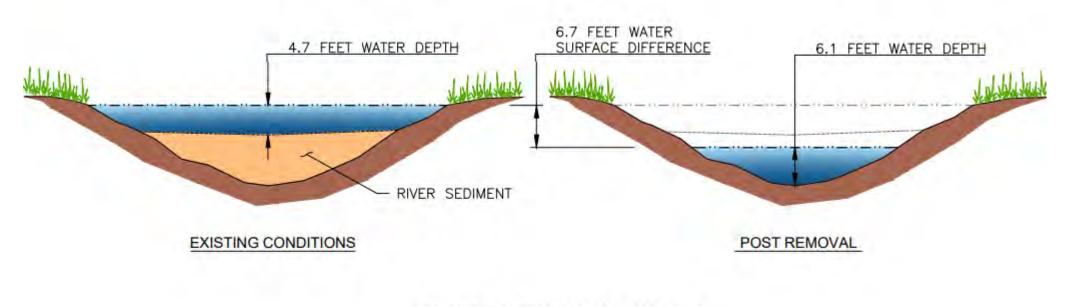
Results – Depth Changes in Riverview Channel

CHANNEL SECTION EXAMPLE

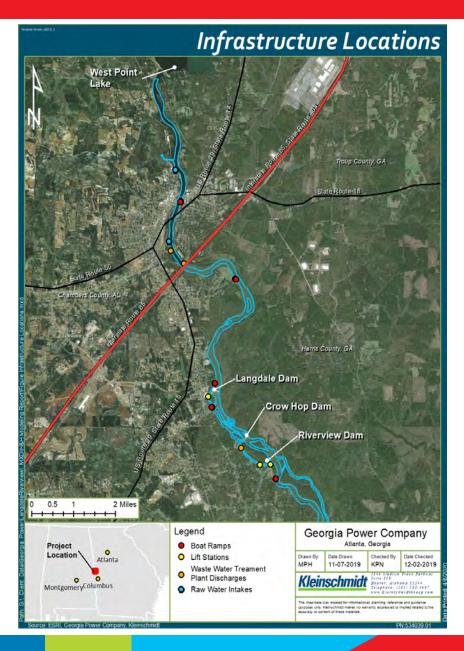
- Cemetery Park boat ramp partially dewatered at West Point Min Flow and velocities decreased under all flows modeled
- Shawmut Airport boat ramp dewatered at West Point Min Flow, reduced depth at other flows, and slightly increased velocities above Min Flow
- Similar results for both dam removal with existing and adjusted bathymetry

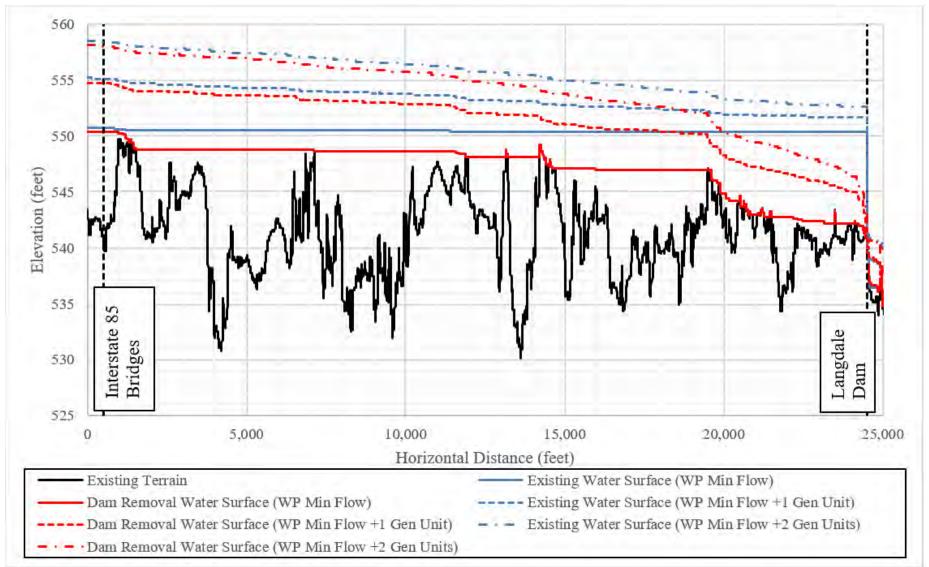
Dams Removed, Existing Bathymetry

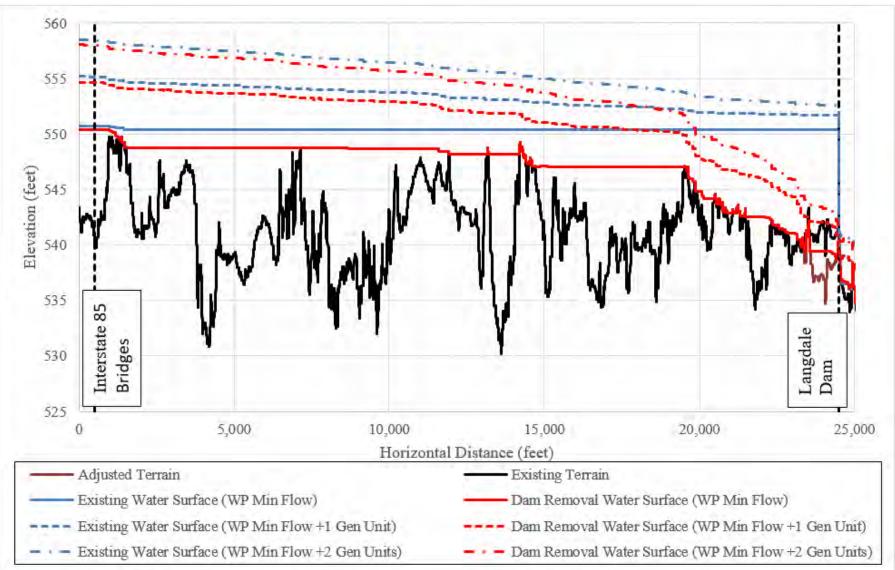
Results – Water Surface Profile I-85 to Langdale Dam

Dams Removed, Adjusted Bathymetry

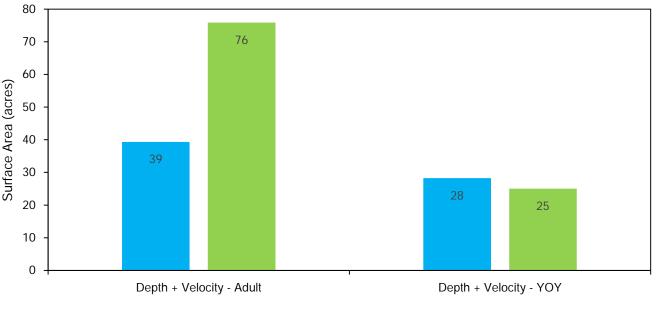
Areas with Optimal Depth and Velocity

- 1990 study on Ocmulgee River developed habitat suitability criteria for Shoal Bass
- Optimal Habitat
 - Adults
 - Depths of ~ 3 to 5 feet
 - Velocities of ~ 0.5 to 0.8 ft/sec
 - Young-of-year (YOY)
 - Depths of ~ 1 to 1.5 feet
 - Velocities < 0.2 ft/sec
- Compared pre- and postremoval availability using HEC-RAS model simulation results

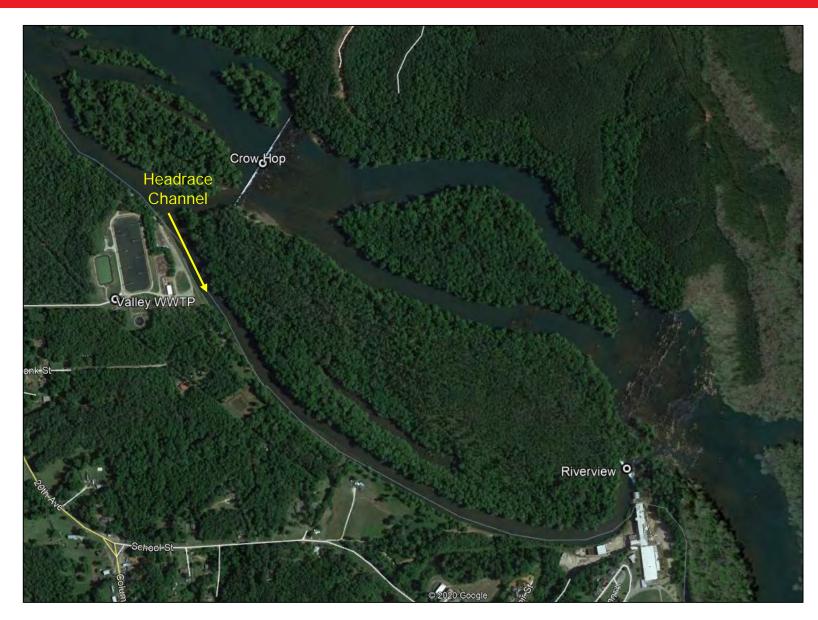
- East Alabama/Lower Valley WWTP discharge permit based on 7Q10 flow of 136 cfs
- H&H modeling indicates post-removal flow of 193 cfs under minimum flow discharge from West Point

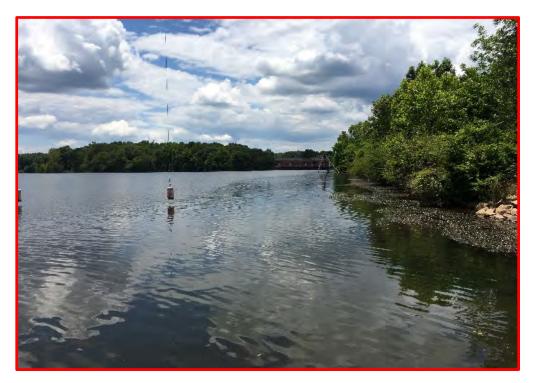
- Above Langdale Dam
 - Habitat: poor to moderate
 - Substrate: mixed sands with varying mixtures of sand, cobble, and clay
 - East side of river had more defined channel with boulders

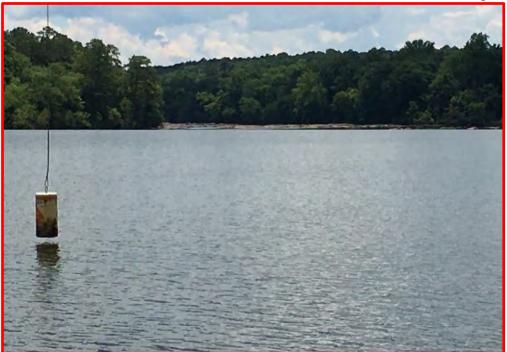
- Below Langdale Dam
 - Habitat: poor to moderate
 - Substrate: mix of bedrock, boulders, and sand
 - East side of river had more defined channel with boulders
 - Side channel with loose sand/silt/clay

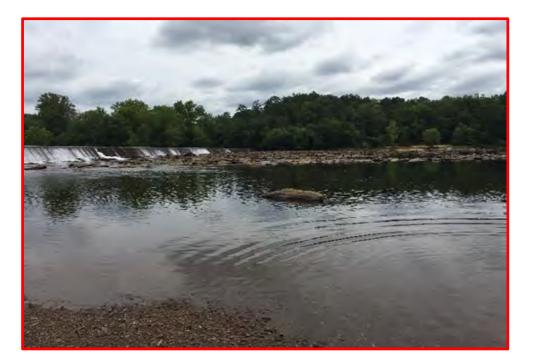
- Below Crow Hop Dam
 - Habitat: poor to moderate
 - Substrate: primarily a mix of bedrock, boulders, and sands
 - East side of river had more defined channel with boulders

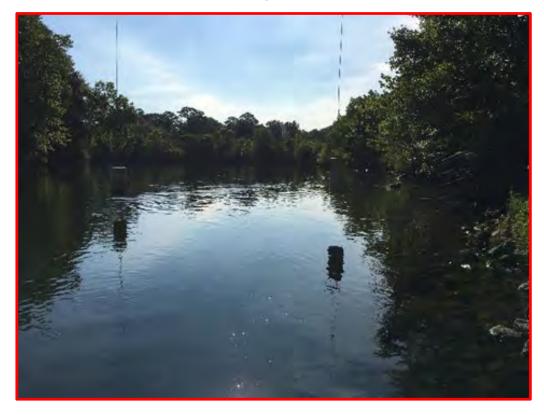
- Above Riverview Dam
 - Habitat: poor
 - Substrate: rock and rip-rap along sides of channel and mixed sands with areas of sand, cobble, clay, and silt in the middle

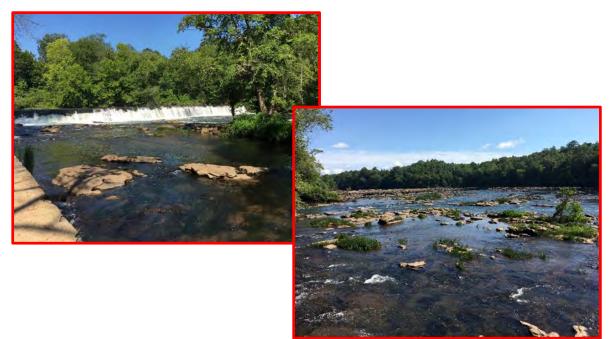
- Below Riverview Dam
 - Habitat: poor to moderate
 - Substrate: primarily a mix of bedrock, boulders, and sands
 - Side channel discharging from powerhouse almost entirely soft, loose substrate
