## 2021 Semi-Annual Groundwater Monitoring and Corrective Action Report

**Georgia Power Company – Plant Mitchell**

Ash Ponds A, 1, and 2 Putney, Georgia

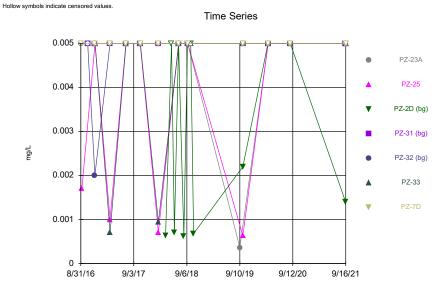
Constituent: Arsenic Analysis Run 11/5/2021 1:38 AM

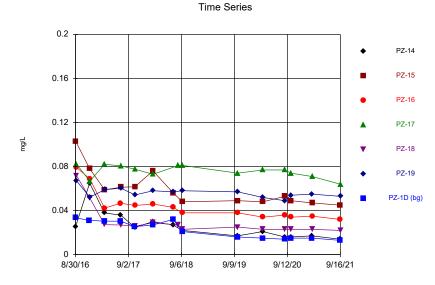
Constituent: Barium Analysis Run 11/5/2021 1:38 AM

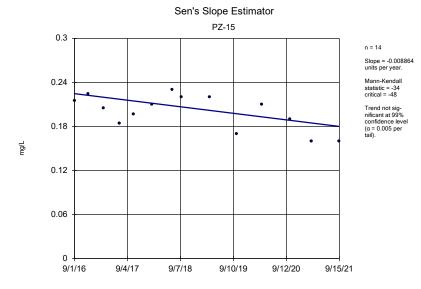
Constituent: Boron Analysis Run 10/24/2021 10:37 PM View: Trend Tests
Plant Mitchell Client: Southern Company Data: Mitchell Ash Pond CCR
