257.83 (b) (2)	REPORT OF ANNUAL INSPECTION OF CCR SURFACE IMPOUNDMENT			
	FACILITY NAME: Plant Hammond, Ash Pond 2 (AP-2)			
	OWNER/OPERATOR OF FACILITY: Georgia Power Company			
	INSPECTION DATE: October 19, 2021			
	INSPECTING ENGINEER: Jacob A. Jordan, P.E. (GA PE# PE028586)

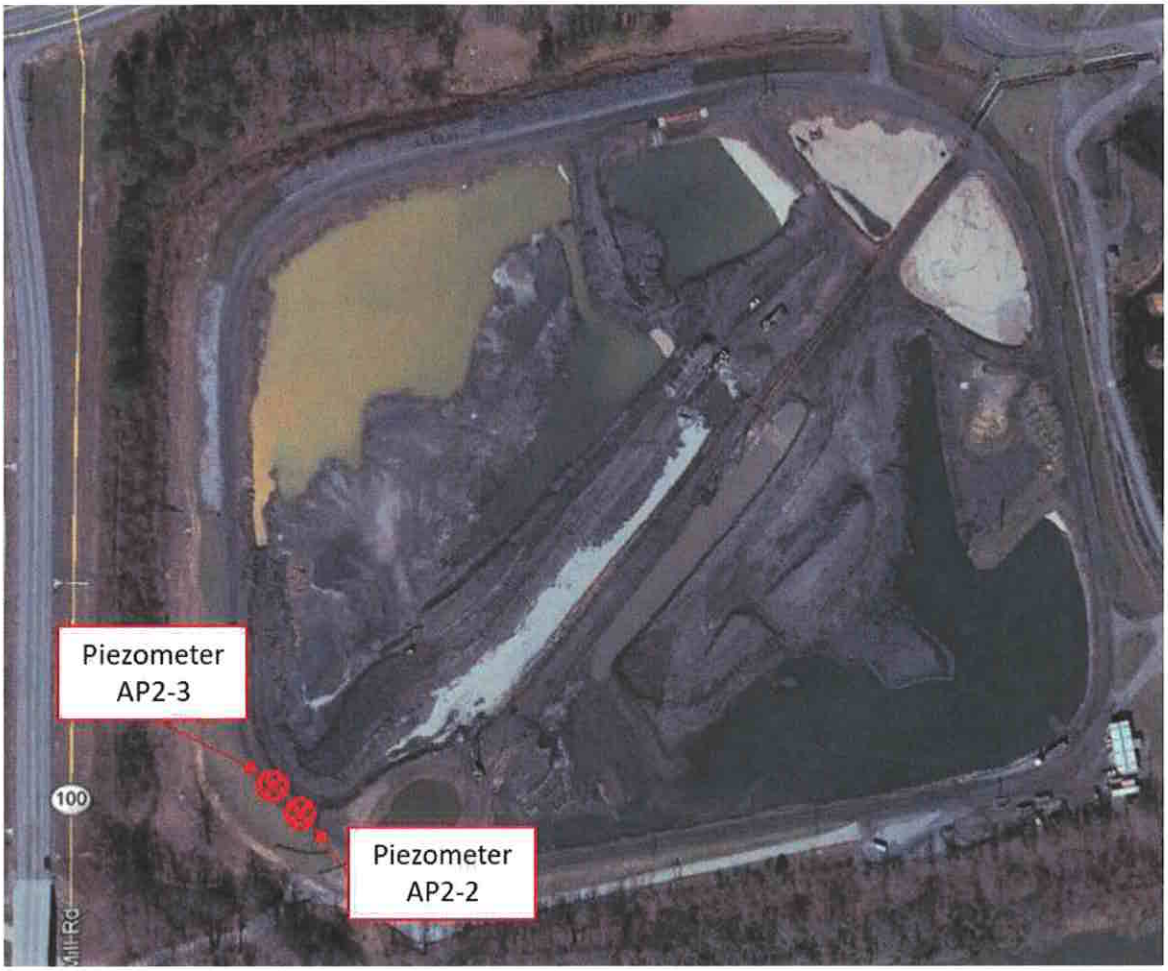
INSTRUMENTATION PLAN
PLANT HAMMOND ASH POND 2

PIEZOMETER NUMBER	MAXIMUM RECORDED READING*
AP2-2	EL 583
AP2-3	EL 571
