# CCR SURFACE IMPOUNDMENT EMERGENCY ACTION PLAN

Georgia Power Company  
Plant Yates  
Ash Pond AP-2  
State ID: 038-063-04138  
NID: GA04184  
Coweta County, GA

**ISSUE DATE:** April 15, 2022  
**REVISION #:** 5

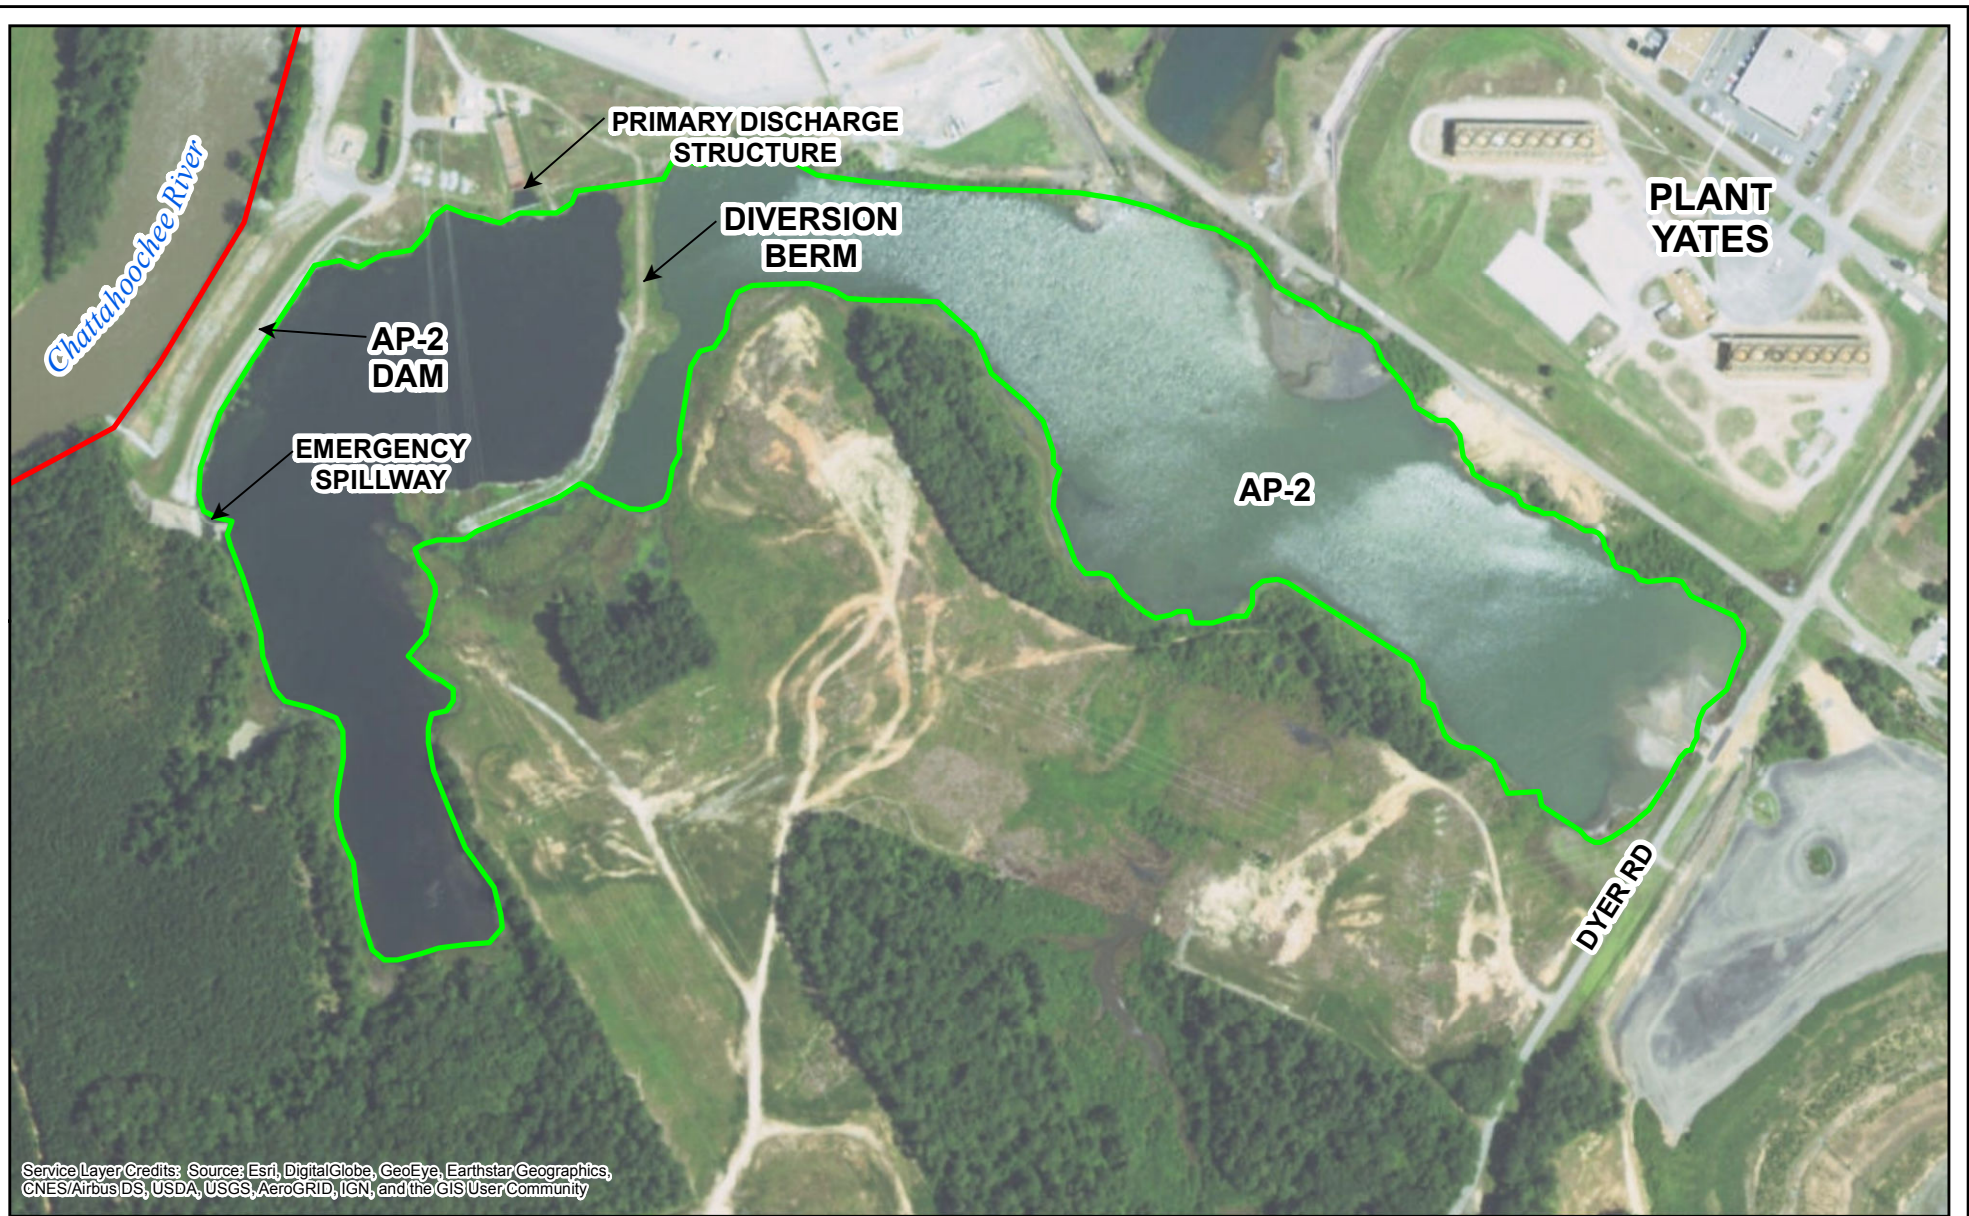
FIGURE 2  
ASH POND OVERVIEW  
PLANT YATES  
COWETA COUNTY, GEORGIA

**Ash Pond AP-2 Overview – Figure 2**

AP-2 has an earthen embankment/dam on its western side and is approximately 63 acres in size at its normal pool elevation of 722 feet (Appendix A – Figure 1 and Figure 2). The dam currently has a maximum height of approximately 39 feet.

Plant personnel are able to access the dam from the north by paved or gravel-surfaced roadways from the main portion of Plant Yates. Figures 1 and 2 show the location of AP-2 on Plant property.
