# CCR SURFACE IMPOUNDMENT EMERGENCY ACTION PLAN

Georgia Power Company  
Plant Hammond  
Ash Pond AP-2  
State ID: 057-036-04321  
NID: GA06023  
Floyd County, GA

**ISSUE DATE:** April 15, 2022  
**REVISION #:** 3

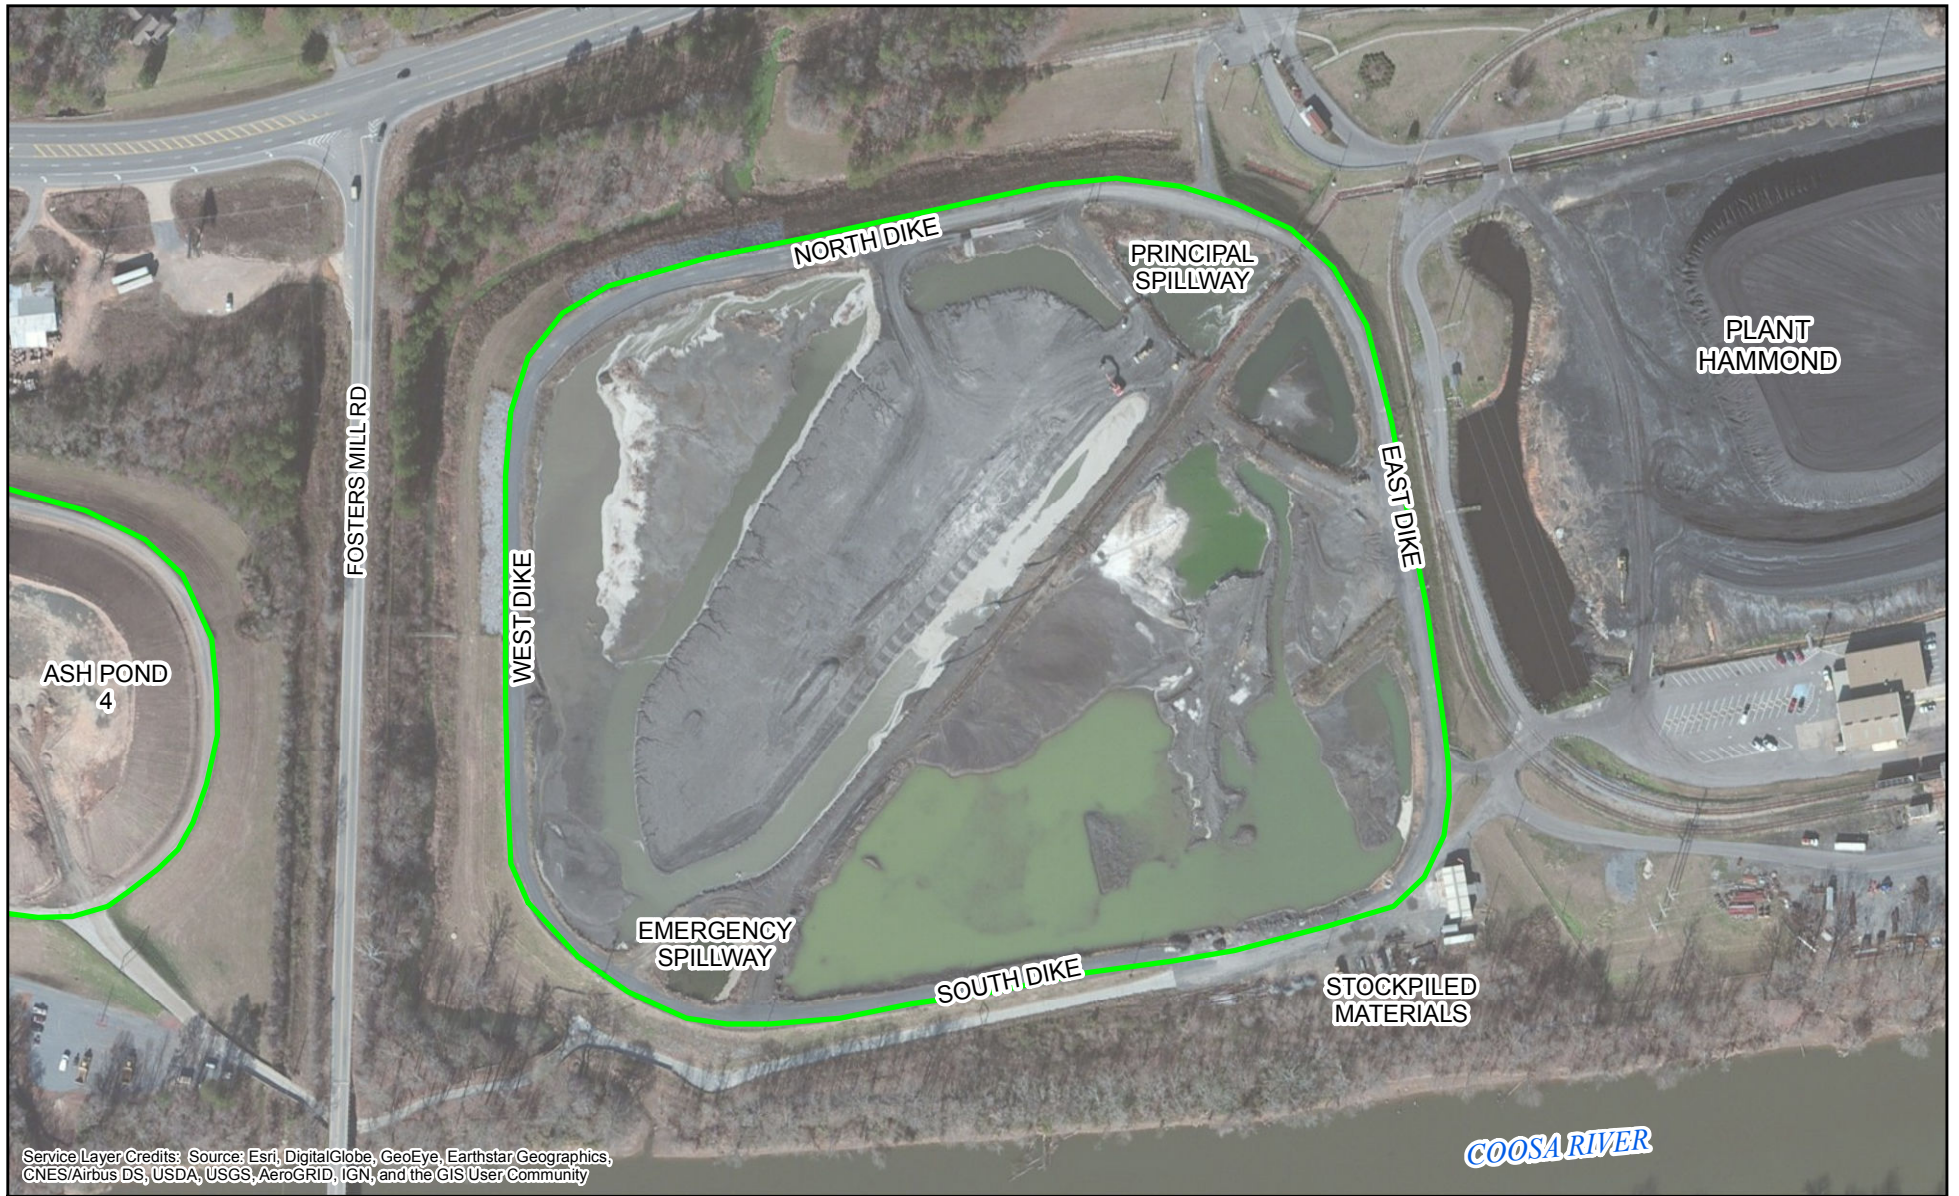
FIGURE 2  
ASH POND 2 OVERVIEW  
PLANT HAMMOND  
FLOYD COUNTY, GEORGIA

AP-2 is approximately 26 acres in size at its previous normal pool elevation of 593.1 feet (Appendix A – Figure 2). AP-2 has earthen embankments (also referred to as dam/dikes) on all sides. The dam/dikes have a maximum height of approximately 24 feet. A network of interior separator dikes divides AP-2 into northern and southern cells, as well as forming two smaller basins in the northeast and southwest corner. These cells initially discharge to a smaller basin located in the northeast corner of the impoundment. The crest surface is composed of grass and a gravel access drive. Downstream slopes are typically covered with grass in the exception of areas of previous repairs, which are covered with riprap. Outlets are located at the northeastern and southwestern portion of AP-2 and consist of:

Plant and emergency personnel are able to access the AP-2 dam/dike from the main portion of Plant Hammond by paved or gravel-surfaced roadways. Figures 1 and 2 show the location of AP-2 on Plant property.
