# CCR SURFACE IMPOUNDMENT EMERGENCY ACTION PLAN

Georgia Power Company  
Plant Scherer  
Ash Pond AP-1  
State ID: 102-032-04236  
NID: GA07217  
Monroe County, GA

ISSUE DATE: 01/17/2024  
REVISION #: 4

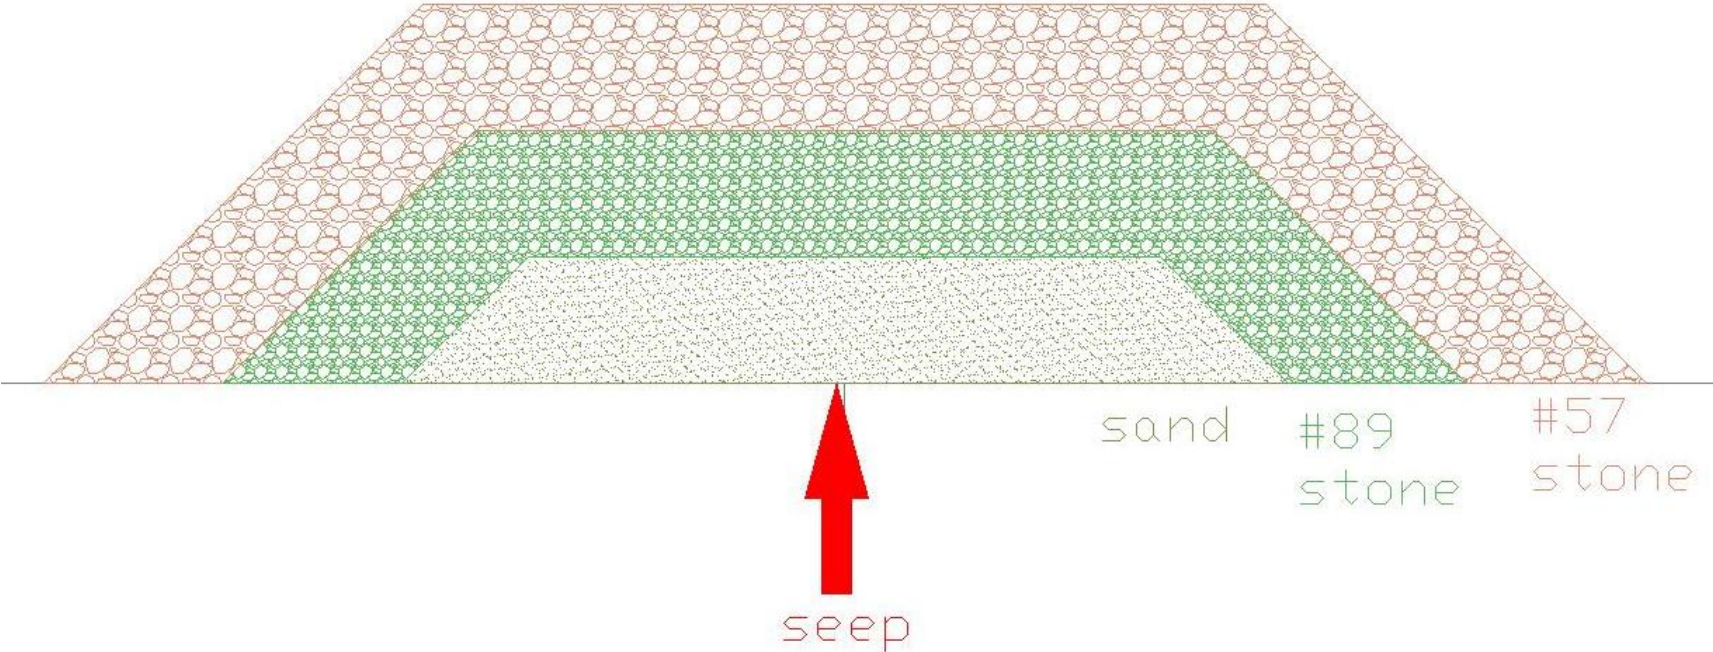
# CROSS SECTION OF A REVERSE FILTER OVER A SEEP OR BOIL

**Filter fabric or geotextile is not acceptable as a substitute for the sand. The fabric tends to smear and clog if applied in a wet situation.**
