EMERGENCY ACTION PLAN

Georgia Power Company
Plant Bowen
Ash Pond AP-1 Dam
State ID: 008-031-04136
NID: GA03958
Bartow County, GA

ISSUE DATE: December 8, 2020
REVISION #: 3

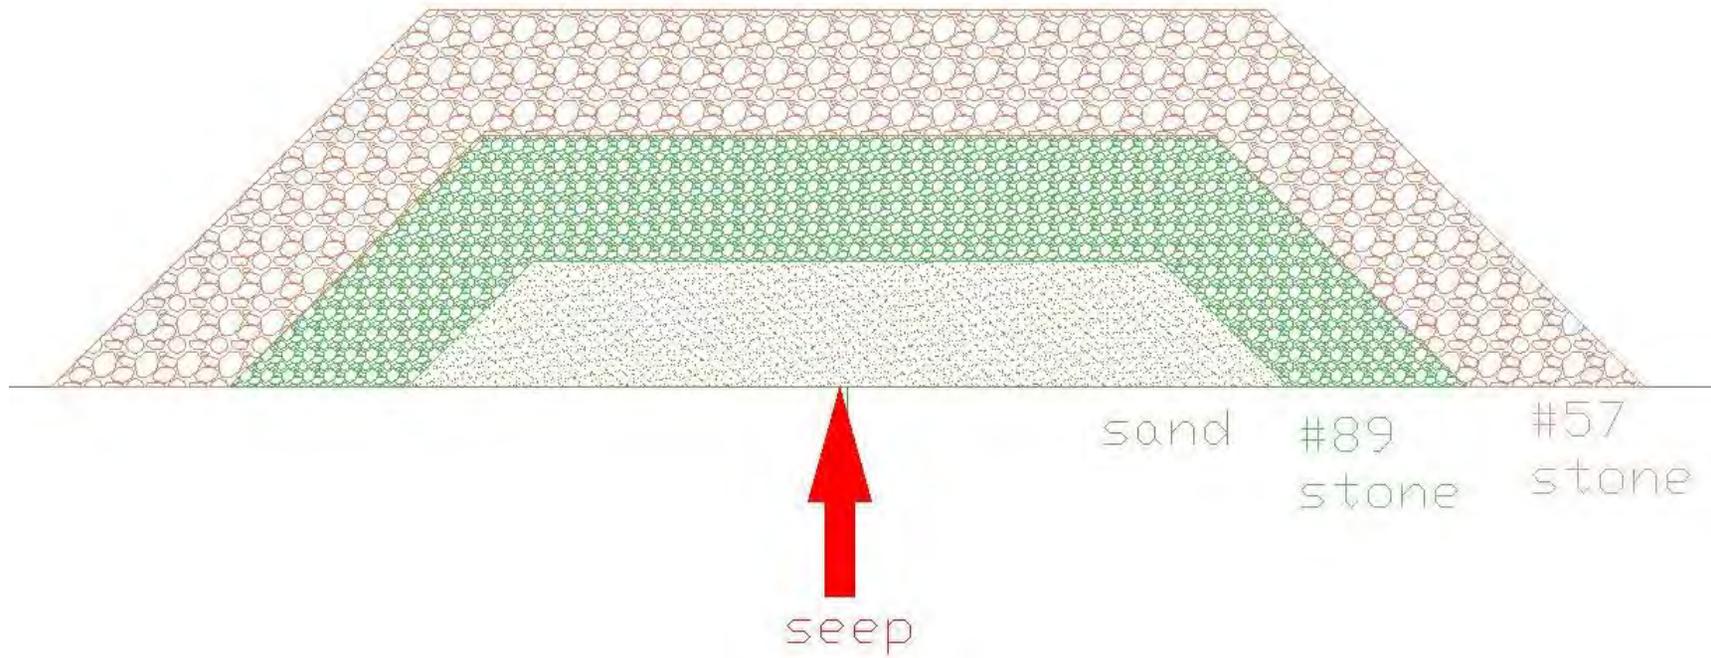
CROSS SECTION OF A REVERSE FILTER OVER A SEEP OR BOIL

Filter fabric or geotextile is not acceptable as a substitute for the sand. The fabric tends to smear and clog if applied in a wet situation.
