CCR SURFACE IMPOUNDMENT EMERGENCY ACTION PLAN

Georgia Power Company
Plant Bowen
Ash Pond AP-1
State ID: 008-031-04136
NID: GA03958
Bartow County, GA

ISSUE DATE: April 15, 2022
REVISION #: 5

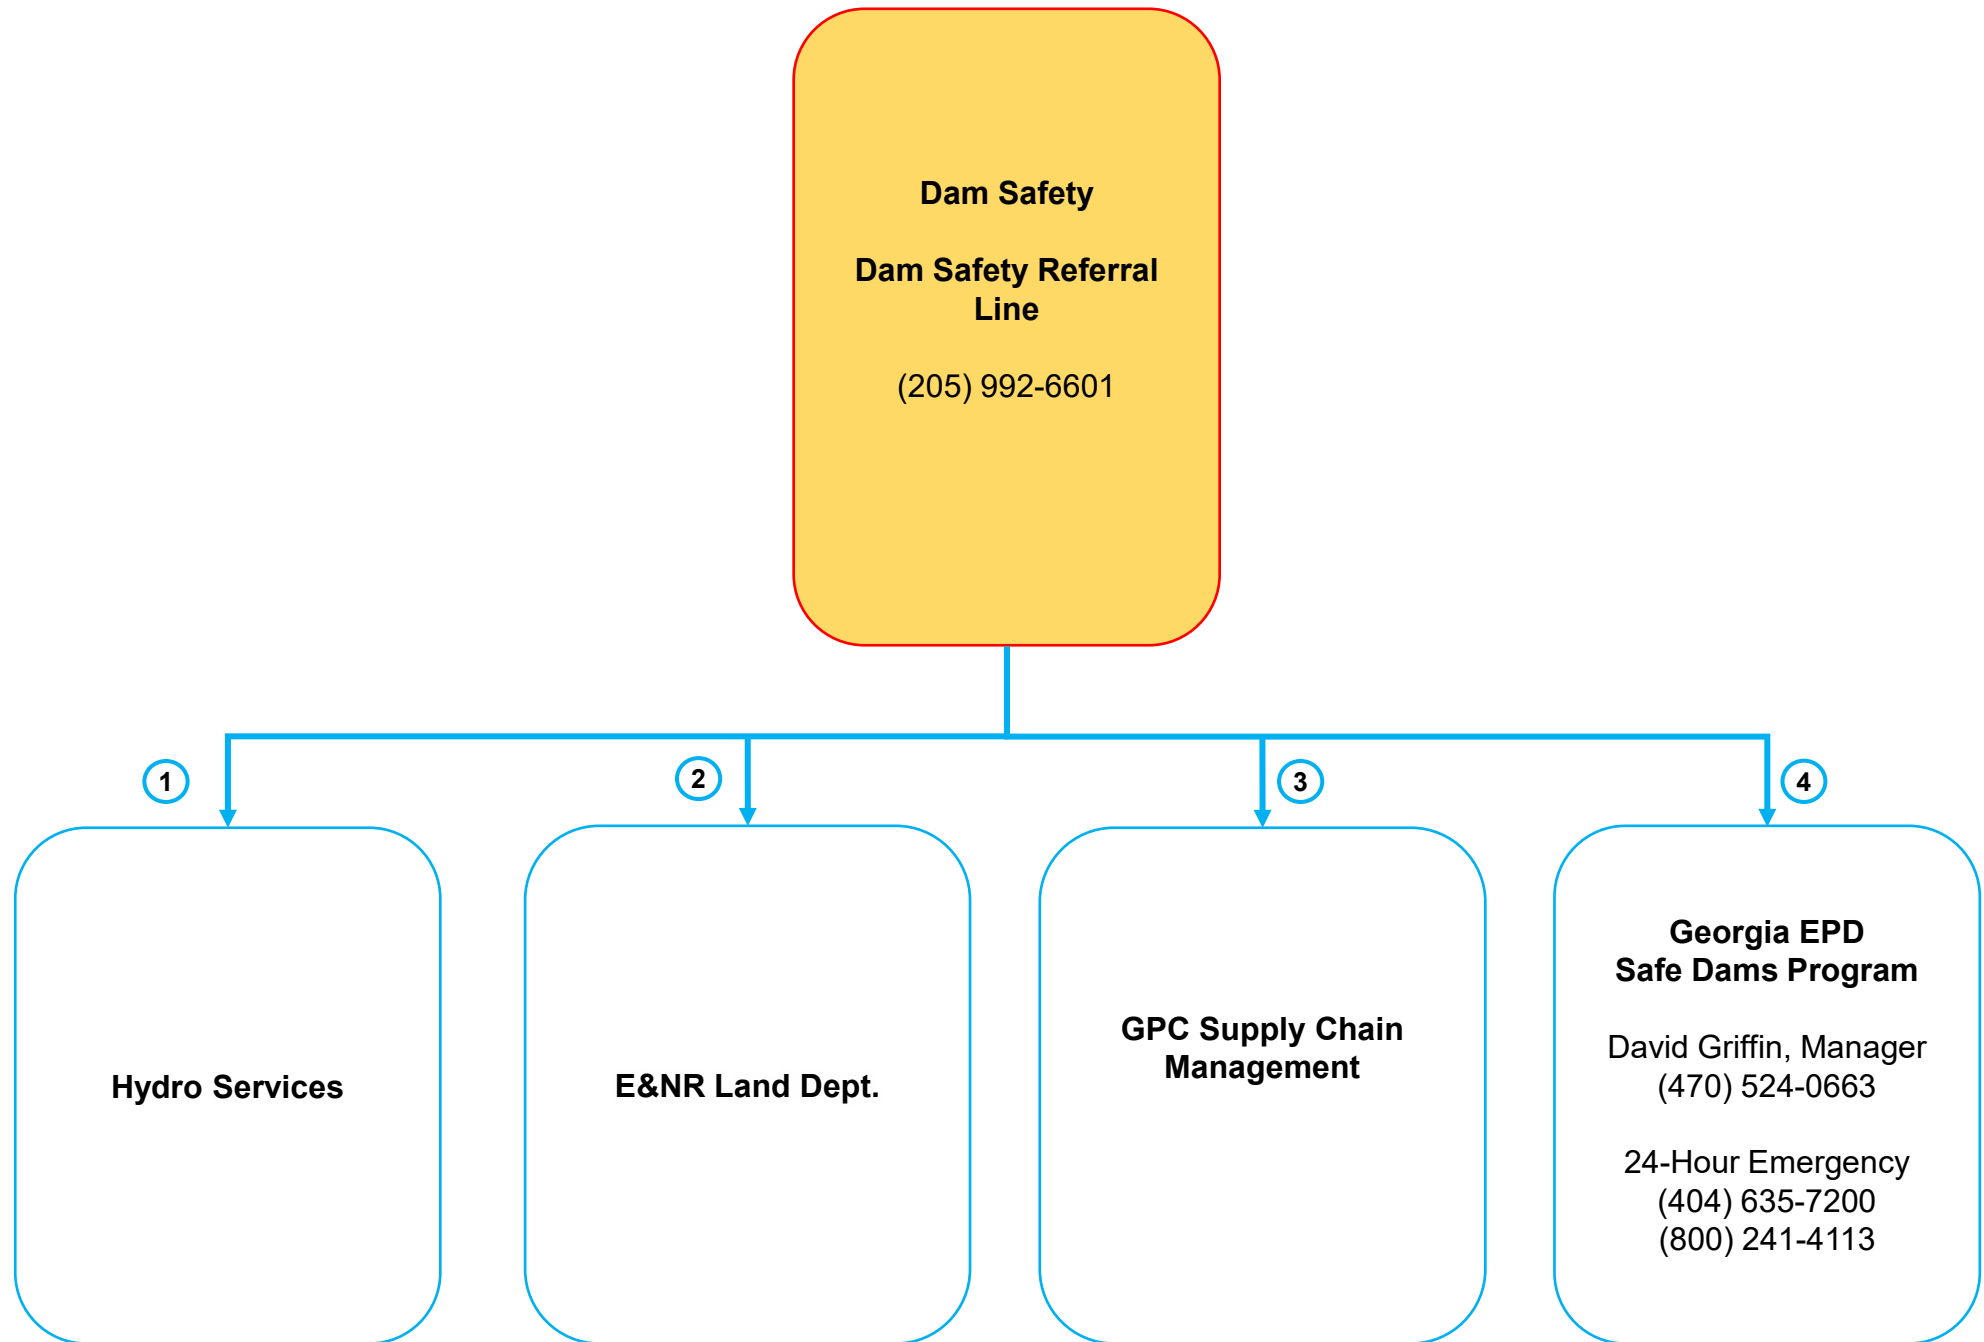
Response Notification Flowchart

Imminent Failure or Potential Failure Emergencies

Fossil Dam Safety Notifications
