# CCR SURFACE IMPOUNDMENT EMERGENCY ACTION PLAN

## Plant Hammond Ash Pond 2 (AP-2)

ISSUE DATE: April 15, 2019  
REVISION #: 2

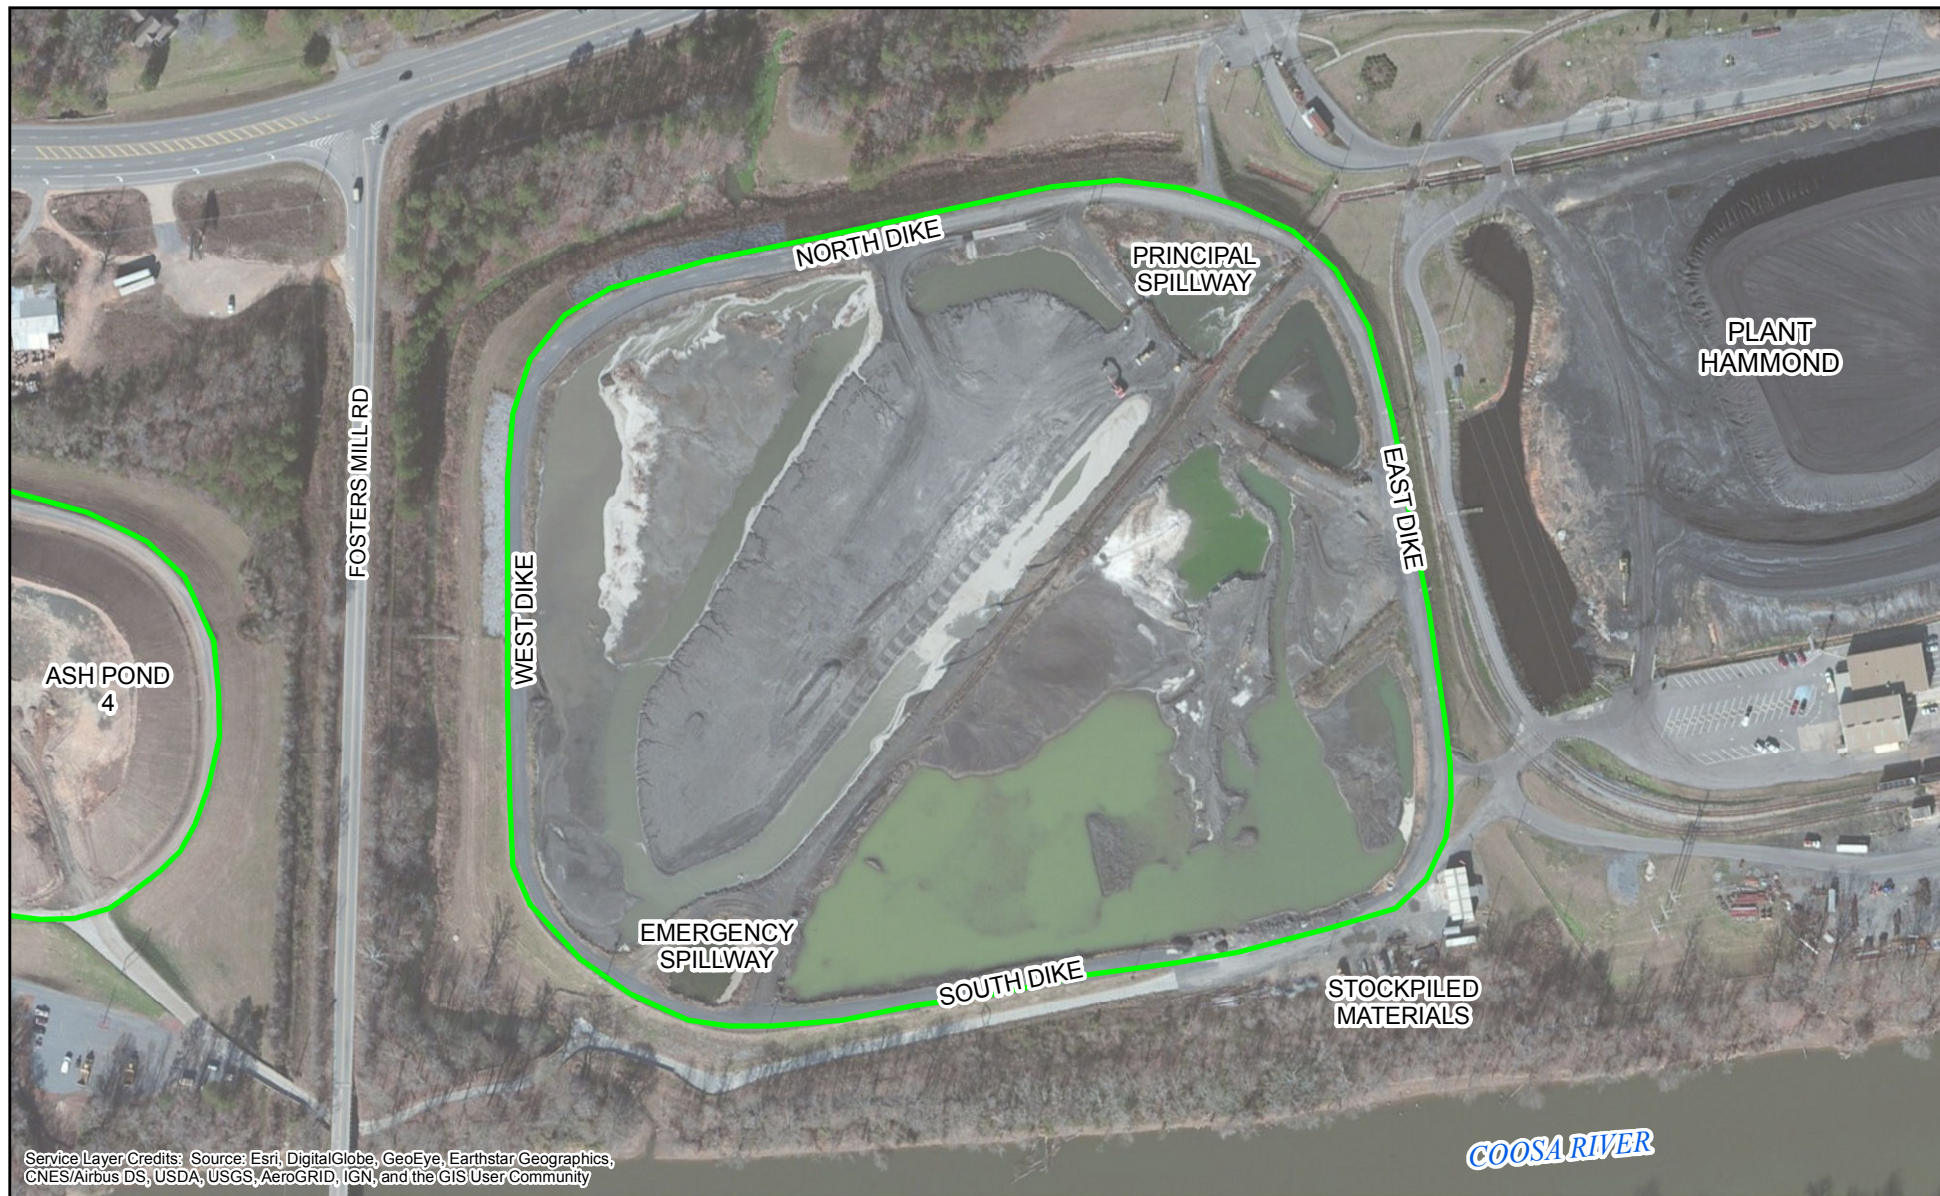
FIGURE 2  
ASH POND 2 OVERVIEW  
PLANT HAMMOND  
FLOYD COUNTY, GEORGIA

AP-2 is approximately 21 acres in size at its normal pool elevation of 593.1 feet (Appendix A – Figure 2). AP-2 has earthen embankments (also referred to as dam/dikes) on all sides. The dam/dikes have a maximum height of approximately 24 feet. A network of interior separator dikes divides AP-2 into northern and southern cells, as well as forming two smaller basins in the northeast and southwest corner, which are designated as recycle basin and emergency overflow basin respectively. The crest surface is composed of grass and a gravel access drive. Downstream slopes are typically covered with grass in the exception of areas of previous repairs, which are covered with riprap. Outlets are located at the northeastern and southwestern portion of AP-2 and consist of:

Plant and emergency personnel are able to access the AP-2 dam/dike from the main portion of Plant Hammond by paved or gravel-surfaced roadways. Figures 1 and 2 show the location of AP-2 on Plant property.
