CCR SURFACE IMPOUNDMENT

EMERGENCY ACTION PLAN

Plant McManus Ash Pond AP-1

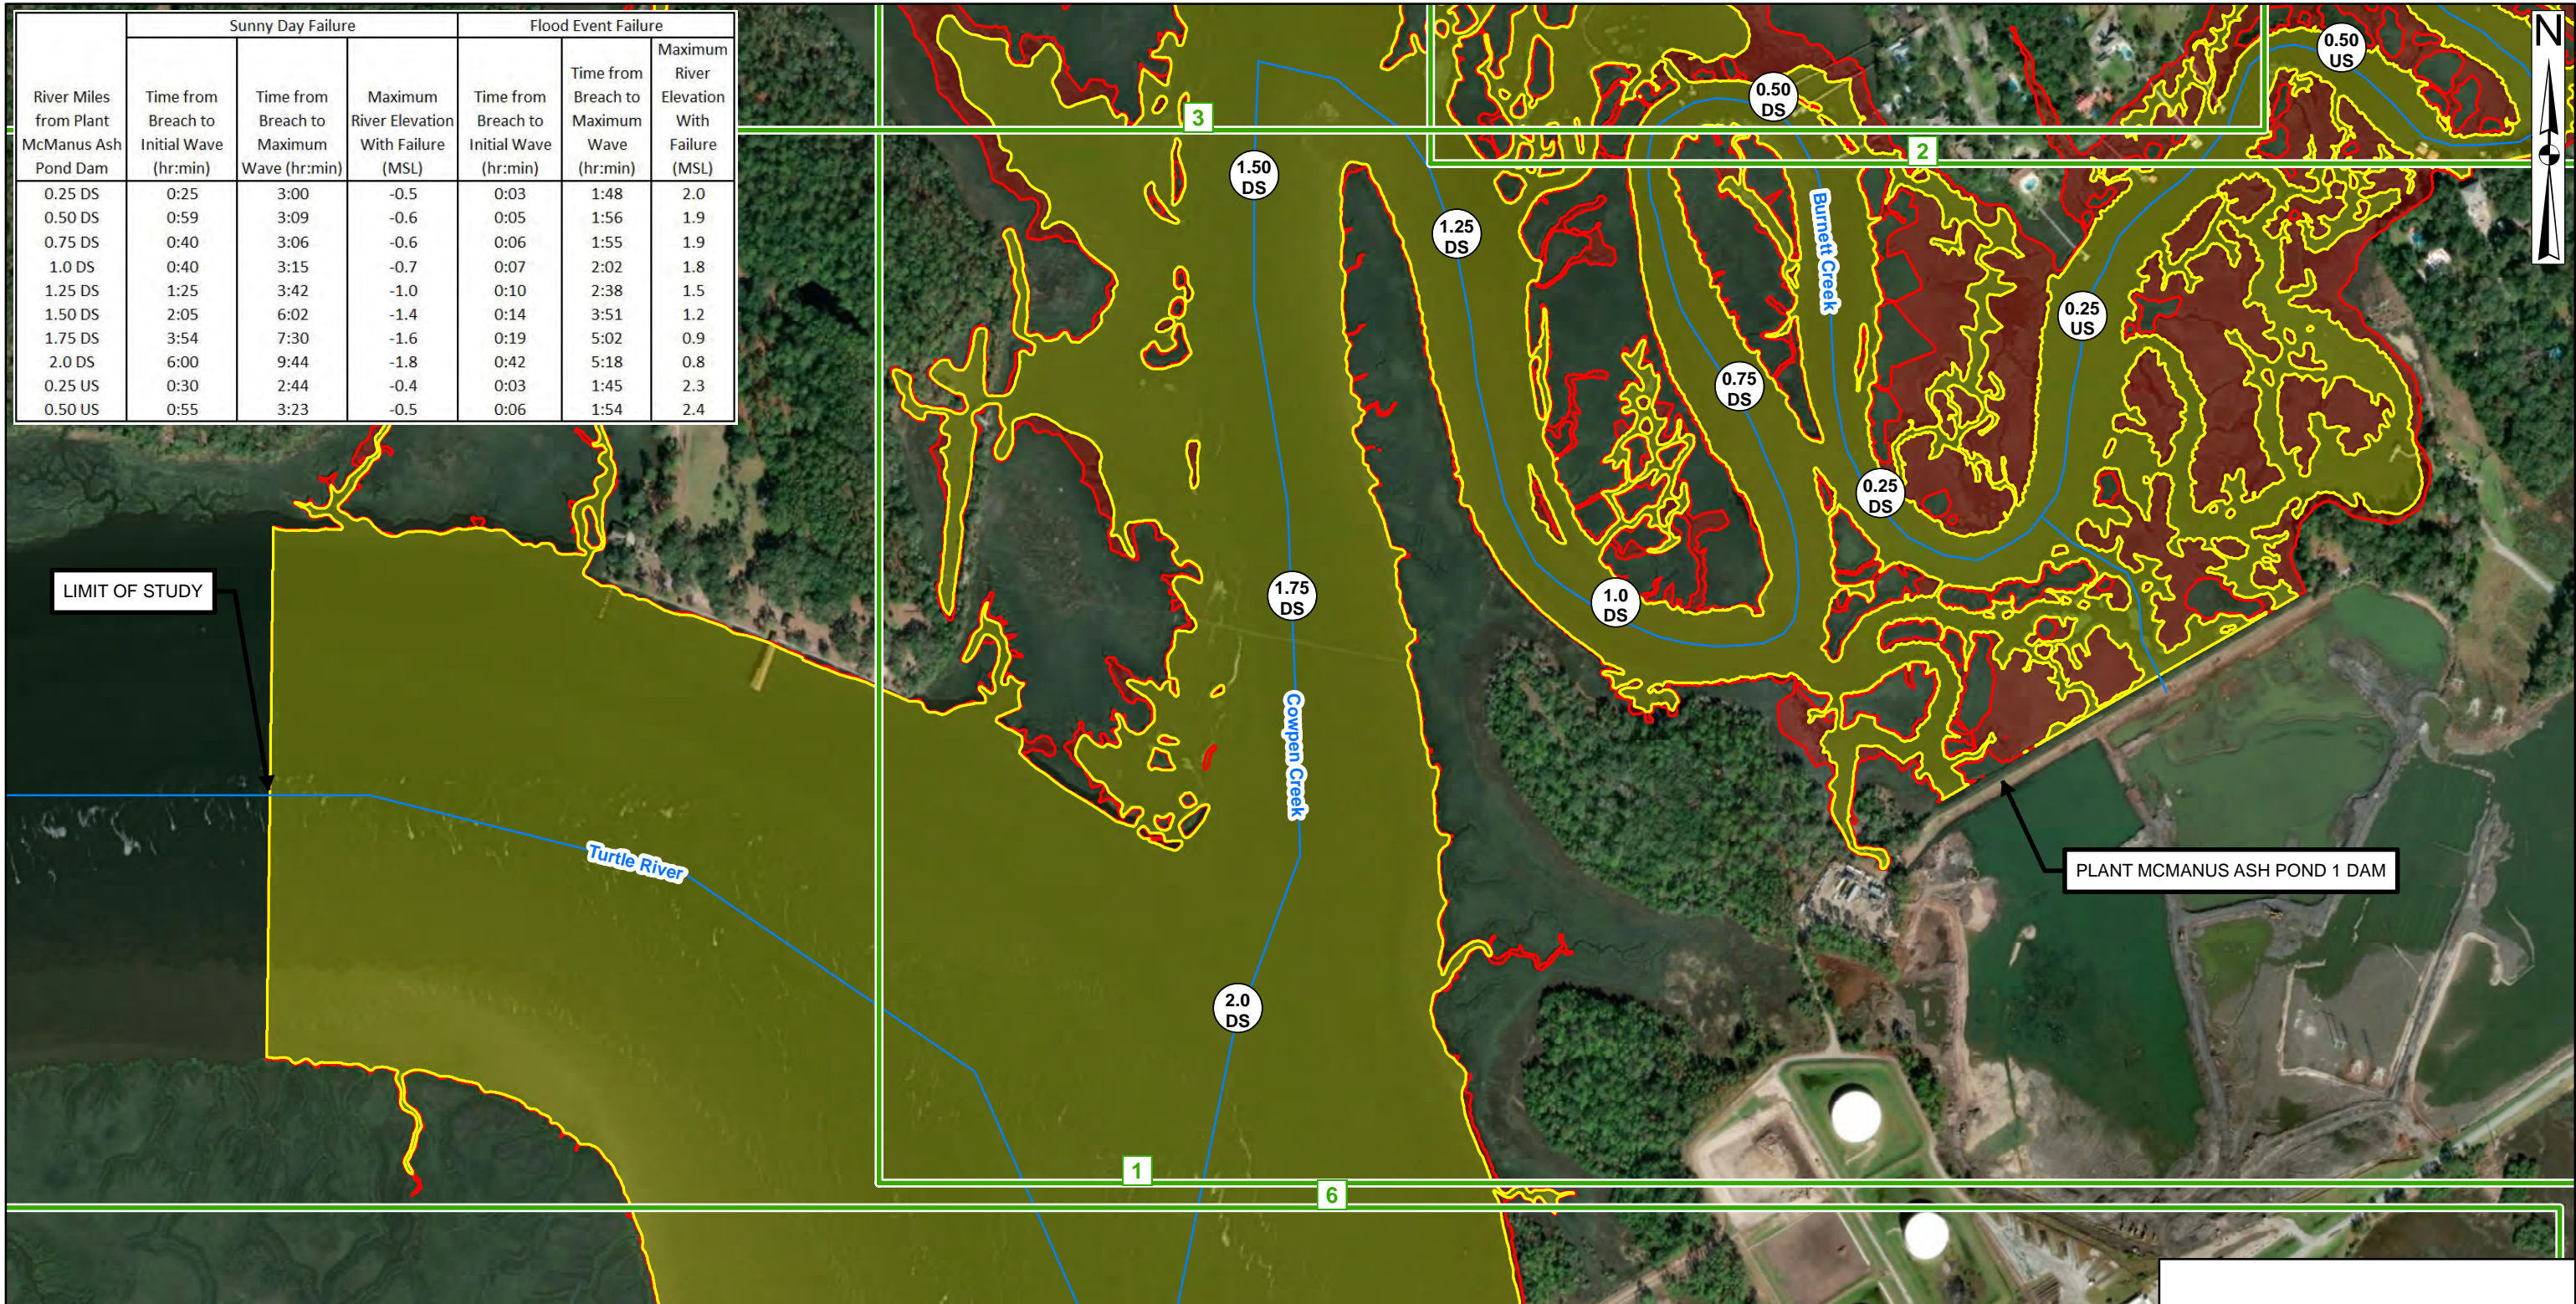
River Miles from Plant McManus Ash Pond Dam	Sunny Day Failure			Flood Event Failure		
	Time from Breach to Initial Wave (hr:min)	Time from Breach to Maximum Wave (hr:min)	Maximum River Elevation With Failure (MSL)	Time from Breach to Initial Wave (hr:min)	Time from Breach to Maximum Wave (hr:min)	Maximum River Elevation With Failure (MSL)
0.25 DS	0:25	3:00	-0.5	0:03	1:48	2.0
0.50 DS	0:59	3:09	-0.6	0:05	1:56	1.9
0.75 DS	0:40	3:06	-0.6	0:06	1:55	1.9
1.0 DS	0:40	3:15	-0.7	0:07	2:02	1.8
1.25 DS	1:25	3:42	-1.0	0:10	2:38	1.5
1.50 DS	2:05	6:02	-1.4	0:14	3:51	1.2
1.75 DS	3:54	7:30	-1.6	0:19	5:02	0.9
2.0 DS	6:00	9:44	-1.8	0:42	5:18	0.8
0.25 US	0:30	2:44	-0.4	0:03	1:45	2.3
0.50 US	0:55	3:23	-0.5	0:06	1:54	2.4

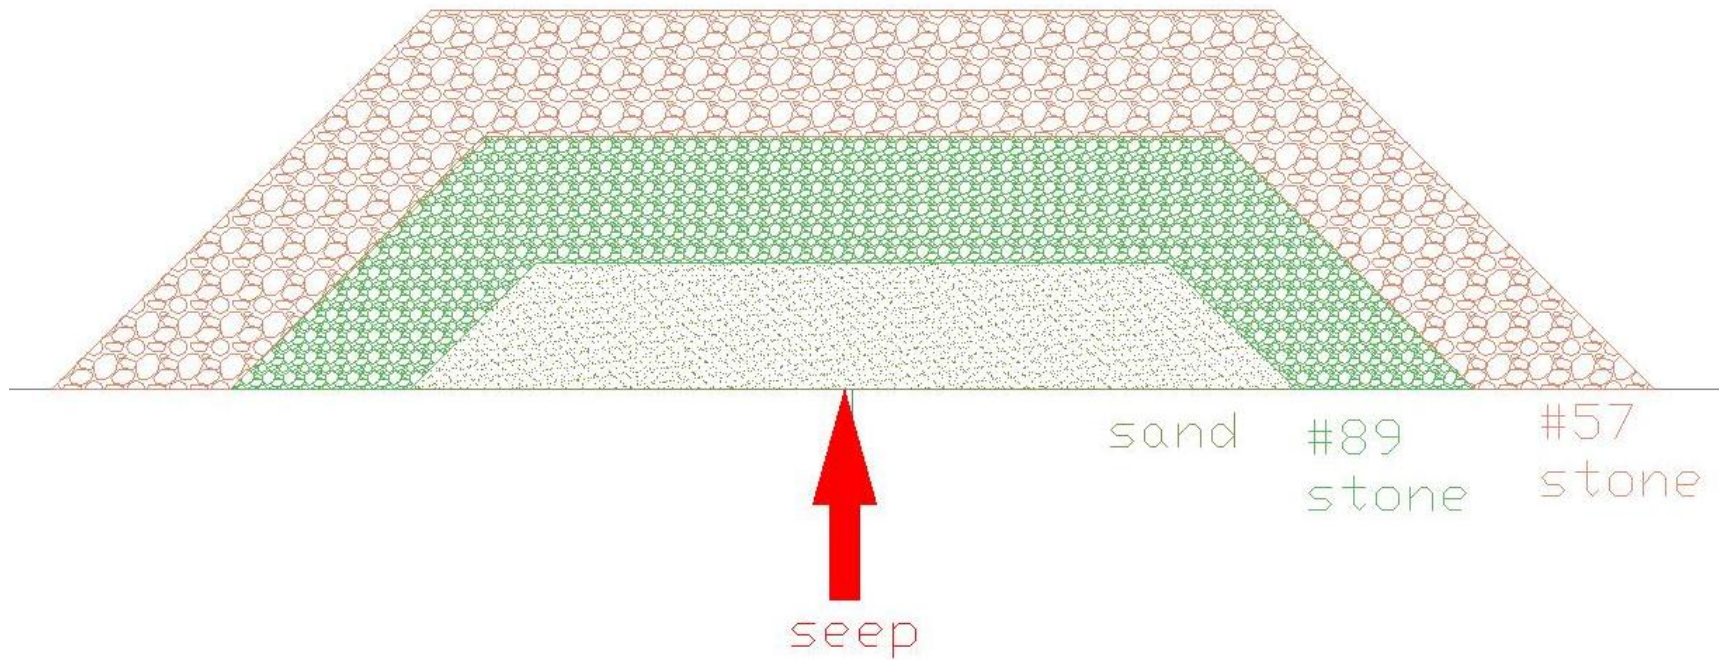
Filter fabric or geotextile is not acceptable as a substitute for the sand. The fabric tends to smear and clog if applied in a wet situation.

CROSS SECTION OF A REVERSE FILTER OVER A SEEP OR BOIL
