EMERGENCY ACTION PLAN

Georgia Power Company
Plant Yates
Ash Pond AP-2 Dam
State ID: 038-063-04138
NID: GA04184
Coweta County, GA

ISSUE DATE: October 23, 2020
REVISION #: 3

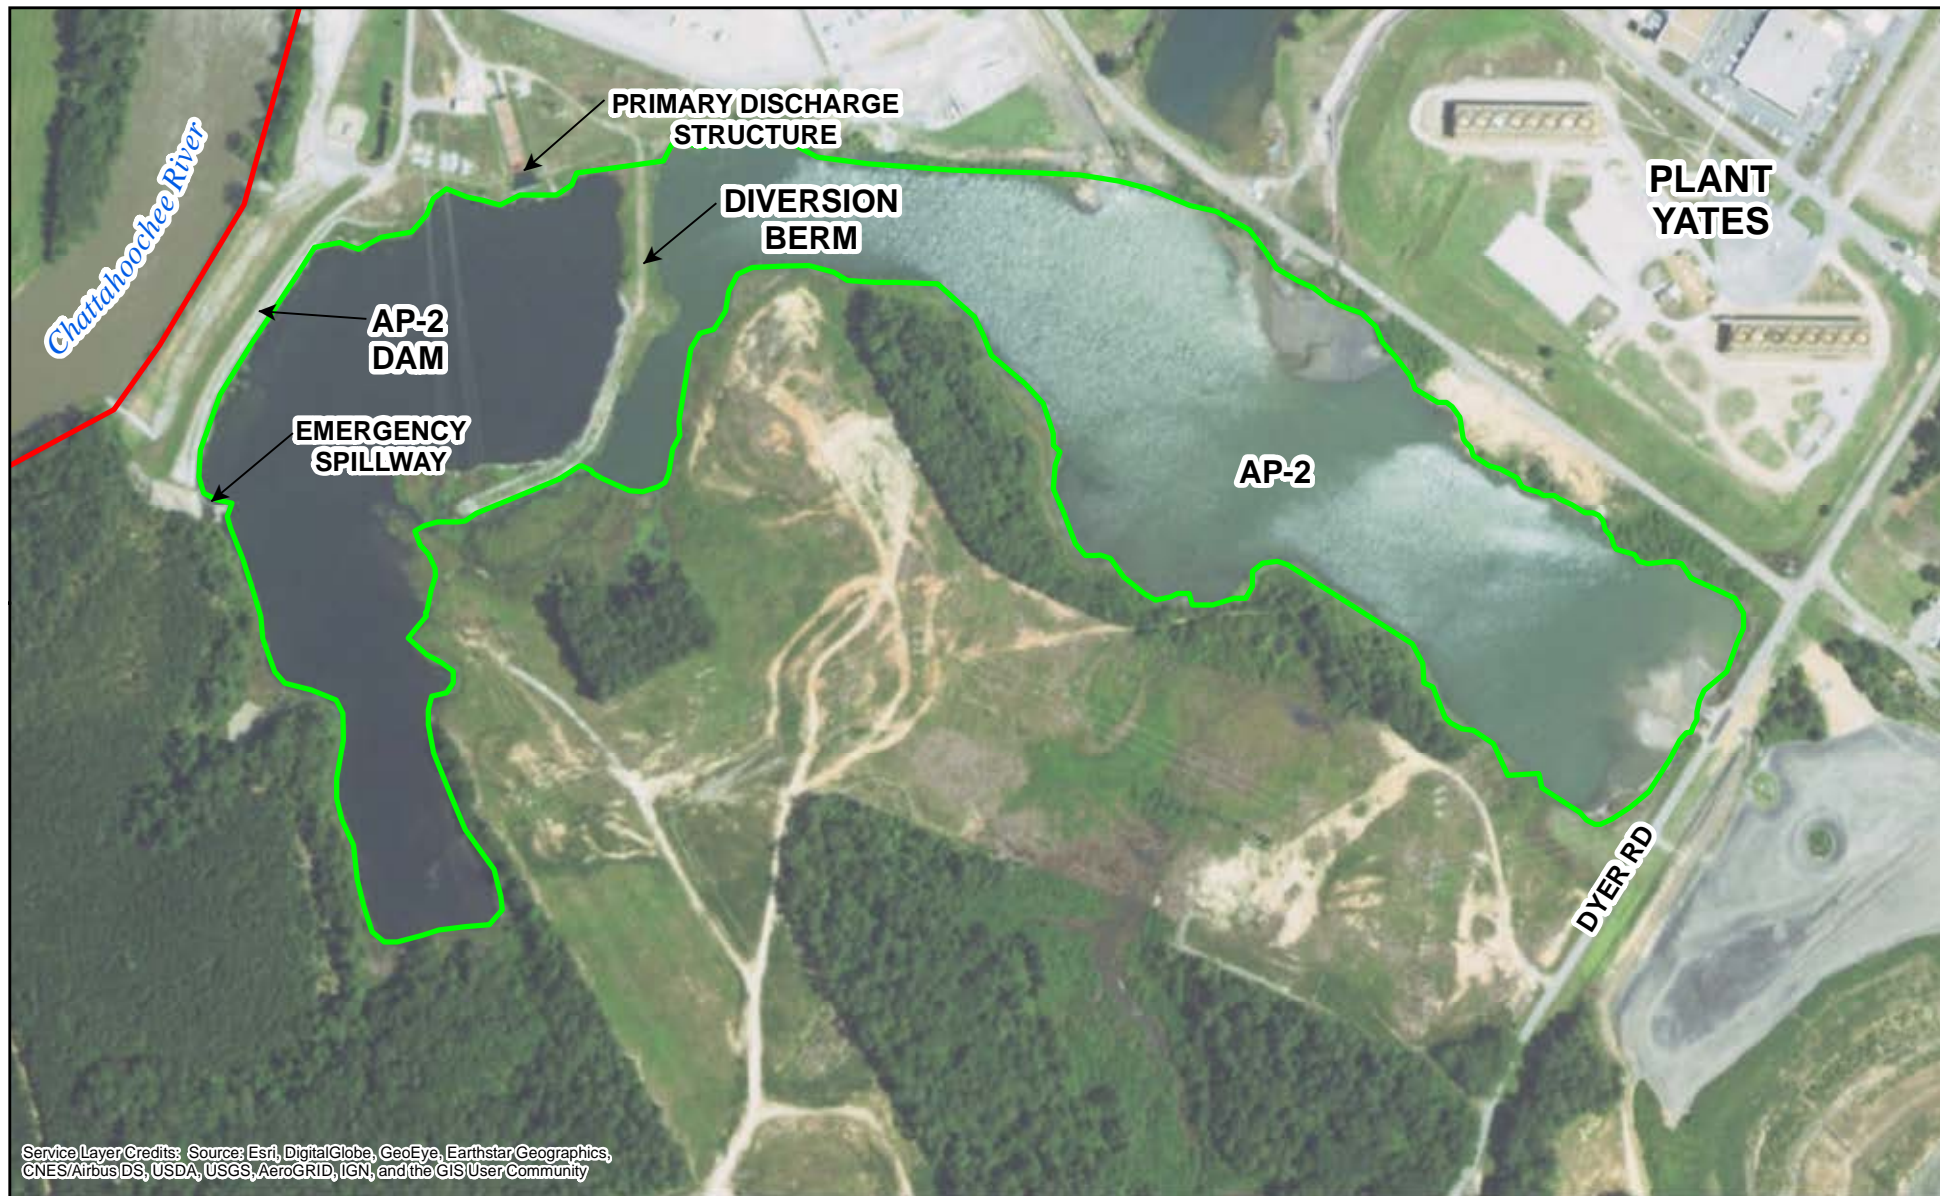
FIGURE 2
ASH POND OVERVIEW
PLANT YATES
COWETA COUNTY, GEORGIA

- Plant Boundary
- Ash Pond AP-2 Boundary

AP-2 has an earthen embankment/dam on its western side and is approximately 63 acres in size at its normal pool elevation of 722 feet (Appendix A – Figure 1 and Figure 2). The dam currently has a maximum height of approximately 39 feet.

Plant personnel are able to access the dam from the north by paved or gravel-surfaced roadways from the main portion of Plant Yates. Figures 1 and 2 show the location of AP-2 on Plant property.

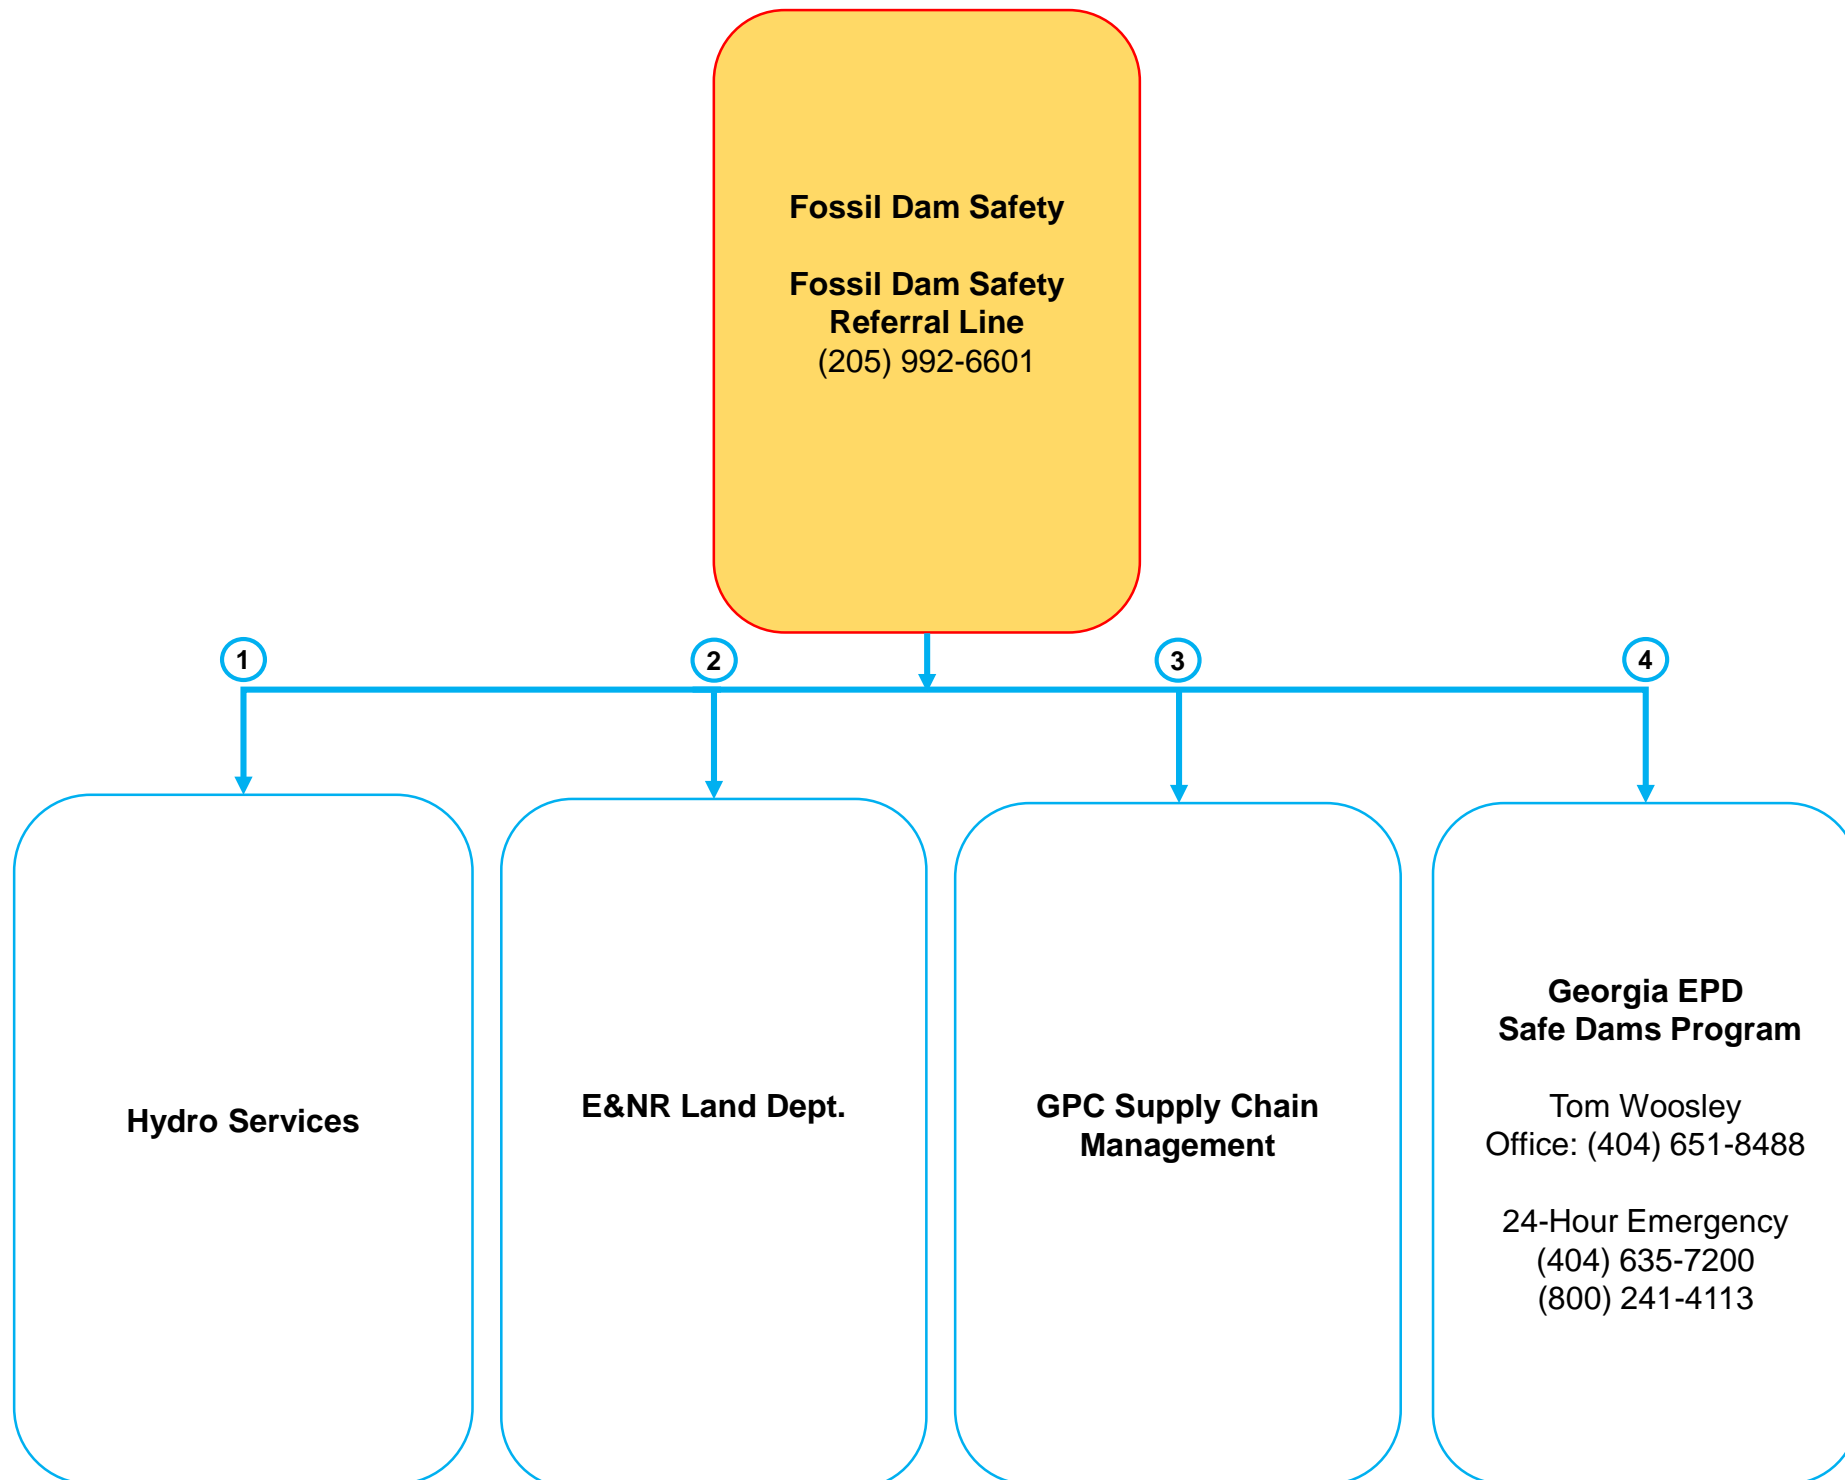
Response Notification Flowchart

Imminent Failure or Potential Failure Emergencies

Fossil Dam Safety Notifications

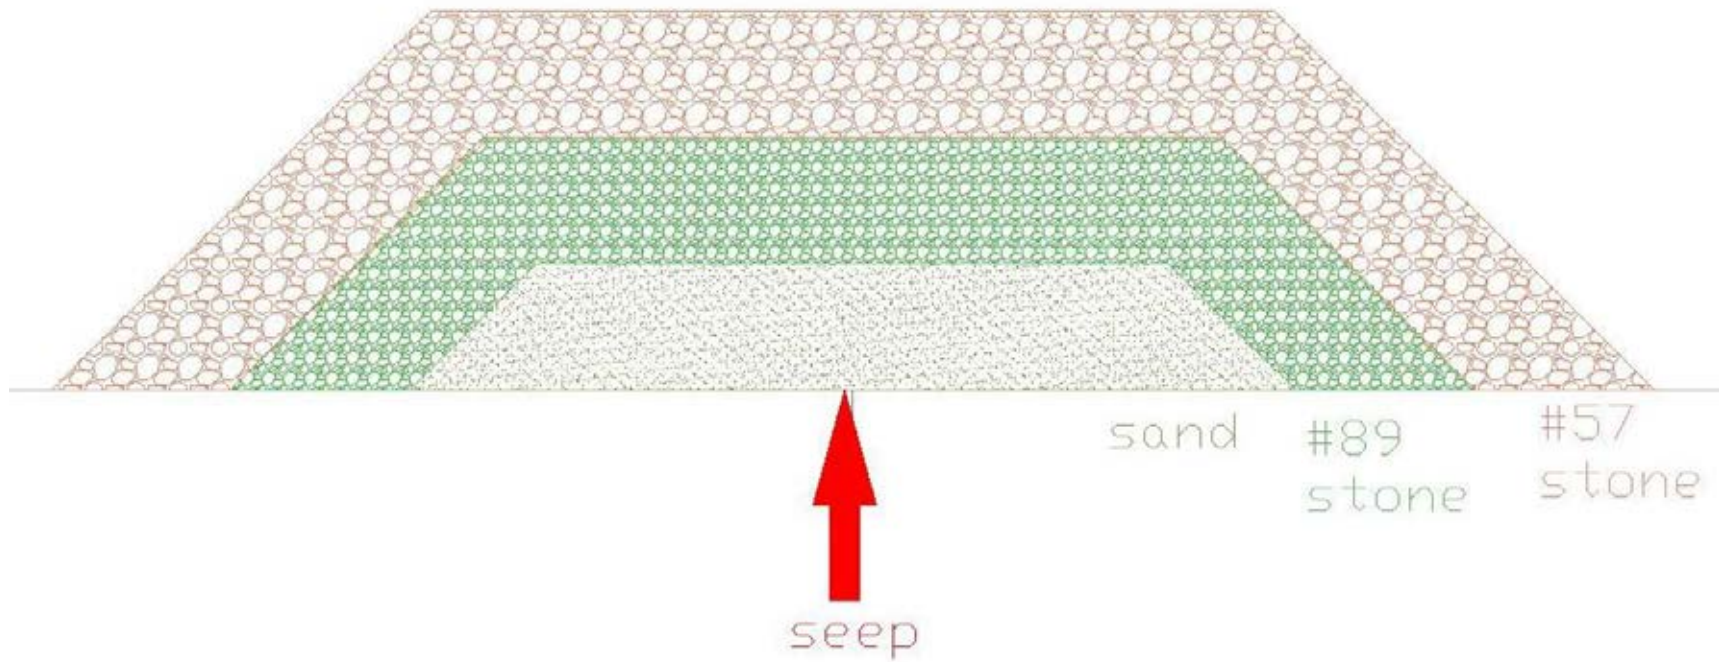
CROSS SECTION OF A REVERSE FILTER OVER A SEEP OR BOIL

Filter fabric or geotextile is not acceptable as a substitute for the sand. The fabric tends to smear and clog if applied in a wet situation.
