# LEGACY CCR SURFACE IMPOUNDMENT EMERGENCY ACTION PLAN

Georgia Power Company  
Plant Arkwright  
Ash Pond No.3 (AP-3)  
State ID: 011-037-04238  
NID: GA03967  
Bibb County, GA

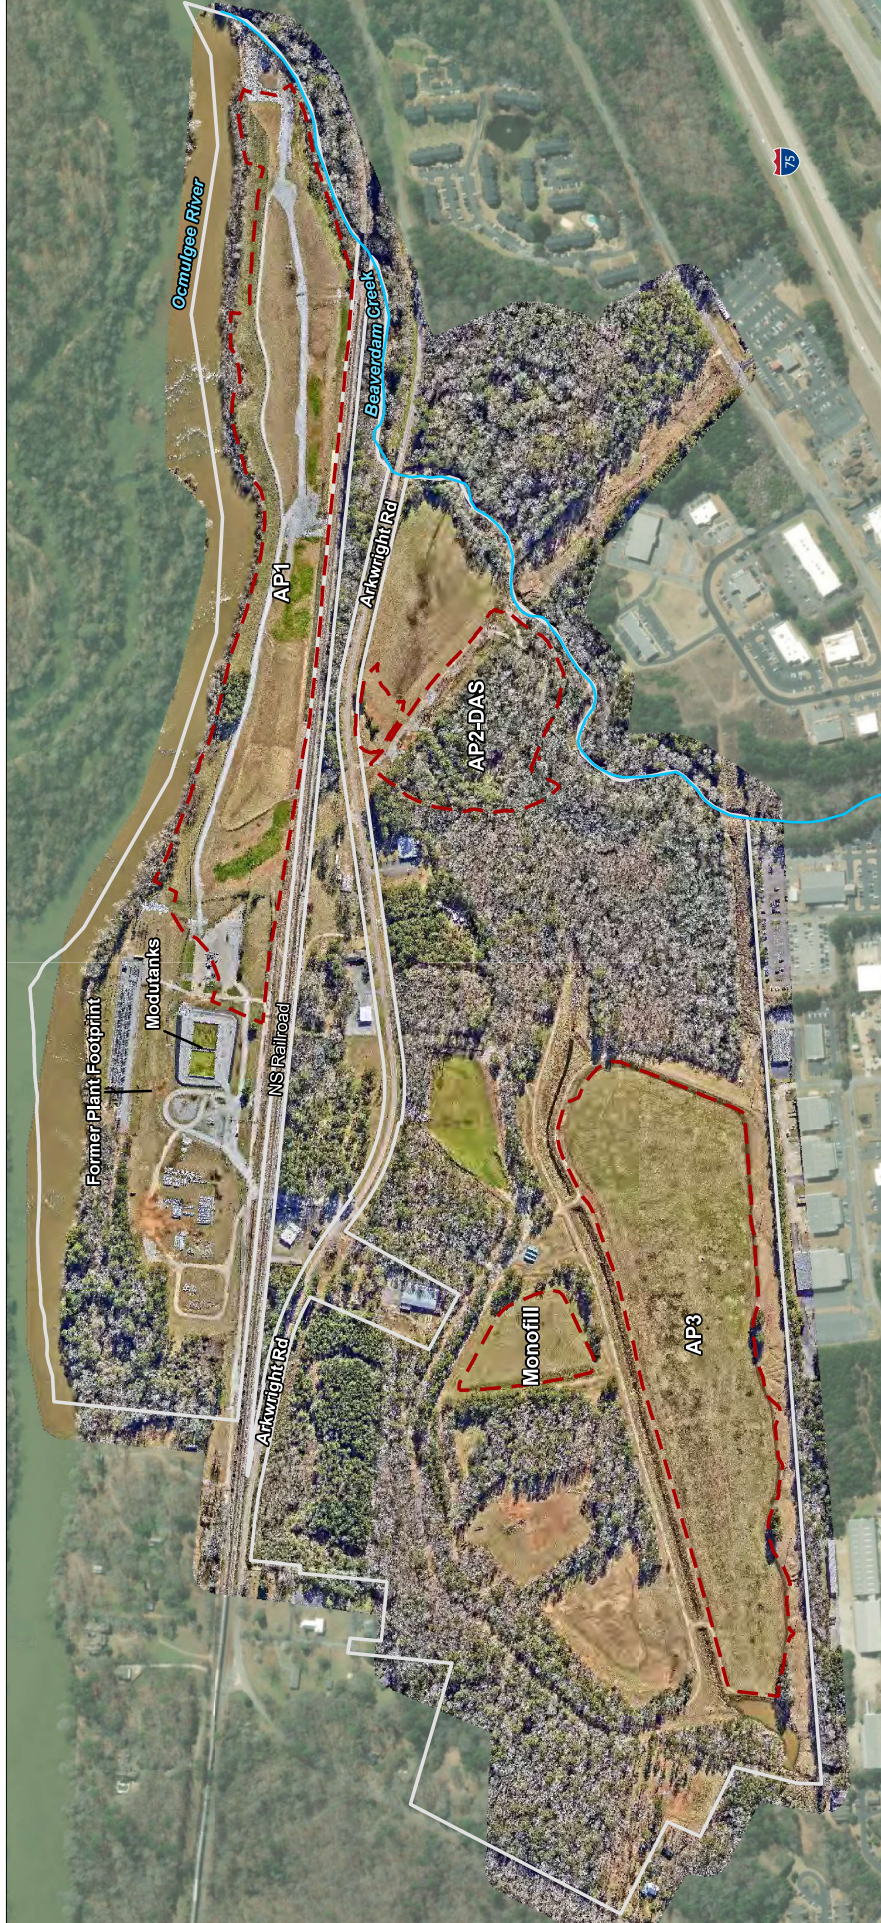
### **Plant Arkwright Location Map – Figure 1**

- Legend**
- Beaverdam Creek
  - CCR Unit
  - Property Boundary

GPC and emergency personnel are able to access the dam by paved or gravel-surfaced roadways. Figure 1 in Appendix A illustrates the location of AP-3 on Plant property.

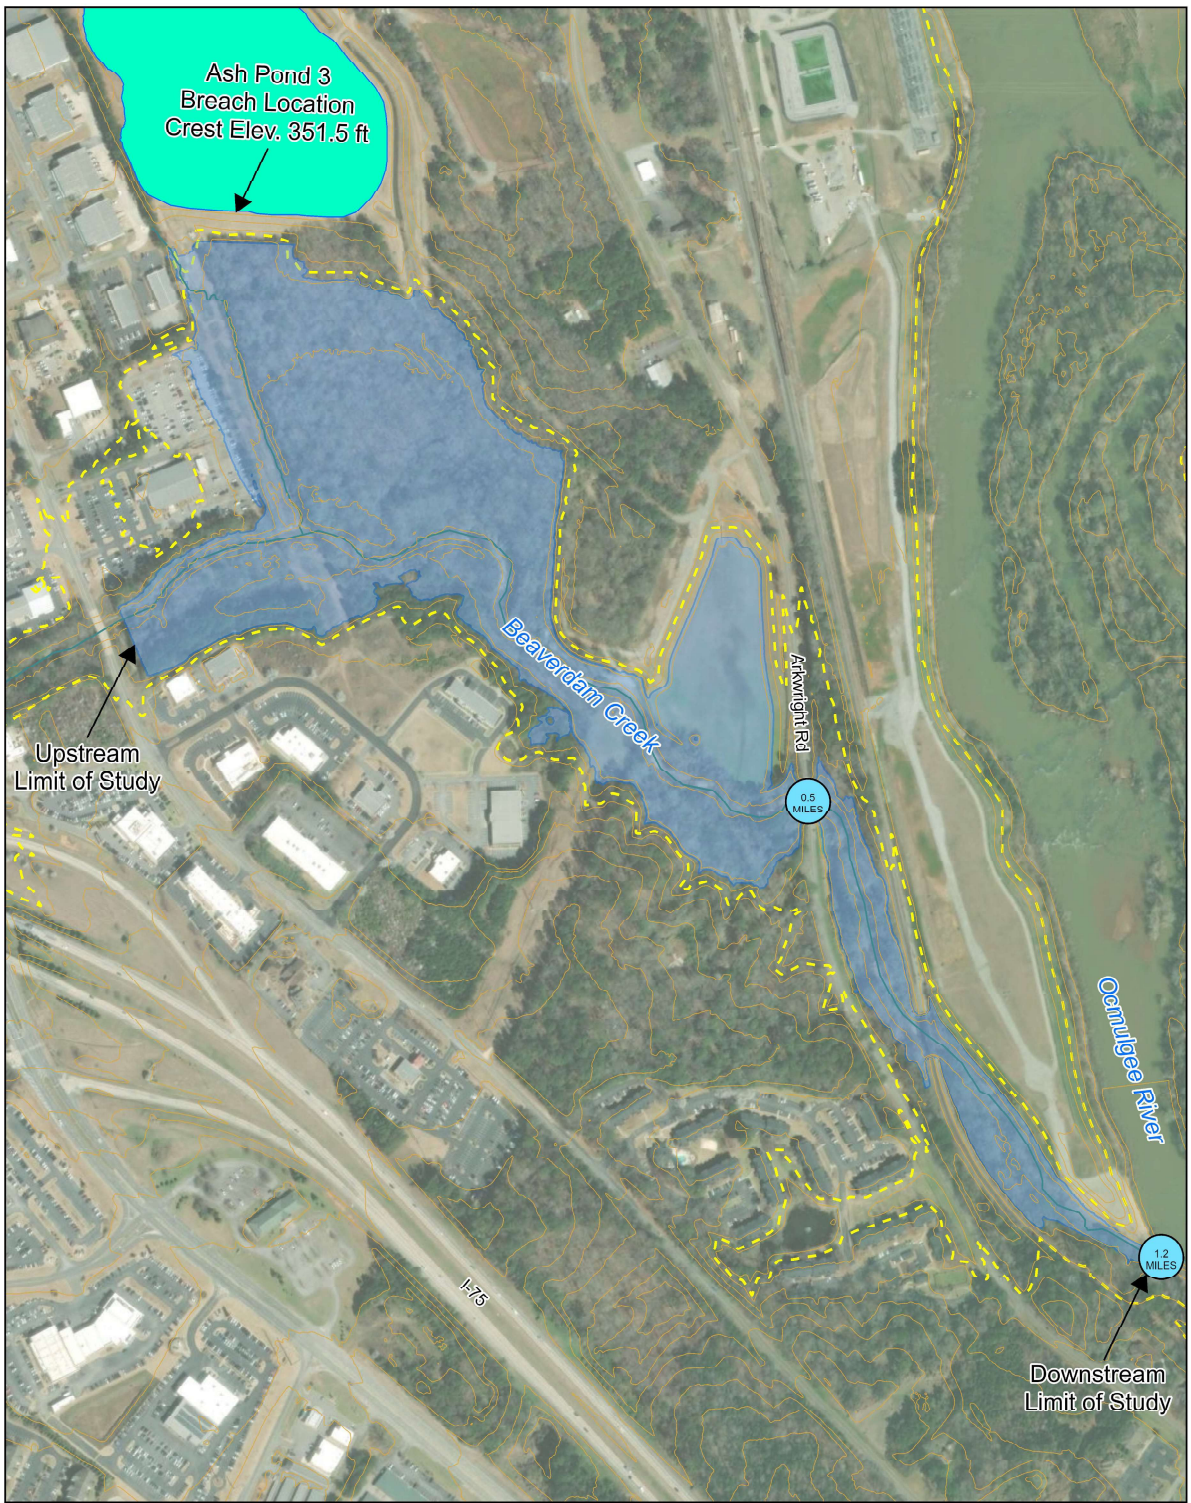
**APPENDIX B**  
**Inundation Maps**

- Legend**
- Initial Conditions WSE - 351.5 ft
  - AP-3 Breach Inundation Boundary
  - Effective 100-year Inundation Boundary
  - Contour (10-ft Interval)
  - 0.5  
MILES Distance Downstream From Dam

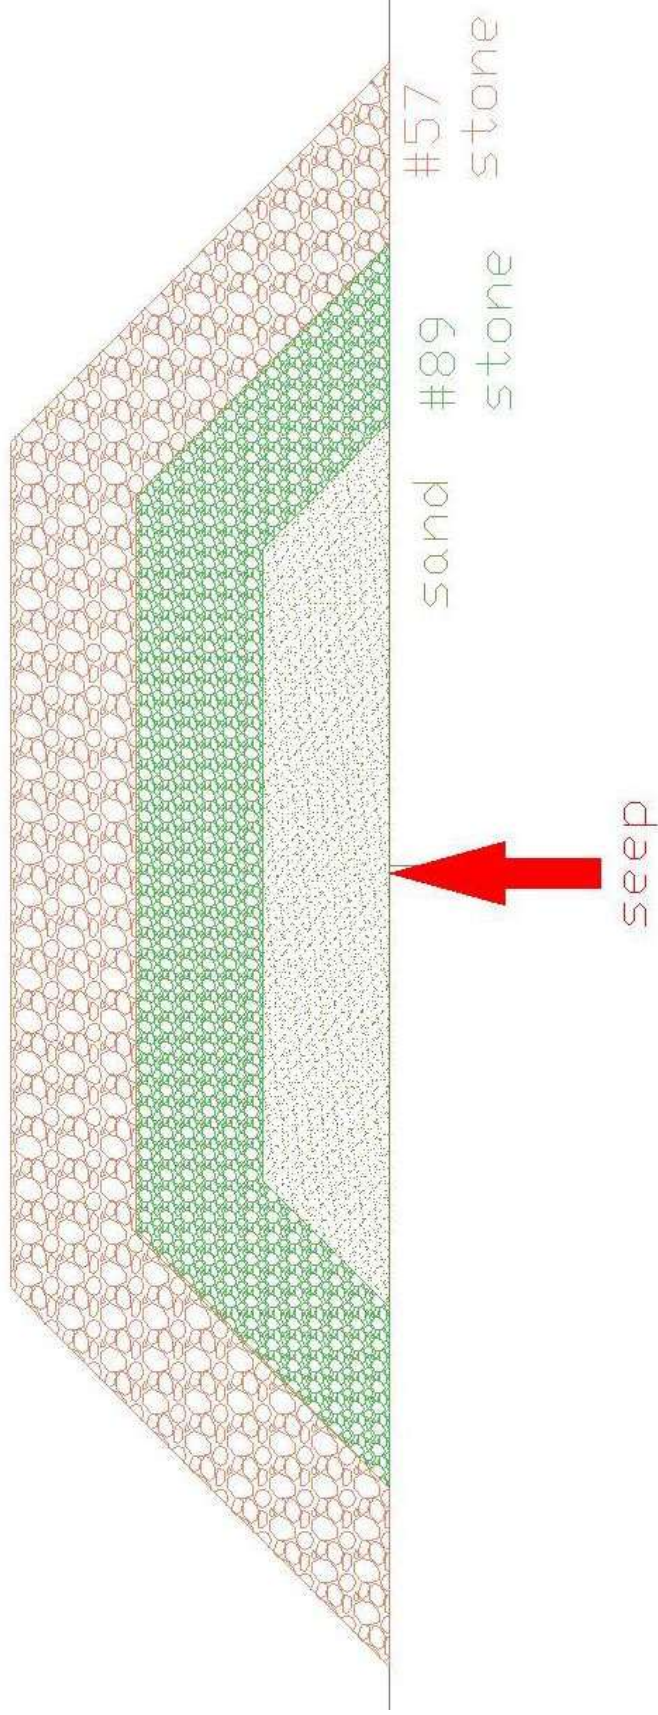
# CROSS SECTION OF A REVERSE FILTER OVER A SEEP OR BOIL

**Filter fabric or geotextile is not acceptable as a substitute for the sand. The fabric tends to smear and clog if applied in a wet situation.**
