HISTORY OF CONSTRUCTION
40 C.F.R. § 257.100(f)(2)(ii) and 40 C.F.R. § 257.73(c)(1)(i)-(xii)
PLANT BRANCH ASH POND C (AP-C)
GEORGIA POWER COMPANY

CCR Impoundment Name: Plant Branch Ash Pond C (AP-C)
Identification Number: NPDES Permit No. GA0026051

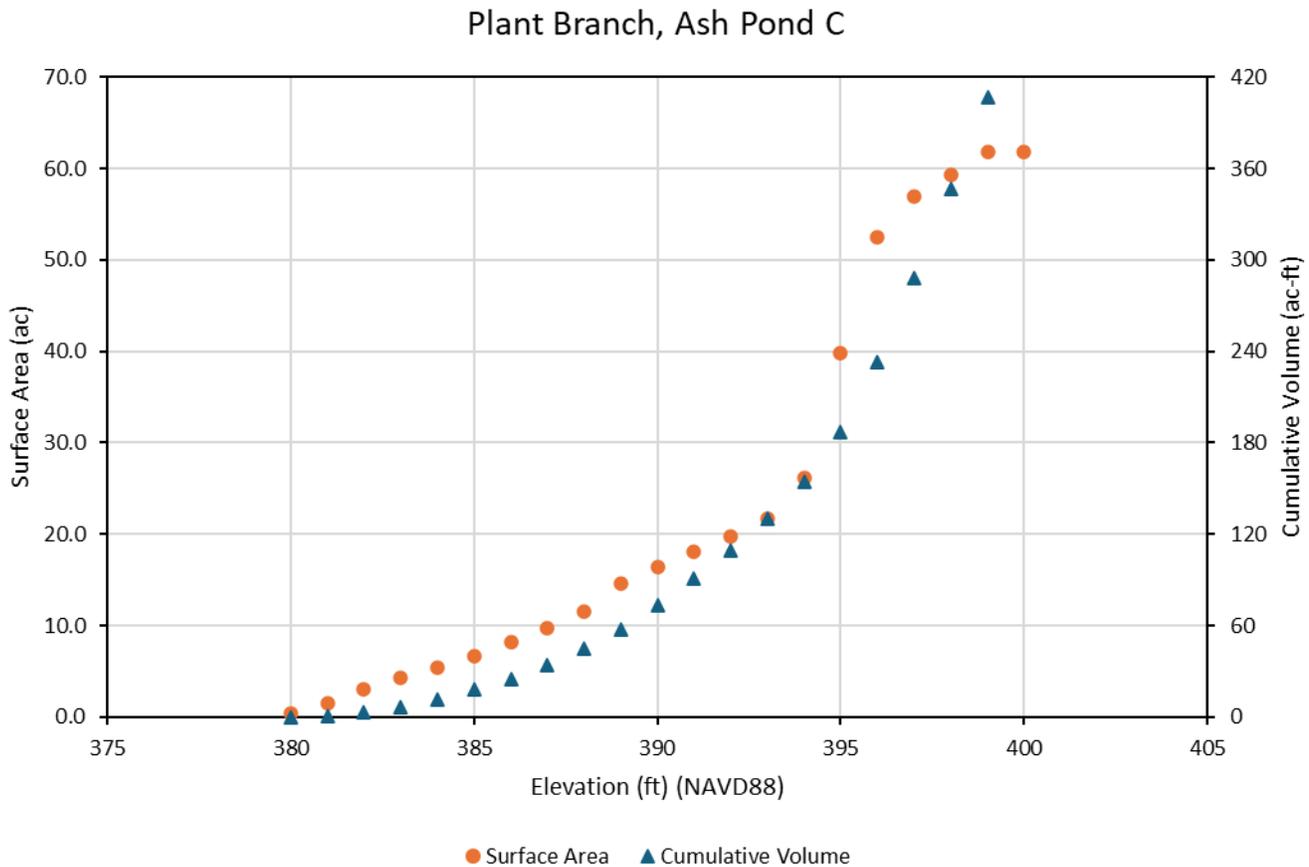
(ix) Area-Capacity Curves:

Note: The surface area of the highest closed contour available from the LiDAR was used as the surface area for elevations above the highest closed contour.

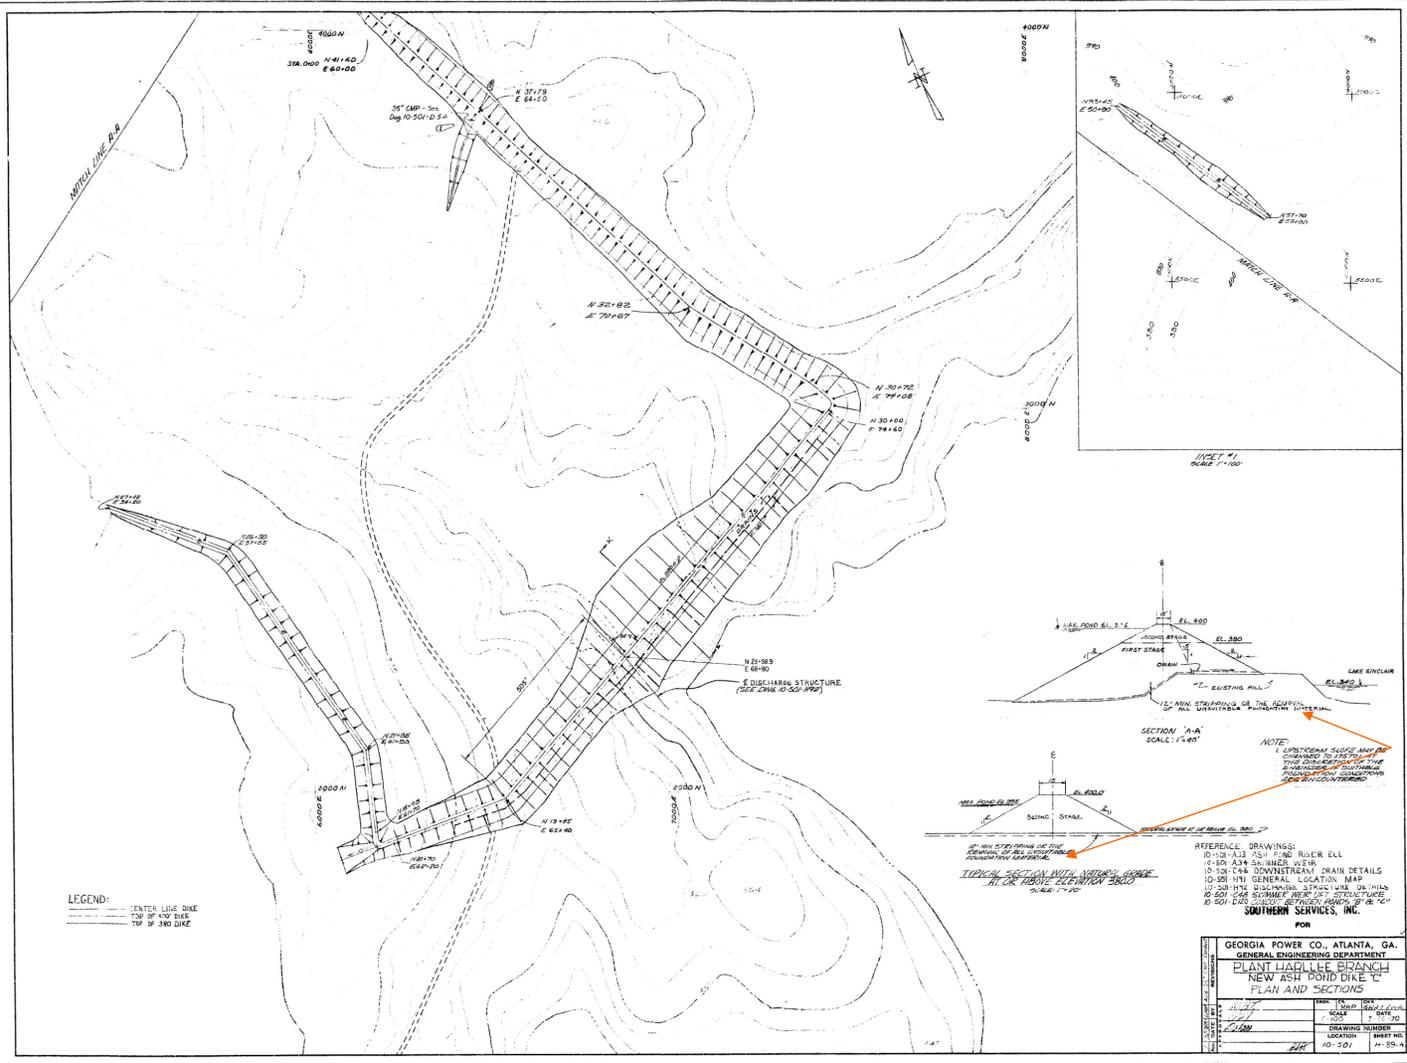
**Plant Harllee Branch New Ash Pond Dike "C" Plan and Sections
(Sheet H-89A dated 3/16/1970)
Georgia Power Company**

12" min stripping or the removal of all unsuitable foundation material.

Original construction of AP-C consists of two major phases. During the first phase, AP-C Dams were raised to El. 380 ft with 2 Horizontal to 1 Vertical (2H to 1V) slopes on both the downstream and upstream sides by placing fill materials. If the existing ground elevation was at or above El. 380 ft, the first construction phase did not include any construction for those portions of the dams. In the second phase, the dams were raised to approximate El. 400 ft. The design drawings show 2H:1V slopes on both downstream and upstream sides, and a crest width of 15 ft. As noted in the design drawings, the upstream slope may be changed to 1.75H:1V at the discretion of the engineer if suitable foundation conditions are encountered. It was noted that the constructed slopes on the downstream side ranged from 1.6H:1V to 2.0H:1V, which is confirmed by the site's topographic maps. Engineering design parameters were obtained from soil samples collected and tested during pre-construction geotechnical investigation, pre-construction borrow studies, and subsequent explorations, and were presented in the original design stability analysis.

- Plant Harllee Branch New Ash Pond Dike "C" Plan and Sections (Sheet H-89A dated 3/16/1970)
- Plant Harllee Branch New Ash Pond Dike Foundation and Embankment Exploration Study Map (Sheet H-85 dated 9/10/1969)

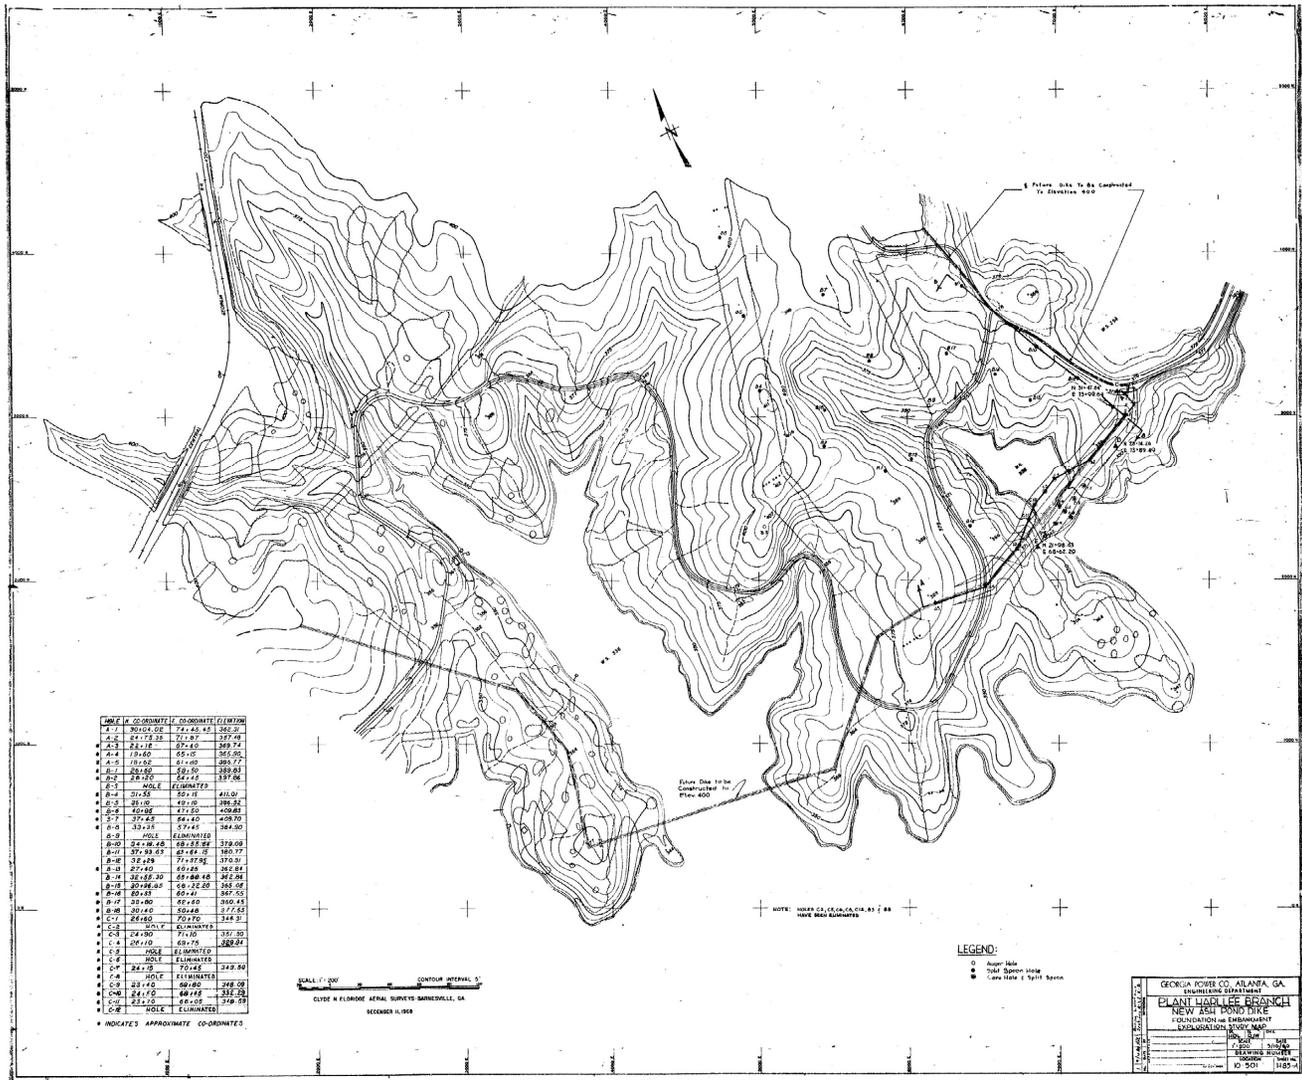
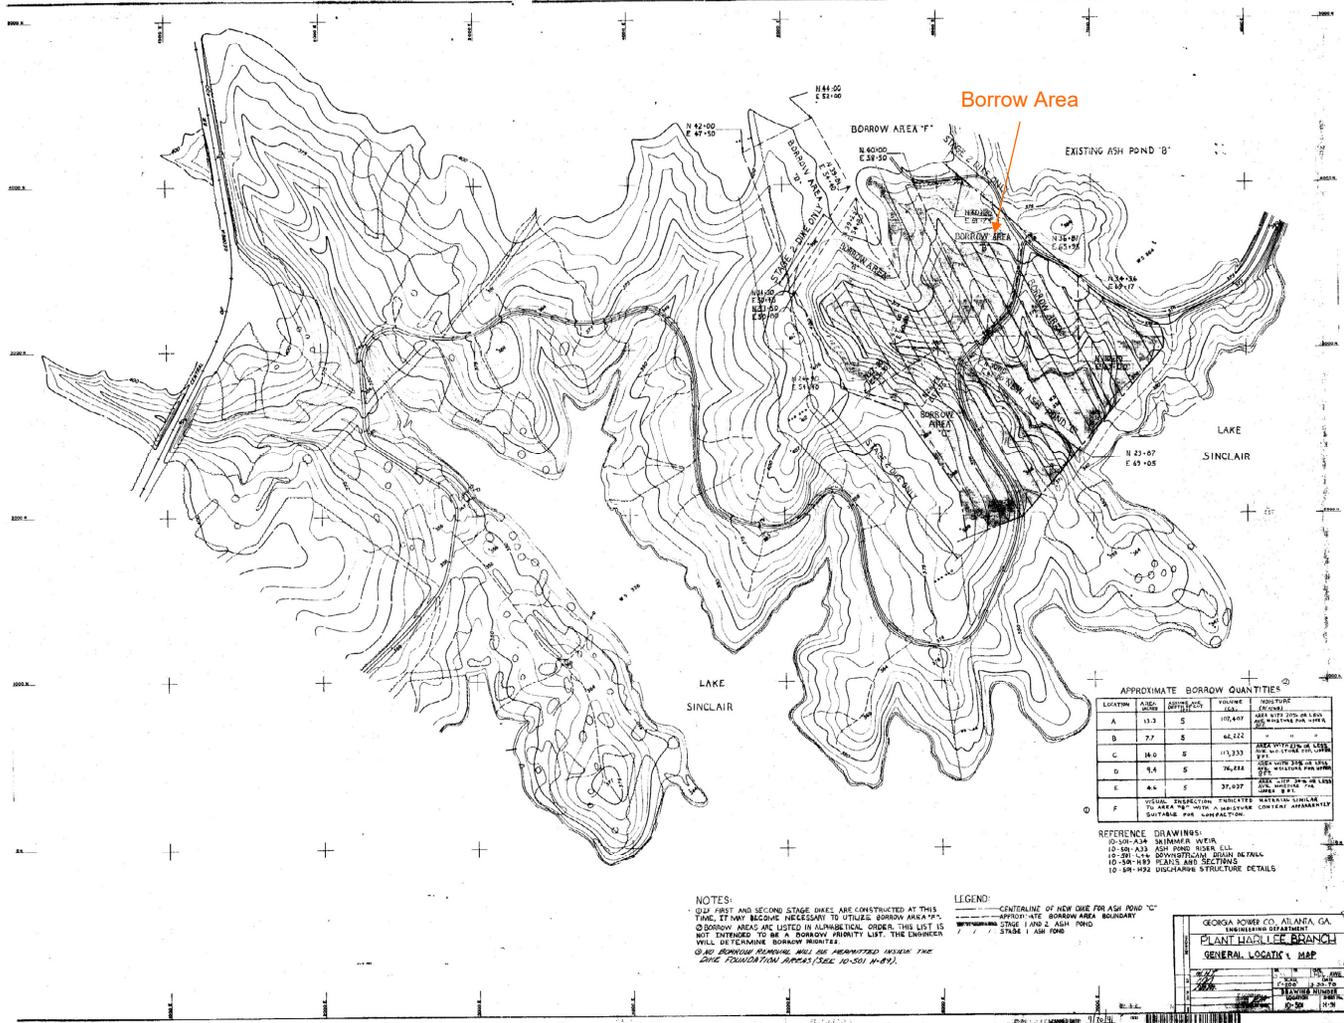
Plant Harlee Branch General Location Map
 (Sheet H-91 dated 3/30/1970)
 Georgia Power Company

APPROXIMATE BORROW QUANTITIES

LOCATION	AREA (AC)	DEPTH (FT)	VOLUME (CY)	REMARKS
A	13.8	5	69,450	SEE NOTE 1 ON SHEET H-92
B	7.7	5	38,825	SEE NOTE 1 ON SHEET H-92
C	18.0	5	90,000	SEE NOTE 1 ON SHEET H-92
D	8.4	5	42,000	SEE NOTE 1 ON SHEET H-92
E	8.6	5	43,050	SEE NOTE 1 ON SHEET H-92
F			30,000	SEE NOTE 1 ON SHEET H-92

- Plant Harllee Branch New Ash Pond Dike Foundation and Embankment Exploration Study Map (Sheet H-85A, date not legible)
- Plant Harllee Branch General Location Map (Sheet H-91 dated 3/30/1970)

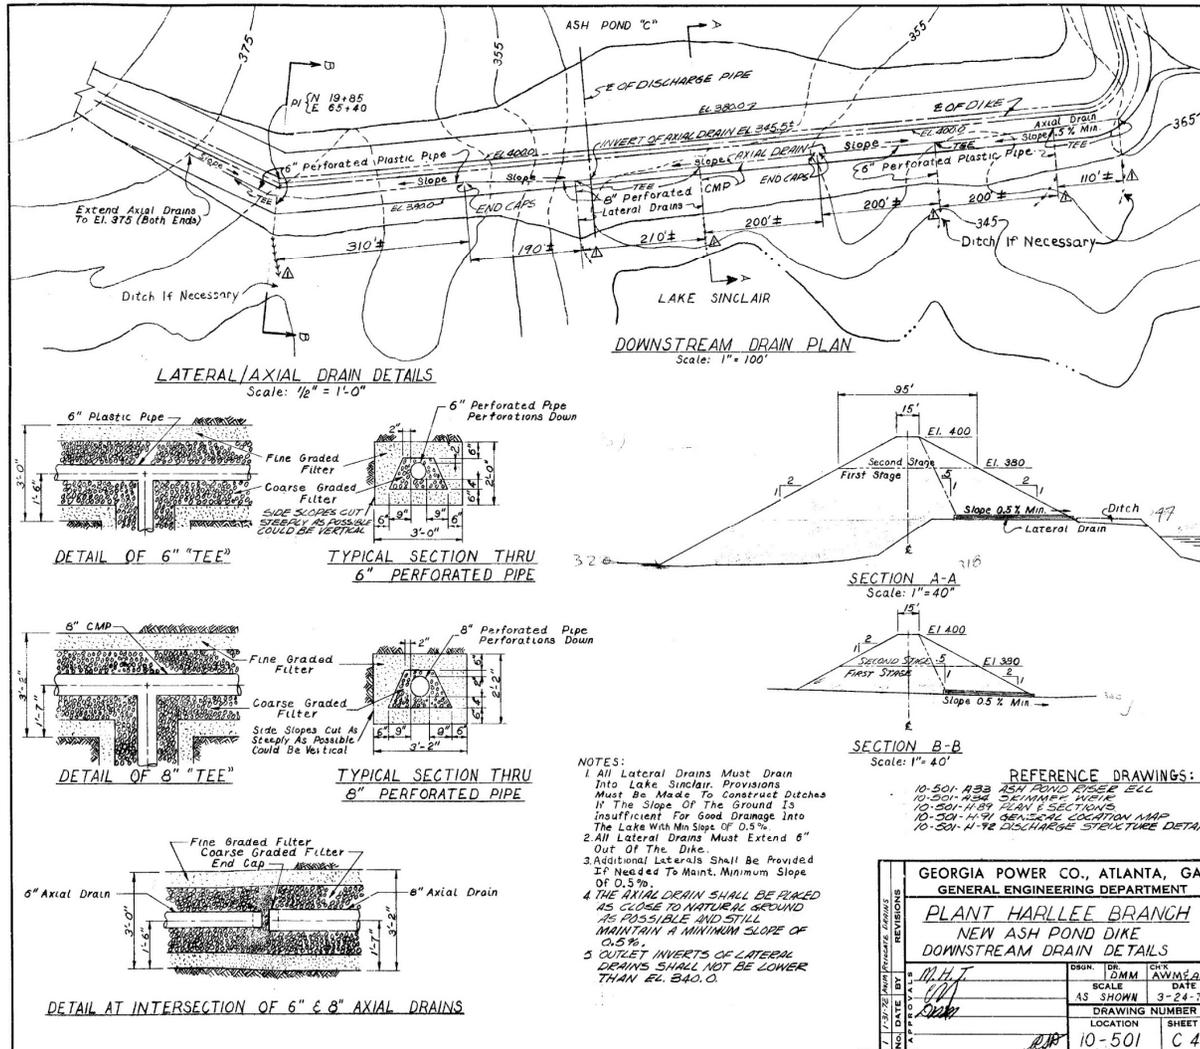
Plant Harlee Branch New Ash Pond Dike Downstream Drain Details
(Sheet C-46 dated 3/24/1970)
Georgia Power Company

Note: The pipe was decommissioned by grouting.

AP-C was built with an overflow structure which consisted of a 42-inch (in.) diameter corrugated metal pipe (CMP) with a 48-in CMP riser. The pipe was decommissioned by grouting and abandoned in place. Additionally, AP-C was built with a recycle structure which consisted of steel sheet piles to El. 400.0 ft. The recycle structure was abandoned in place. Presently, AP-C has an auxiliary spillway on the southwestern dam near the southwest corner of the pond. The auxiliary spillway, permitted under National Pollutant Discharge Elimination System (NPDES) Permit Number GA0026051, includes two 24-inch (in.) diameter high-density polyethylene (HDPE)

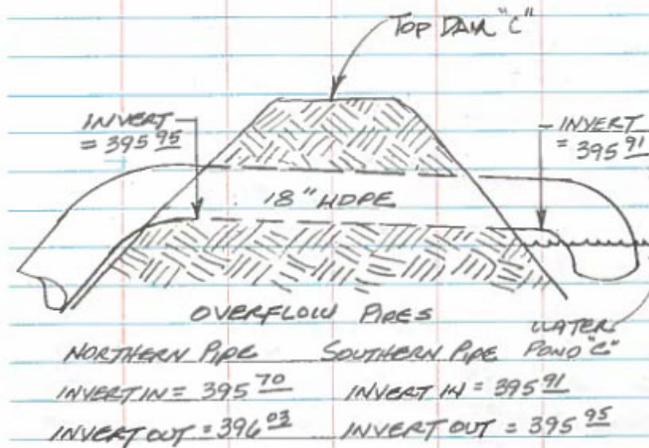
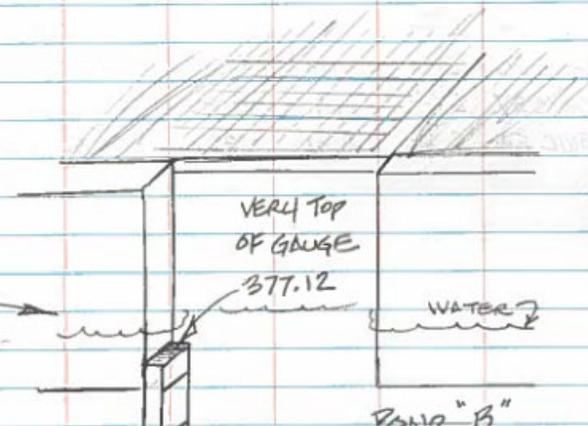
Plant Branch, Field Notes from 12 February 2020
(Georgia Power Company, 2020)
Georgia Power Company

STAFF GAUGE IN POND "C" TOP DAM 399.86
STAFF GAUGE CHECKED ✓

INVERT ELEVATIONS FOR EMERGENCY
OVERFLOW PIPES POND "C" (1.85 TO 1.00 TO INVERT)
SOUTH PIPE INVERT = 395.91
NORTH PIPE INVERT = 395.70

siphon pipes. The northern pipe is approximately 250-ft long with an upgradient invert elevation of El. 395.70 ft and a downgradient invert elevation of El. 378.54 ft. The southern pipe is approximately 250-ft long with an upgradient invert elevation of El. 395.91 ft and a downgradient invert elevation of El. 378.33 ft.
