**HISTORY OF CONSTRUCTION**  
**40 C.F.R. § 257.100(f)(2)(ii) and 40 C.F.R. § 257.73(c)(1)(i)-(xii)**  
**PLANT BRANCH ASH POND D (AP-D)**  
**GEORGIA POWER COMPANY**

CCR Impoundment Name: Plant Branch Ash Pond D (AP-D)  
Identification Number: NPDES Permit No. GA0026051

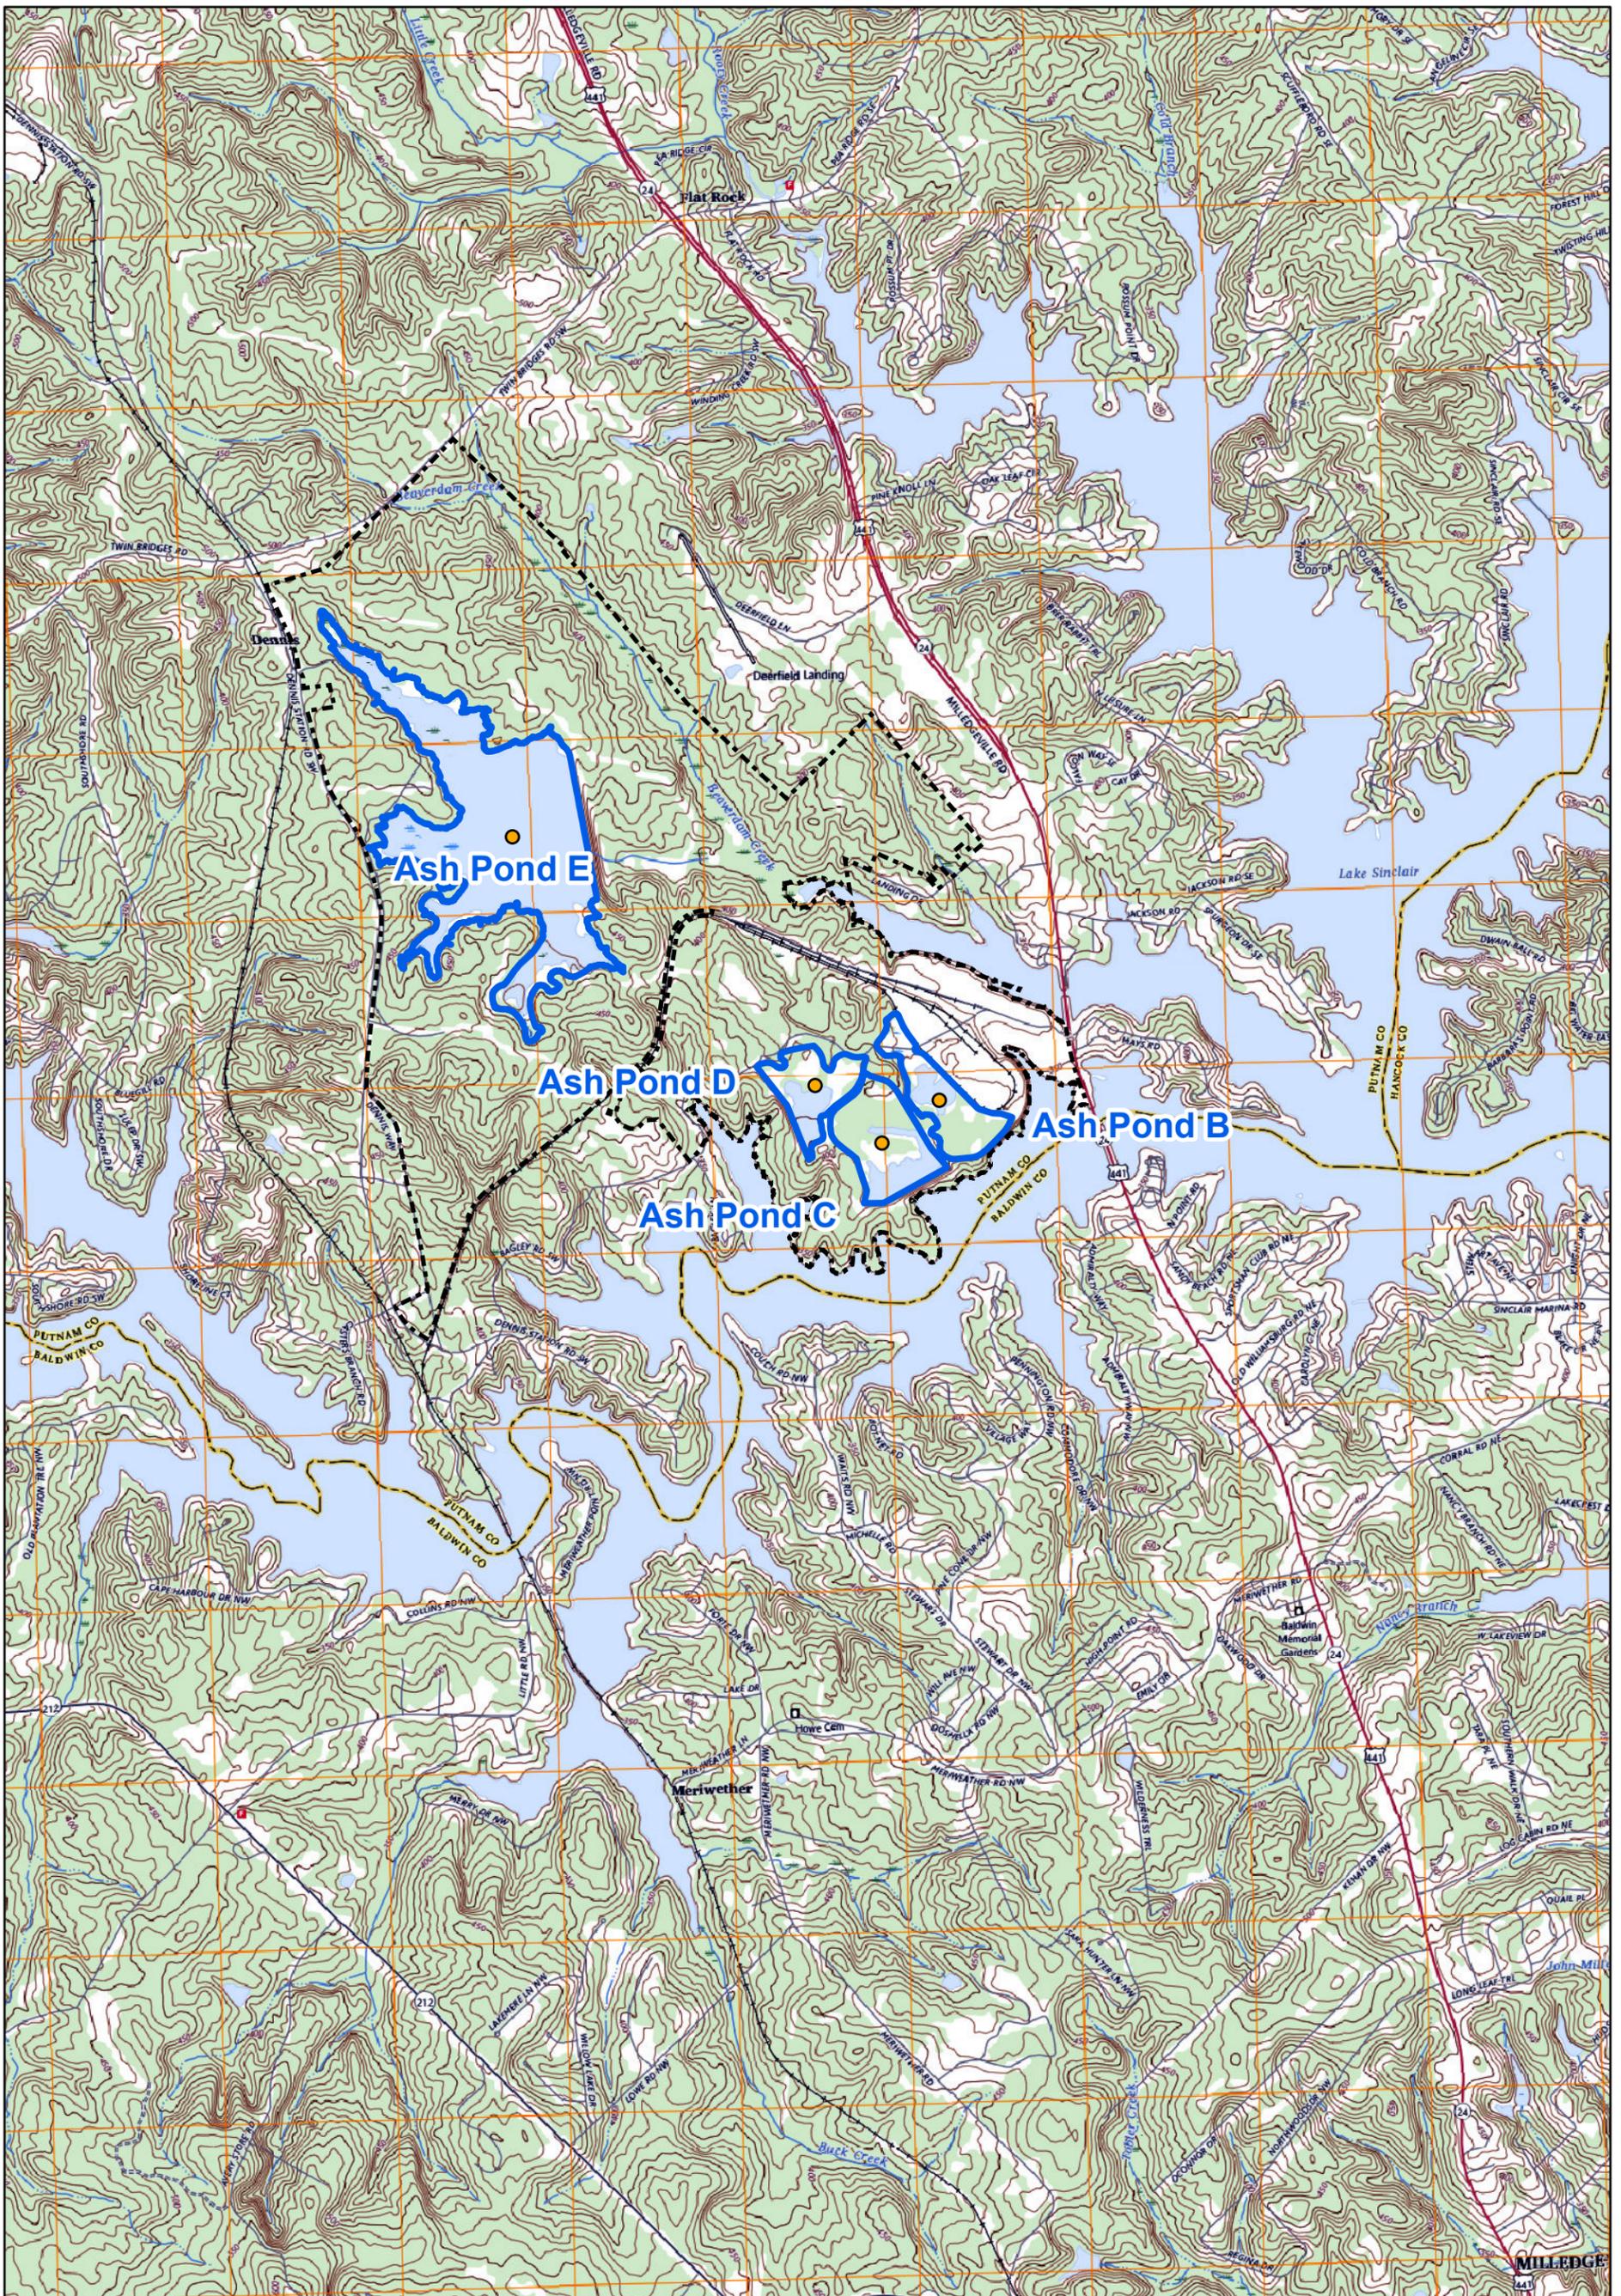
**USGS Topographic Map  
 Lake Sinclair West Quadrangle**

- Legend**
- Property Boundary
  - Pond Boundary
  - Topographic Contour (10-ft intervals)

The location of AP-D is shown on the United States Geological Survey (USGS) 7½-minute topographic quadrangle map presented in the Appendix.
