LEGACY CCR SURFACE IMPOUNDMENT EMERGENCY ACTION PLAN

Georgia Power Company
Plant Harllee Branch
Ash Pond C (AP-C)
State ID: 117-027-05839
NID: GA06336
Putnam County, GA

ISSUE DATE: 05/06/2026
REVISION #: 0

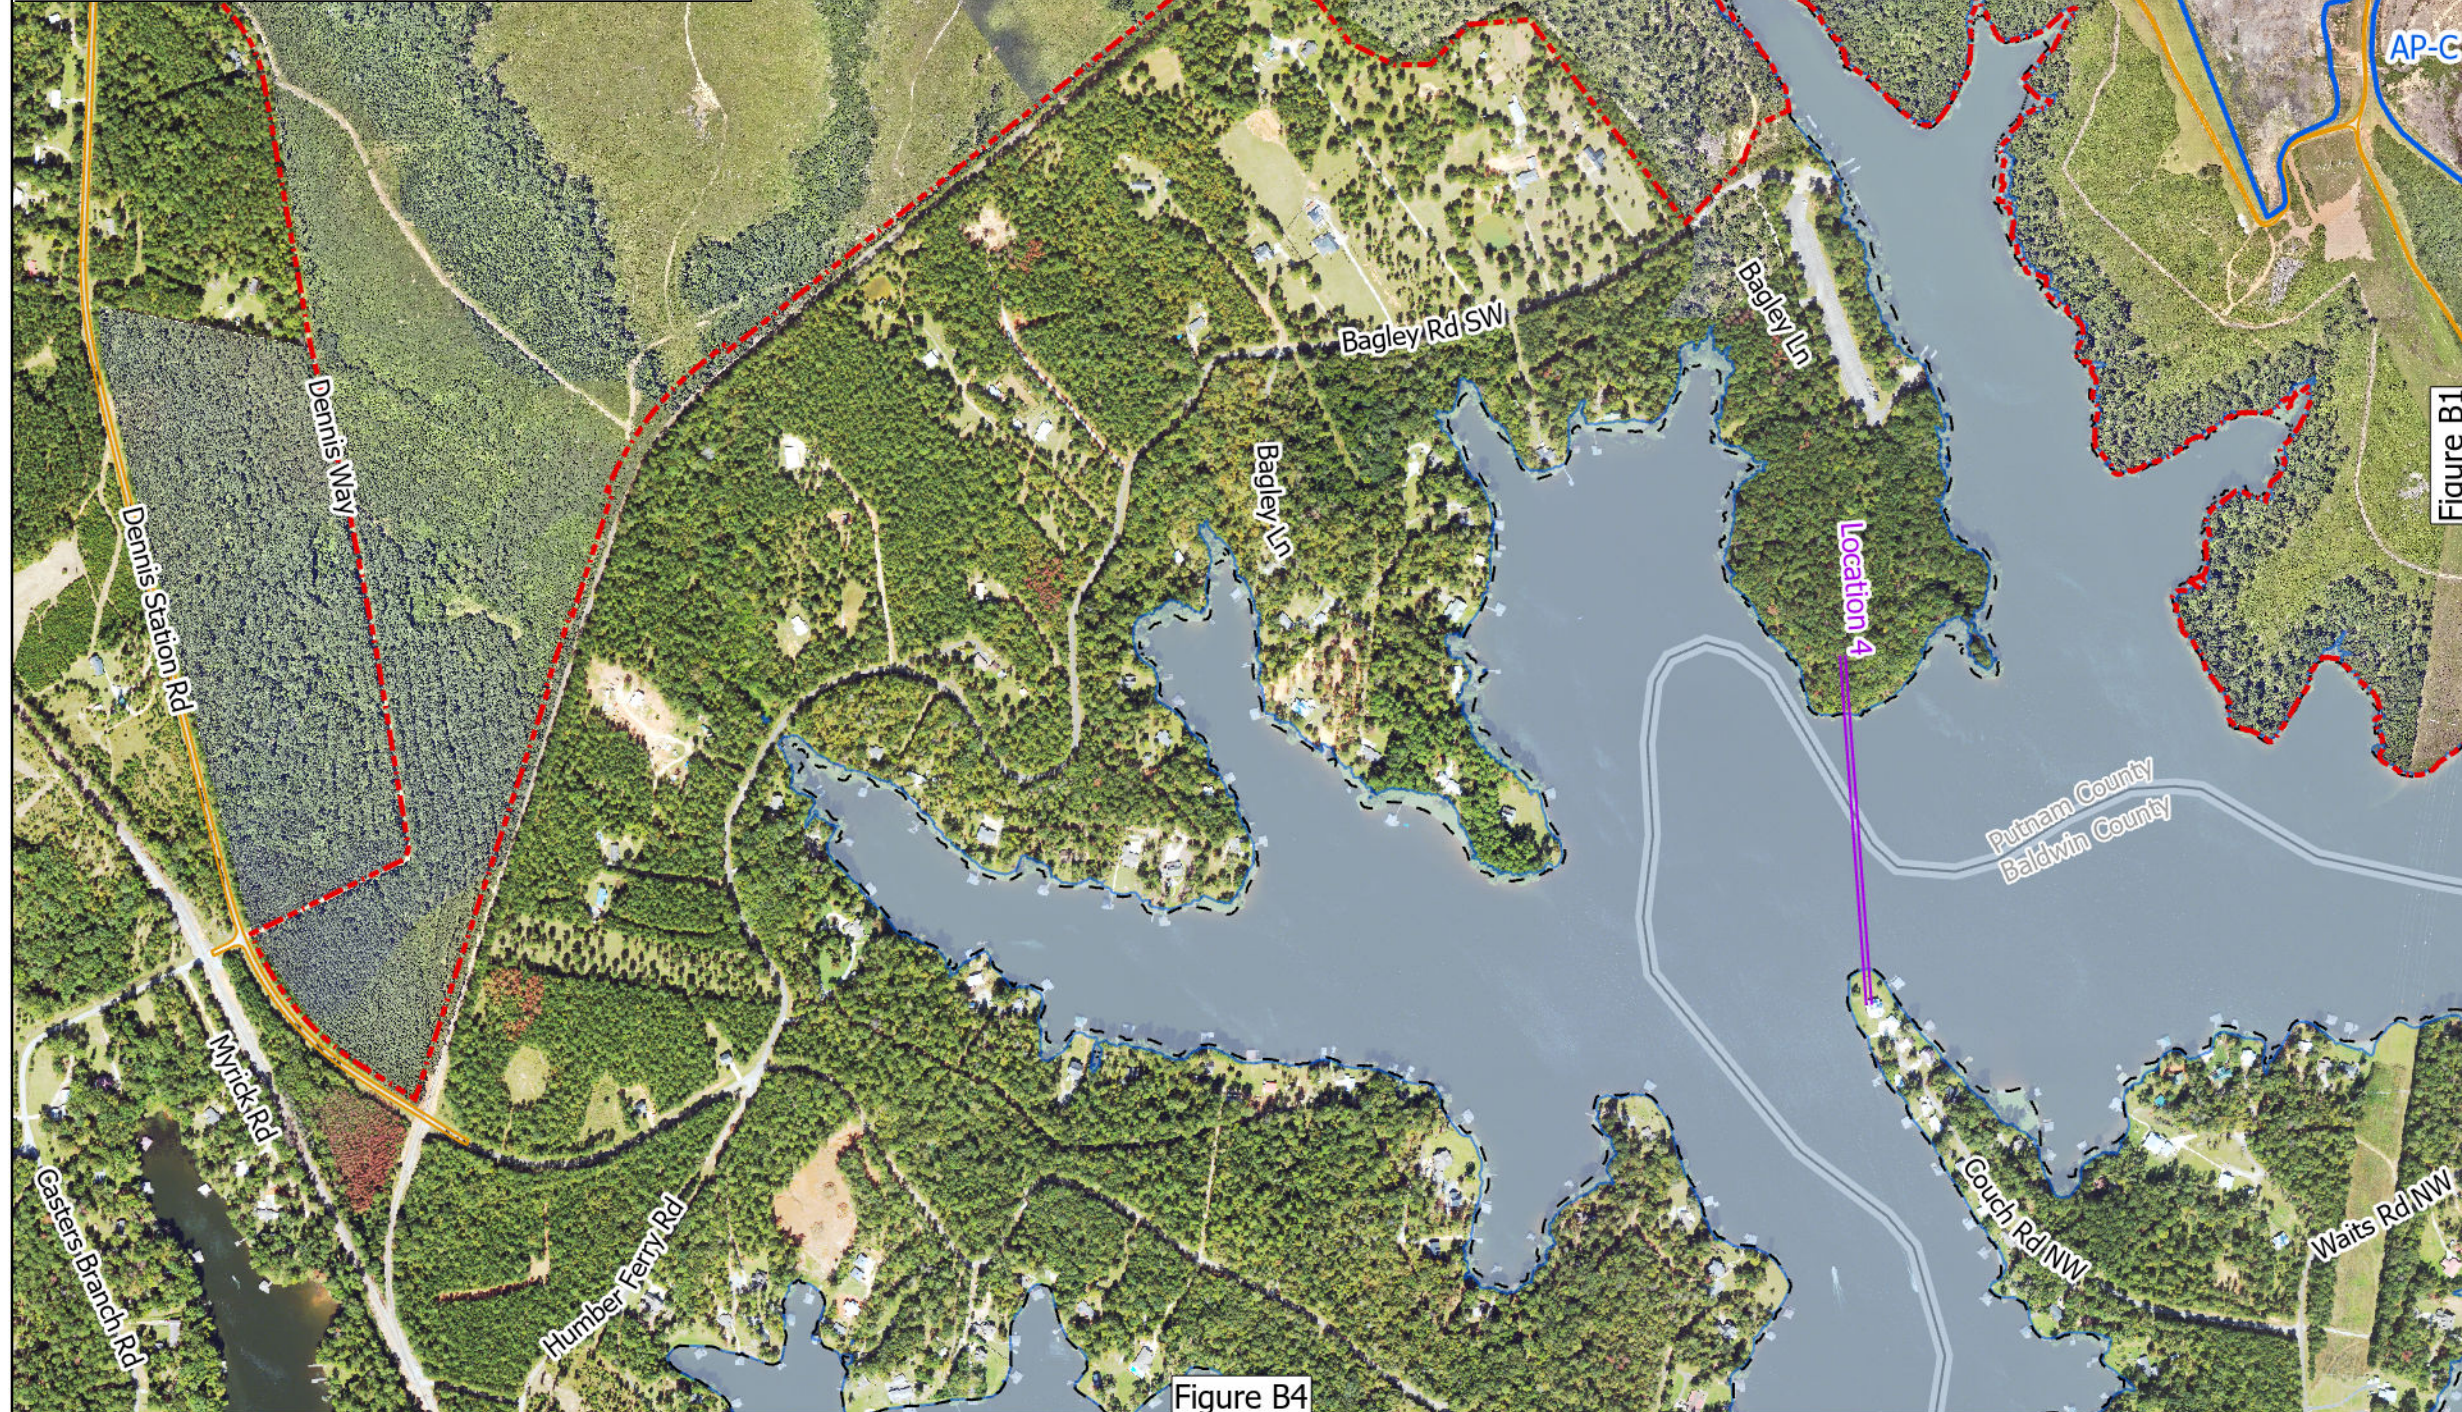
FIGURE B3

- Locations (purple line)
- Plant Branch Property Boundary (red dashed line)
- Lake Sinclair Boundary (black dashed line)
- Sunny Day Inundation (light blue fill)
- Ash Pond Boundaries (blue outline)
- Access Roads (yellow line)
- County Boundaries (grey line)

- ELEVATION PROVIDED IN FEET (FT) REFERENCED TO THE NORTH AMERICAN VERTICAL DATUM OF 1988 (NAVD 88).
- COORDINATE SYSTEM: NAD 1983 STATE PLANE GEORGIA WEST_FIPS (U.S. FEET).
- PROPERTY BOUNDARY PROVIDED BY SOUTHERN COMPANY SERVICES.
- LAKE SINCLAIR WATER SURFACE ELEVATION AT TIME OF BREACH = 338.7 FEET-NAVD88
- THE INUNDATION AREAS DEPICTED ARE THOSE RESULTING FROM THE HYPOTHETICAL FAILURE OF PLANT BRANCH AP-C DAM DURING SUNNY DAY CONDITIONS.
- THE ACTUAL BREACH INUNDATION ZONES MAY VARY FROM THAT SHOWN AND ARE DEPENDENT ON THE HYDROLOGIC AND BREACH CONDITIONS AT THE TIME OF FAILURE.
- NO STRUCTURES WERE INUNDATED BASED ON RESULTING WATER SURFACE ELEVATIONS AND GROUND ELEVATIONS FROM NATIONAL STRUCTURE INVENTORY.

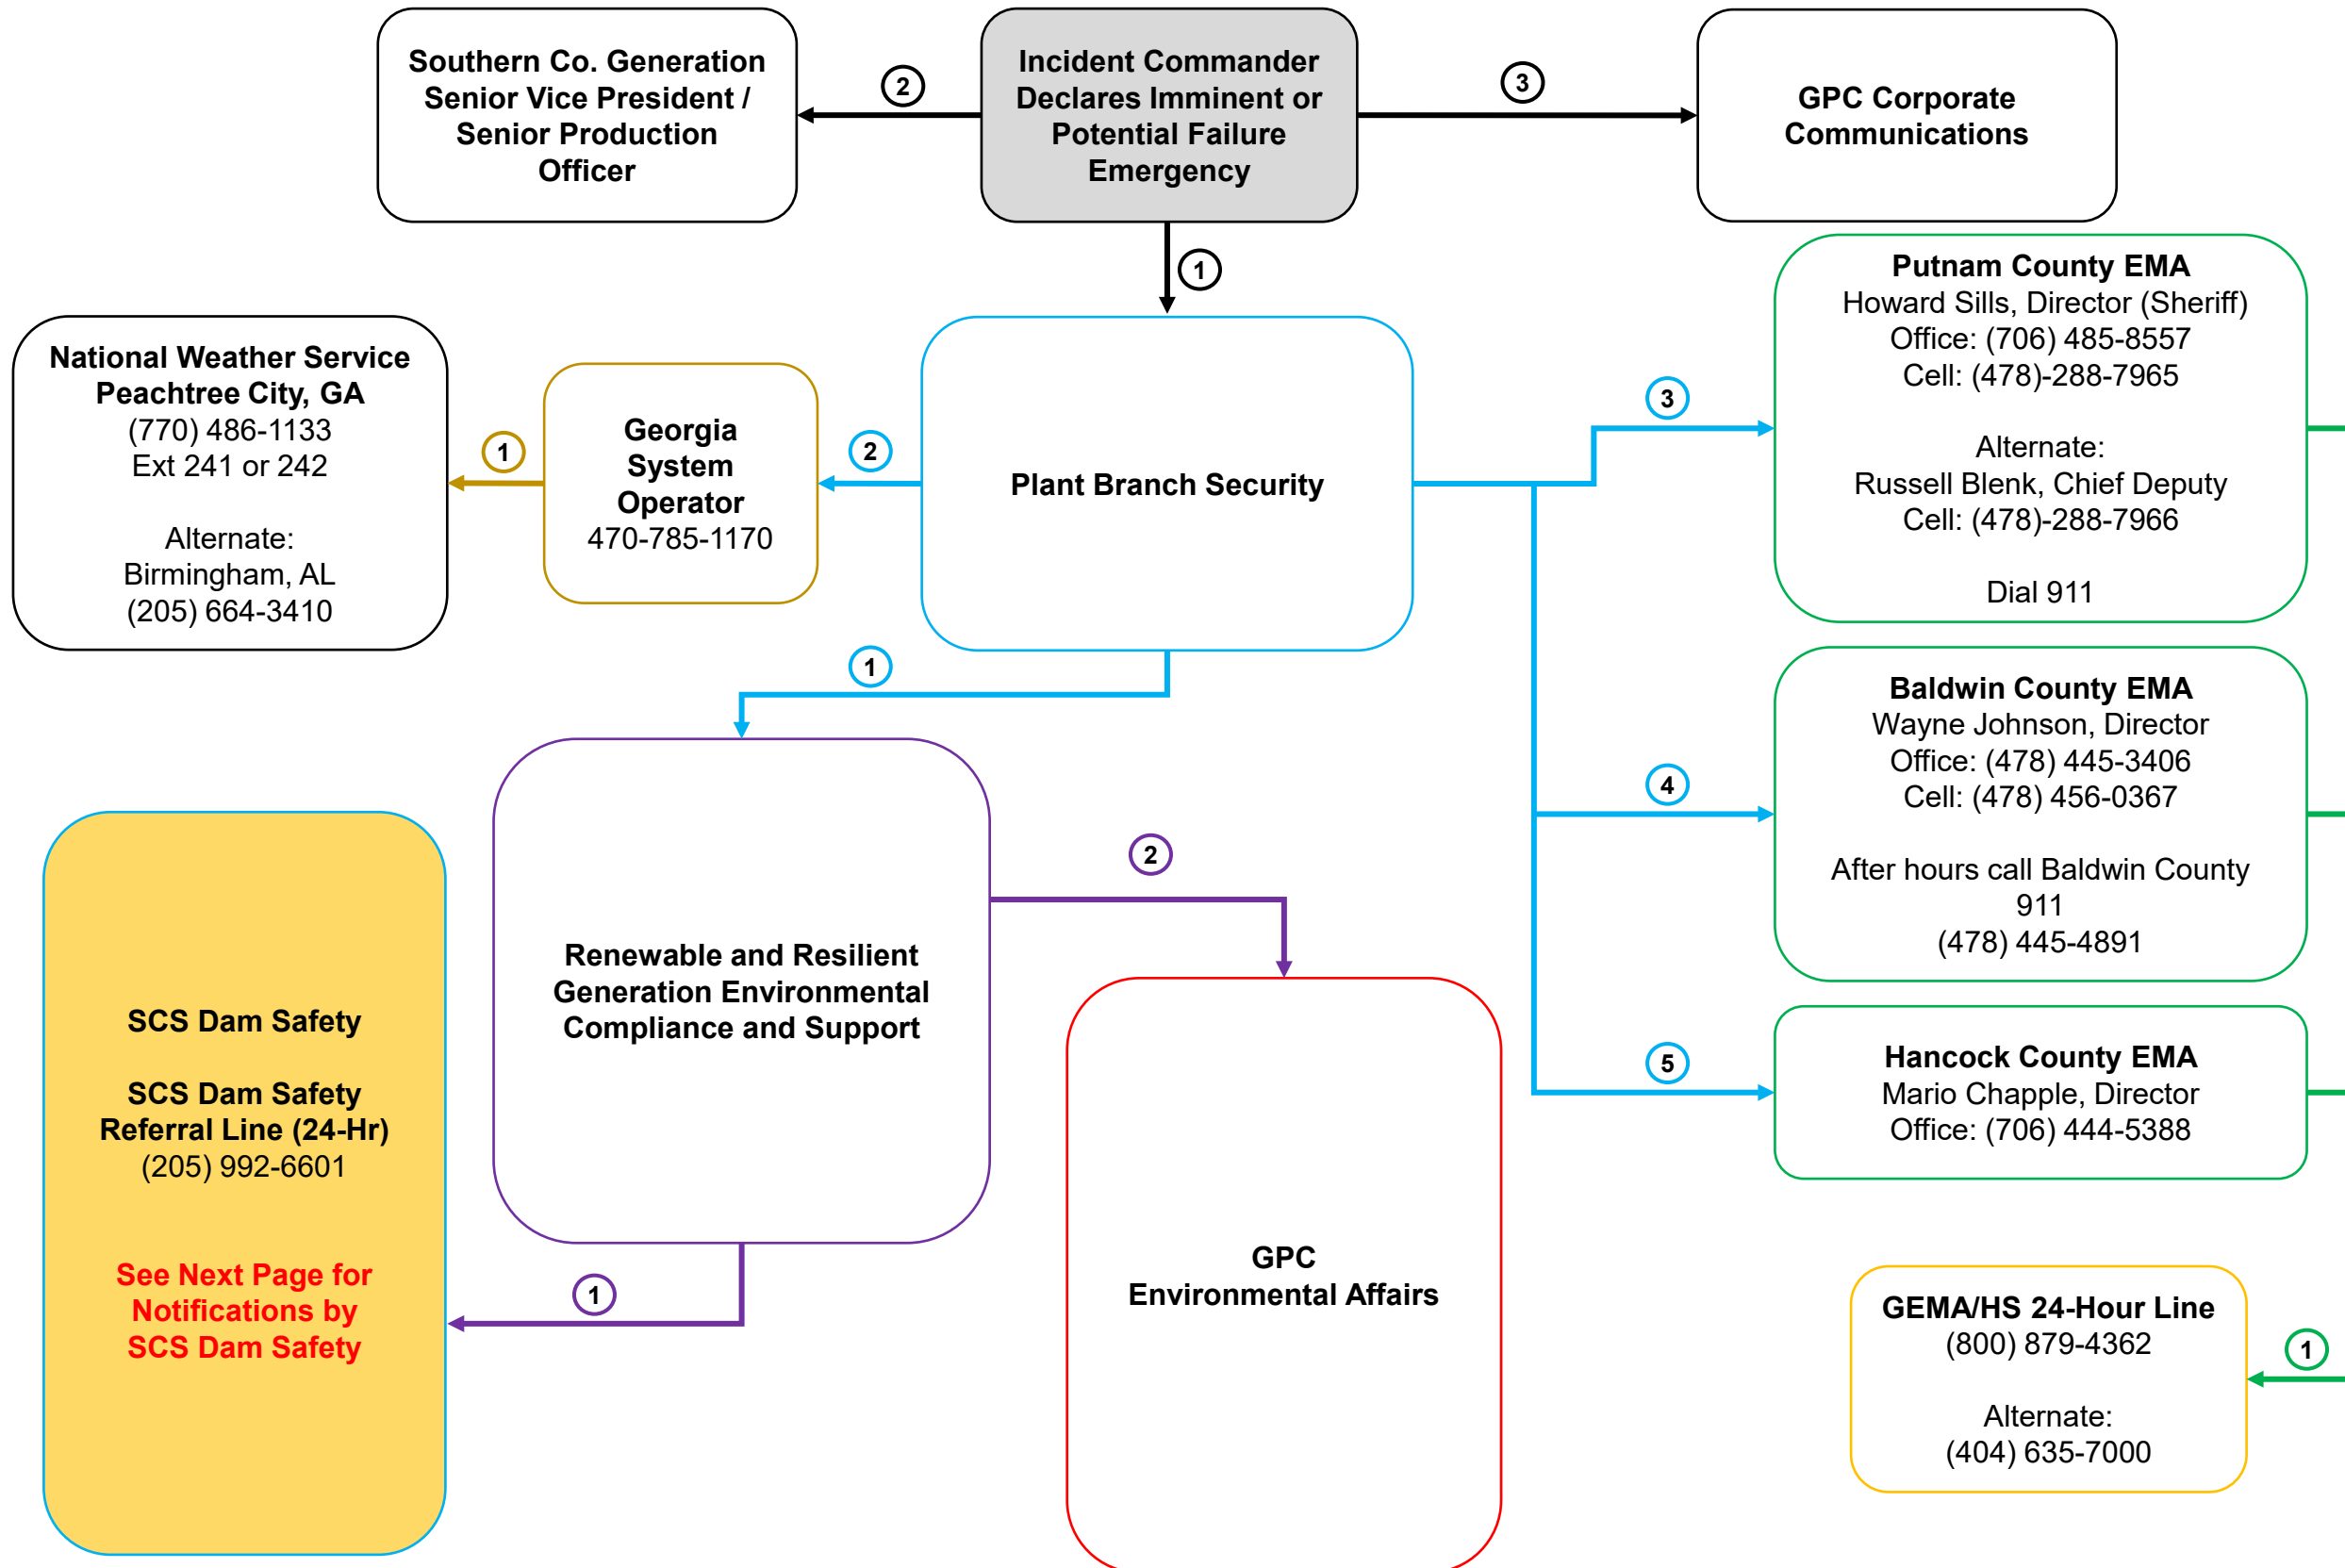
Imminent Failure or Potential Failure Emergencies

① Denotes Call Sequence

- E. If a **Potential Failure (Condition B Emergency)** has been declared, the Incident Commander will activate the EAP and notifications will be made on the Response Notification Flowchart (Appendix D). They will document all communications using the appropriate forms contained in Appendix E. Once outside agencies have been notified of an issue or potential problem, the Incident Commander or their designee is responsible for keeping local EMAs informed of any change in conditions.

- K. If an **Imminent Failure (Condition A Emergency)** has been declared by the Incident Commander or their designee, ensure that all personnel have been moved to a safe area and perform notifications per the Response Notification Flowchart (Appendix D). Document all communications using the appropriate forms contained in Appendix E. Once outside agencies have been notified of a problem or potential problem, the Incident Commander or their designee is responsible for keeping local EMAs informed of any change in conditions. SCS Dam Safety will be responsible for preparing the after-action report, which is in Appendix E.
