LEGACY CCR SURFACE IMPOUNDMENT EMERGENCY ACTION PLAN

Georgia Power Company
Plant Harllee Branch
Ash Pond D (AP-D)
State ID: 117-021-02354
NID: GA04932
Putnam County, GA

ISSUE DATE: 05/06/2026
REVISION #: 0

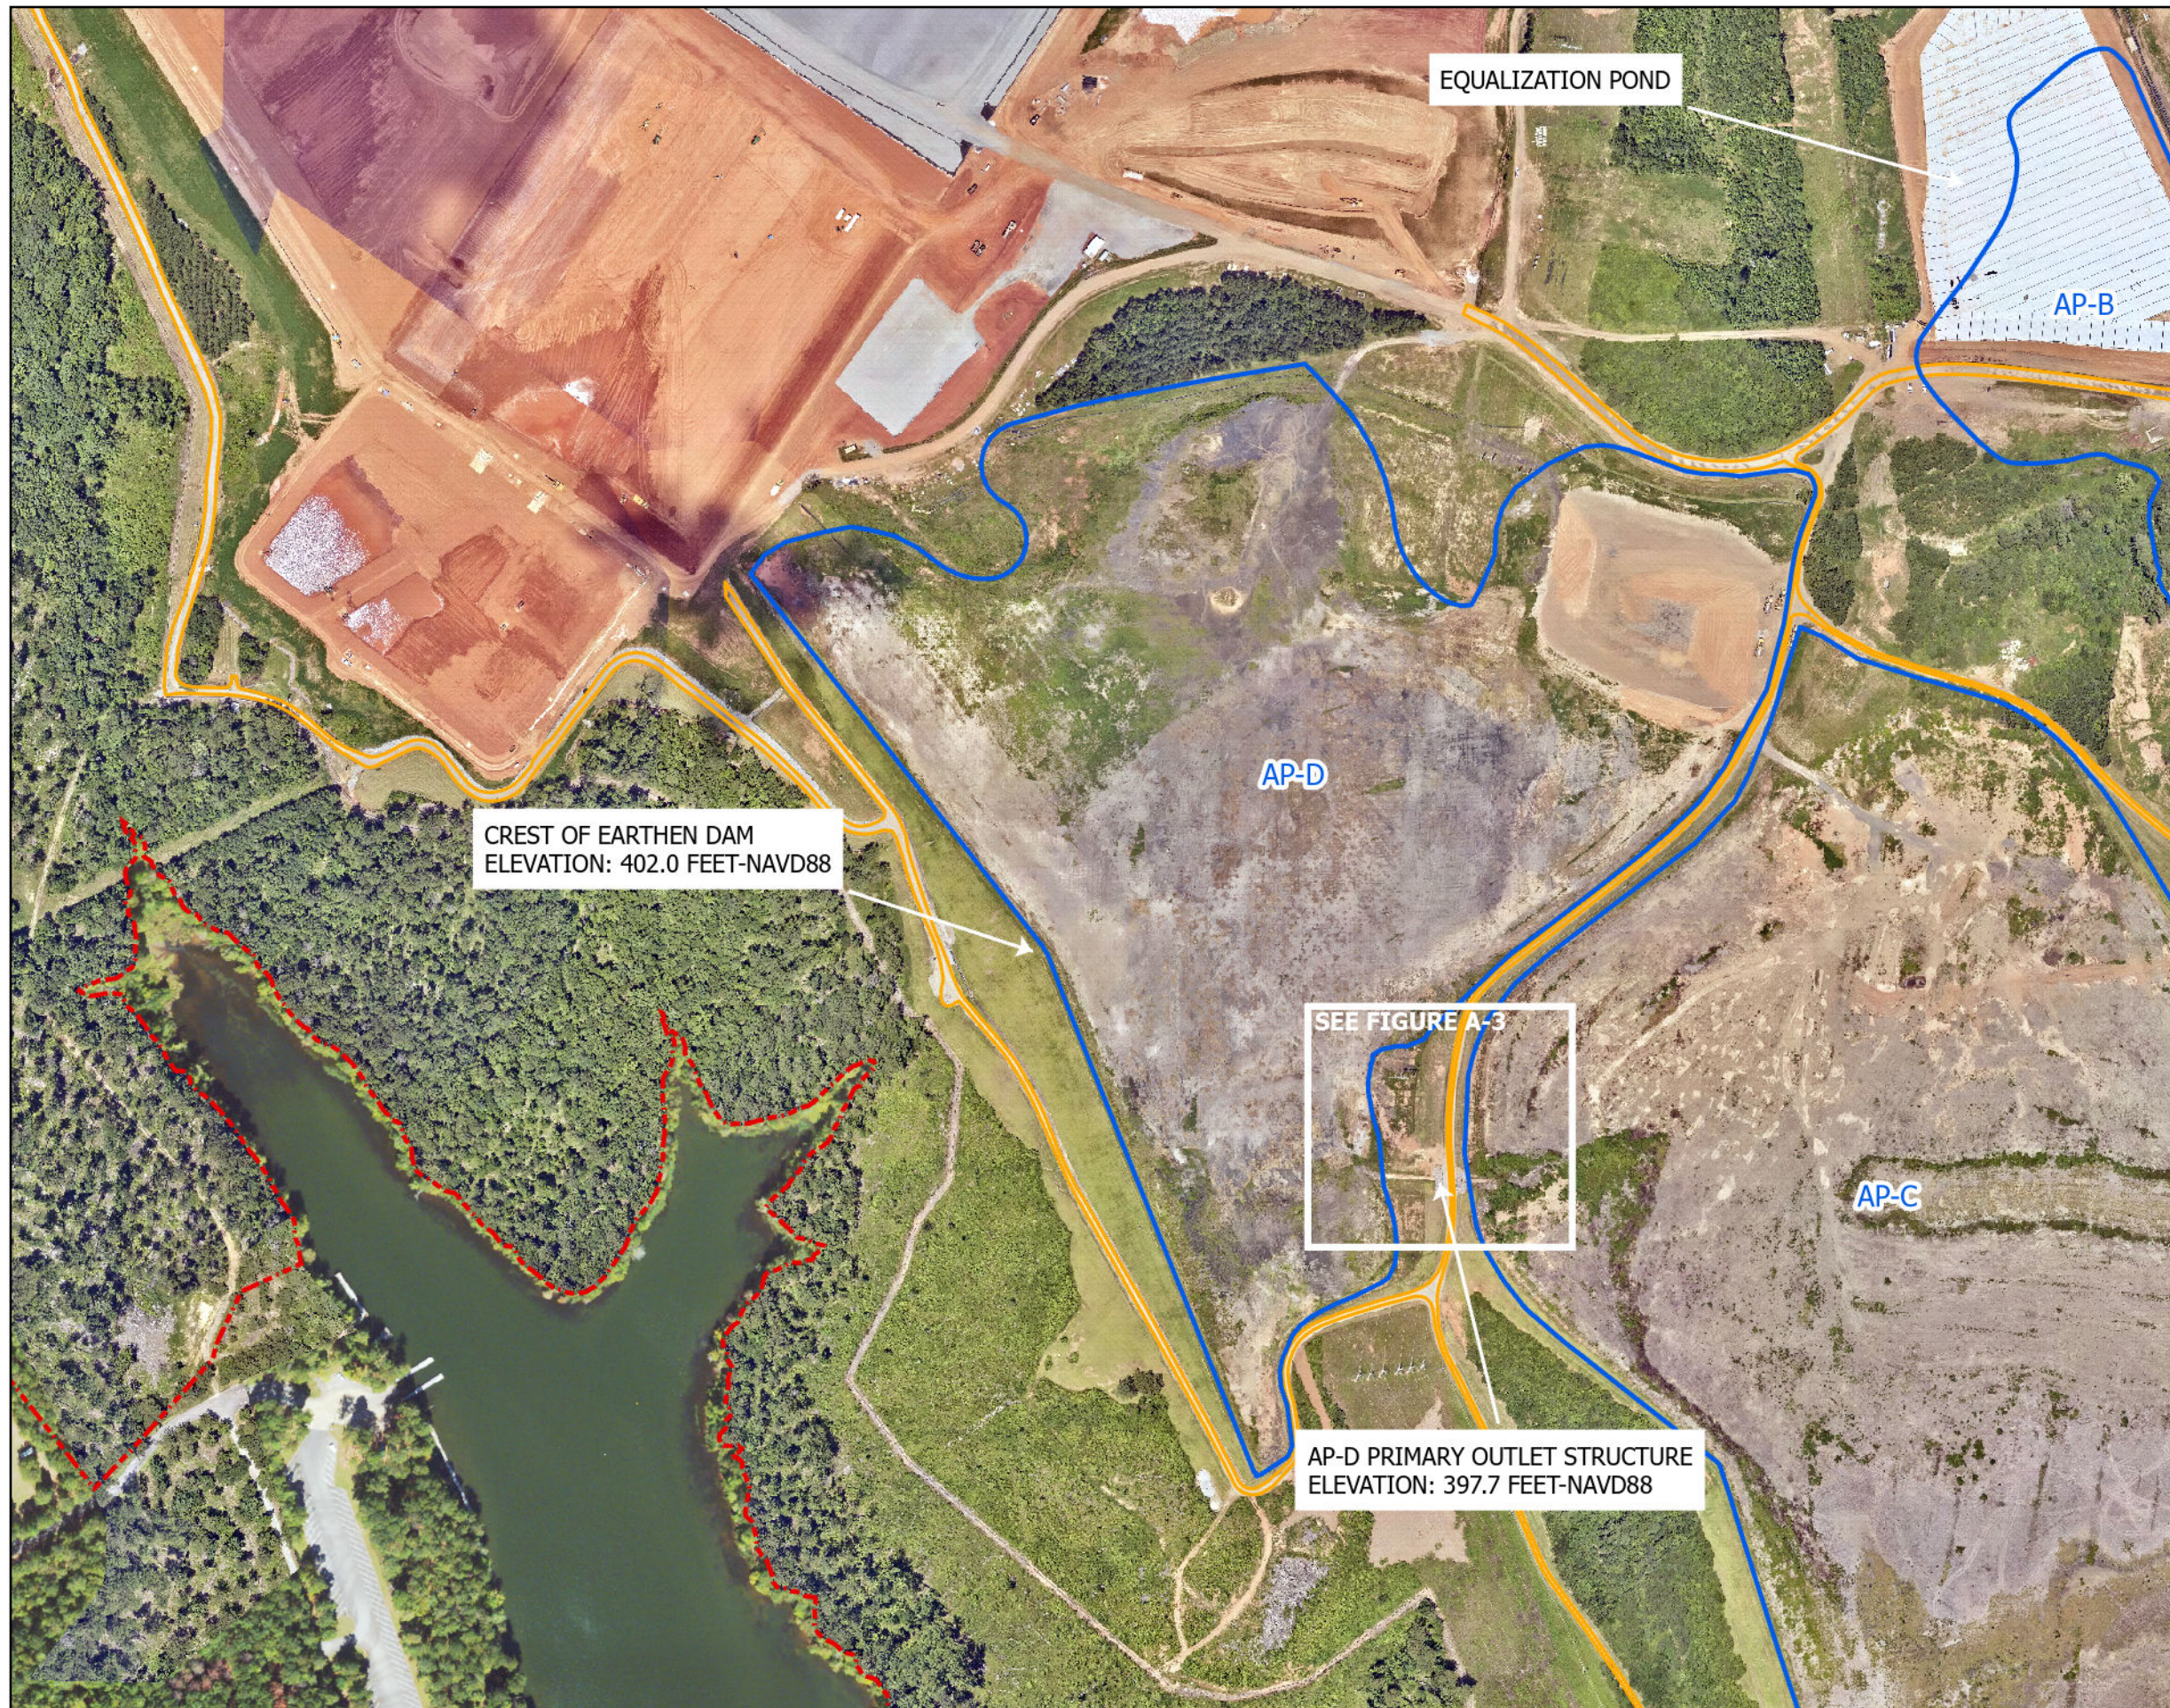
**FIGURE
 A-2**

AP-D Overview - Figure A-2

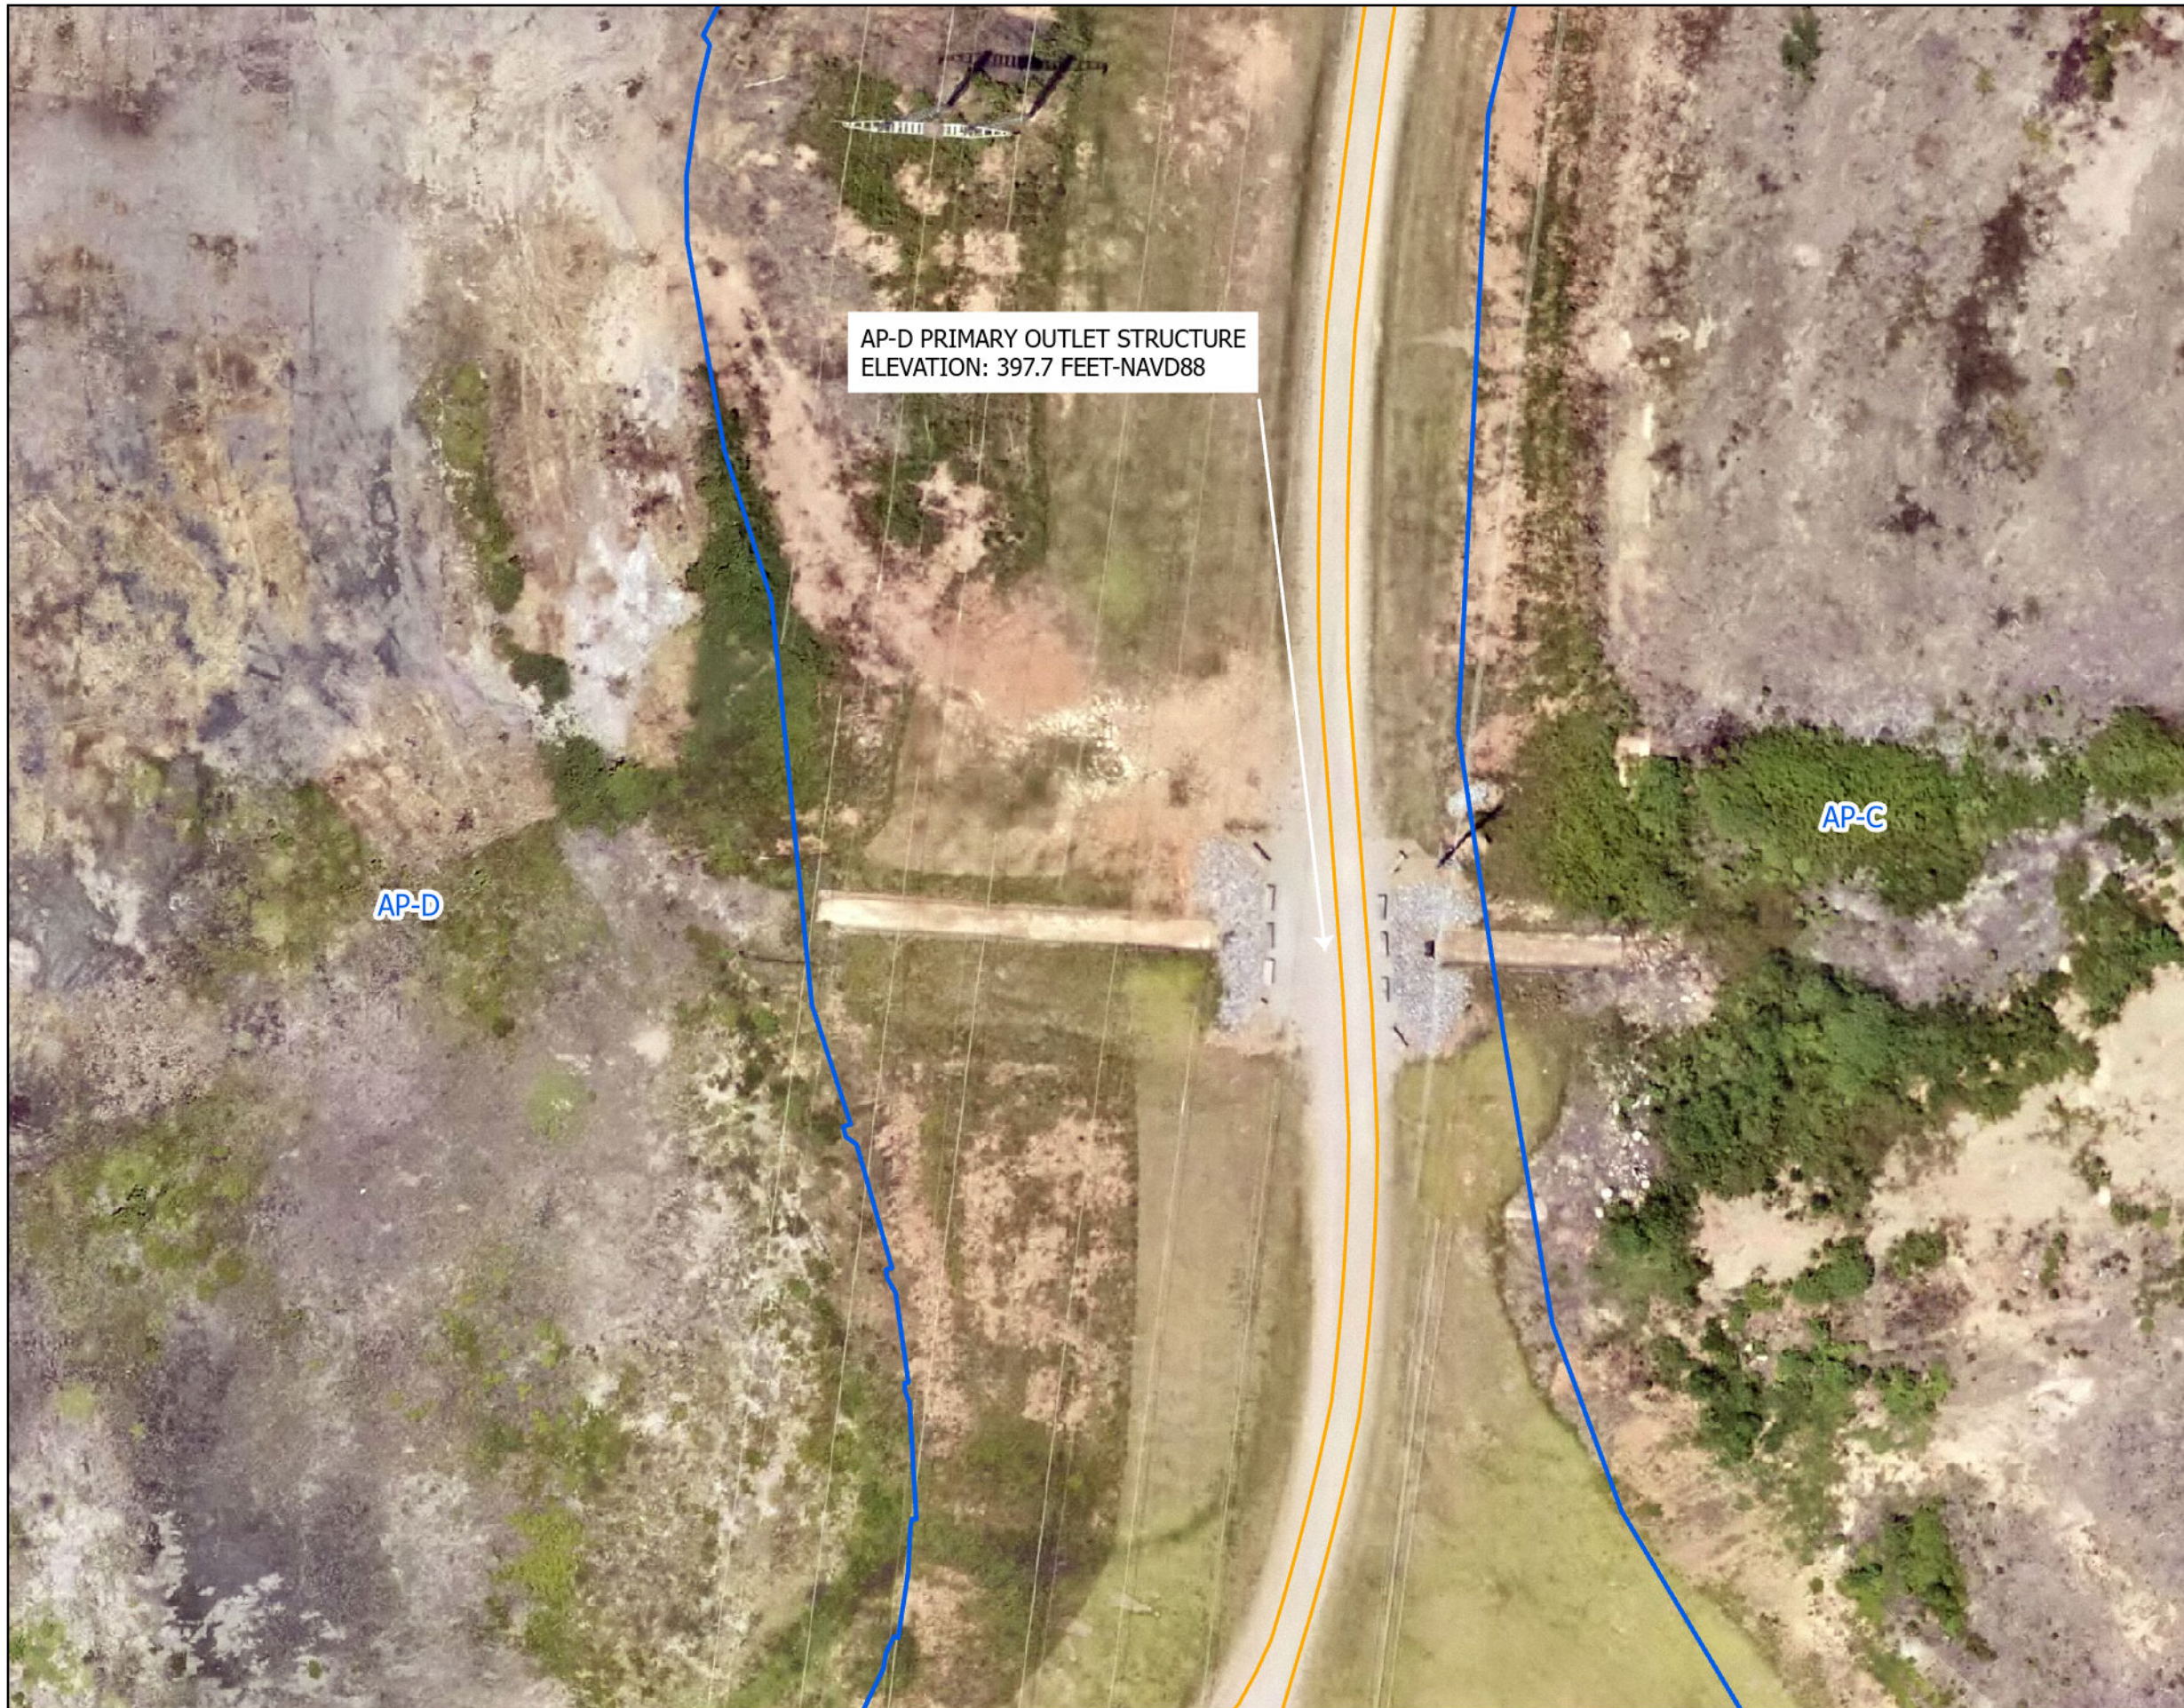
**FIGURE
A-3**

AP-D Primary Outlet Structure - Figure A-3

AP-D PRIMARY OUTLET STRUCTURE
ELEVATION: 397.7 FEET-NAVD88

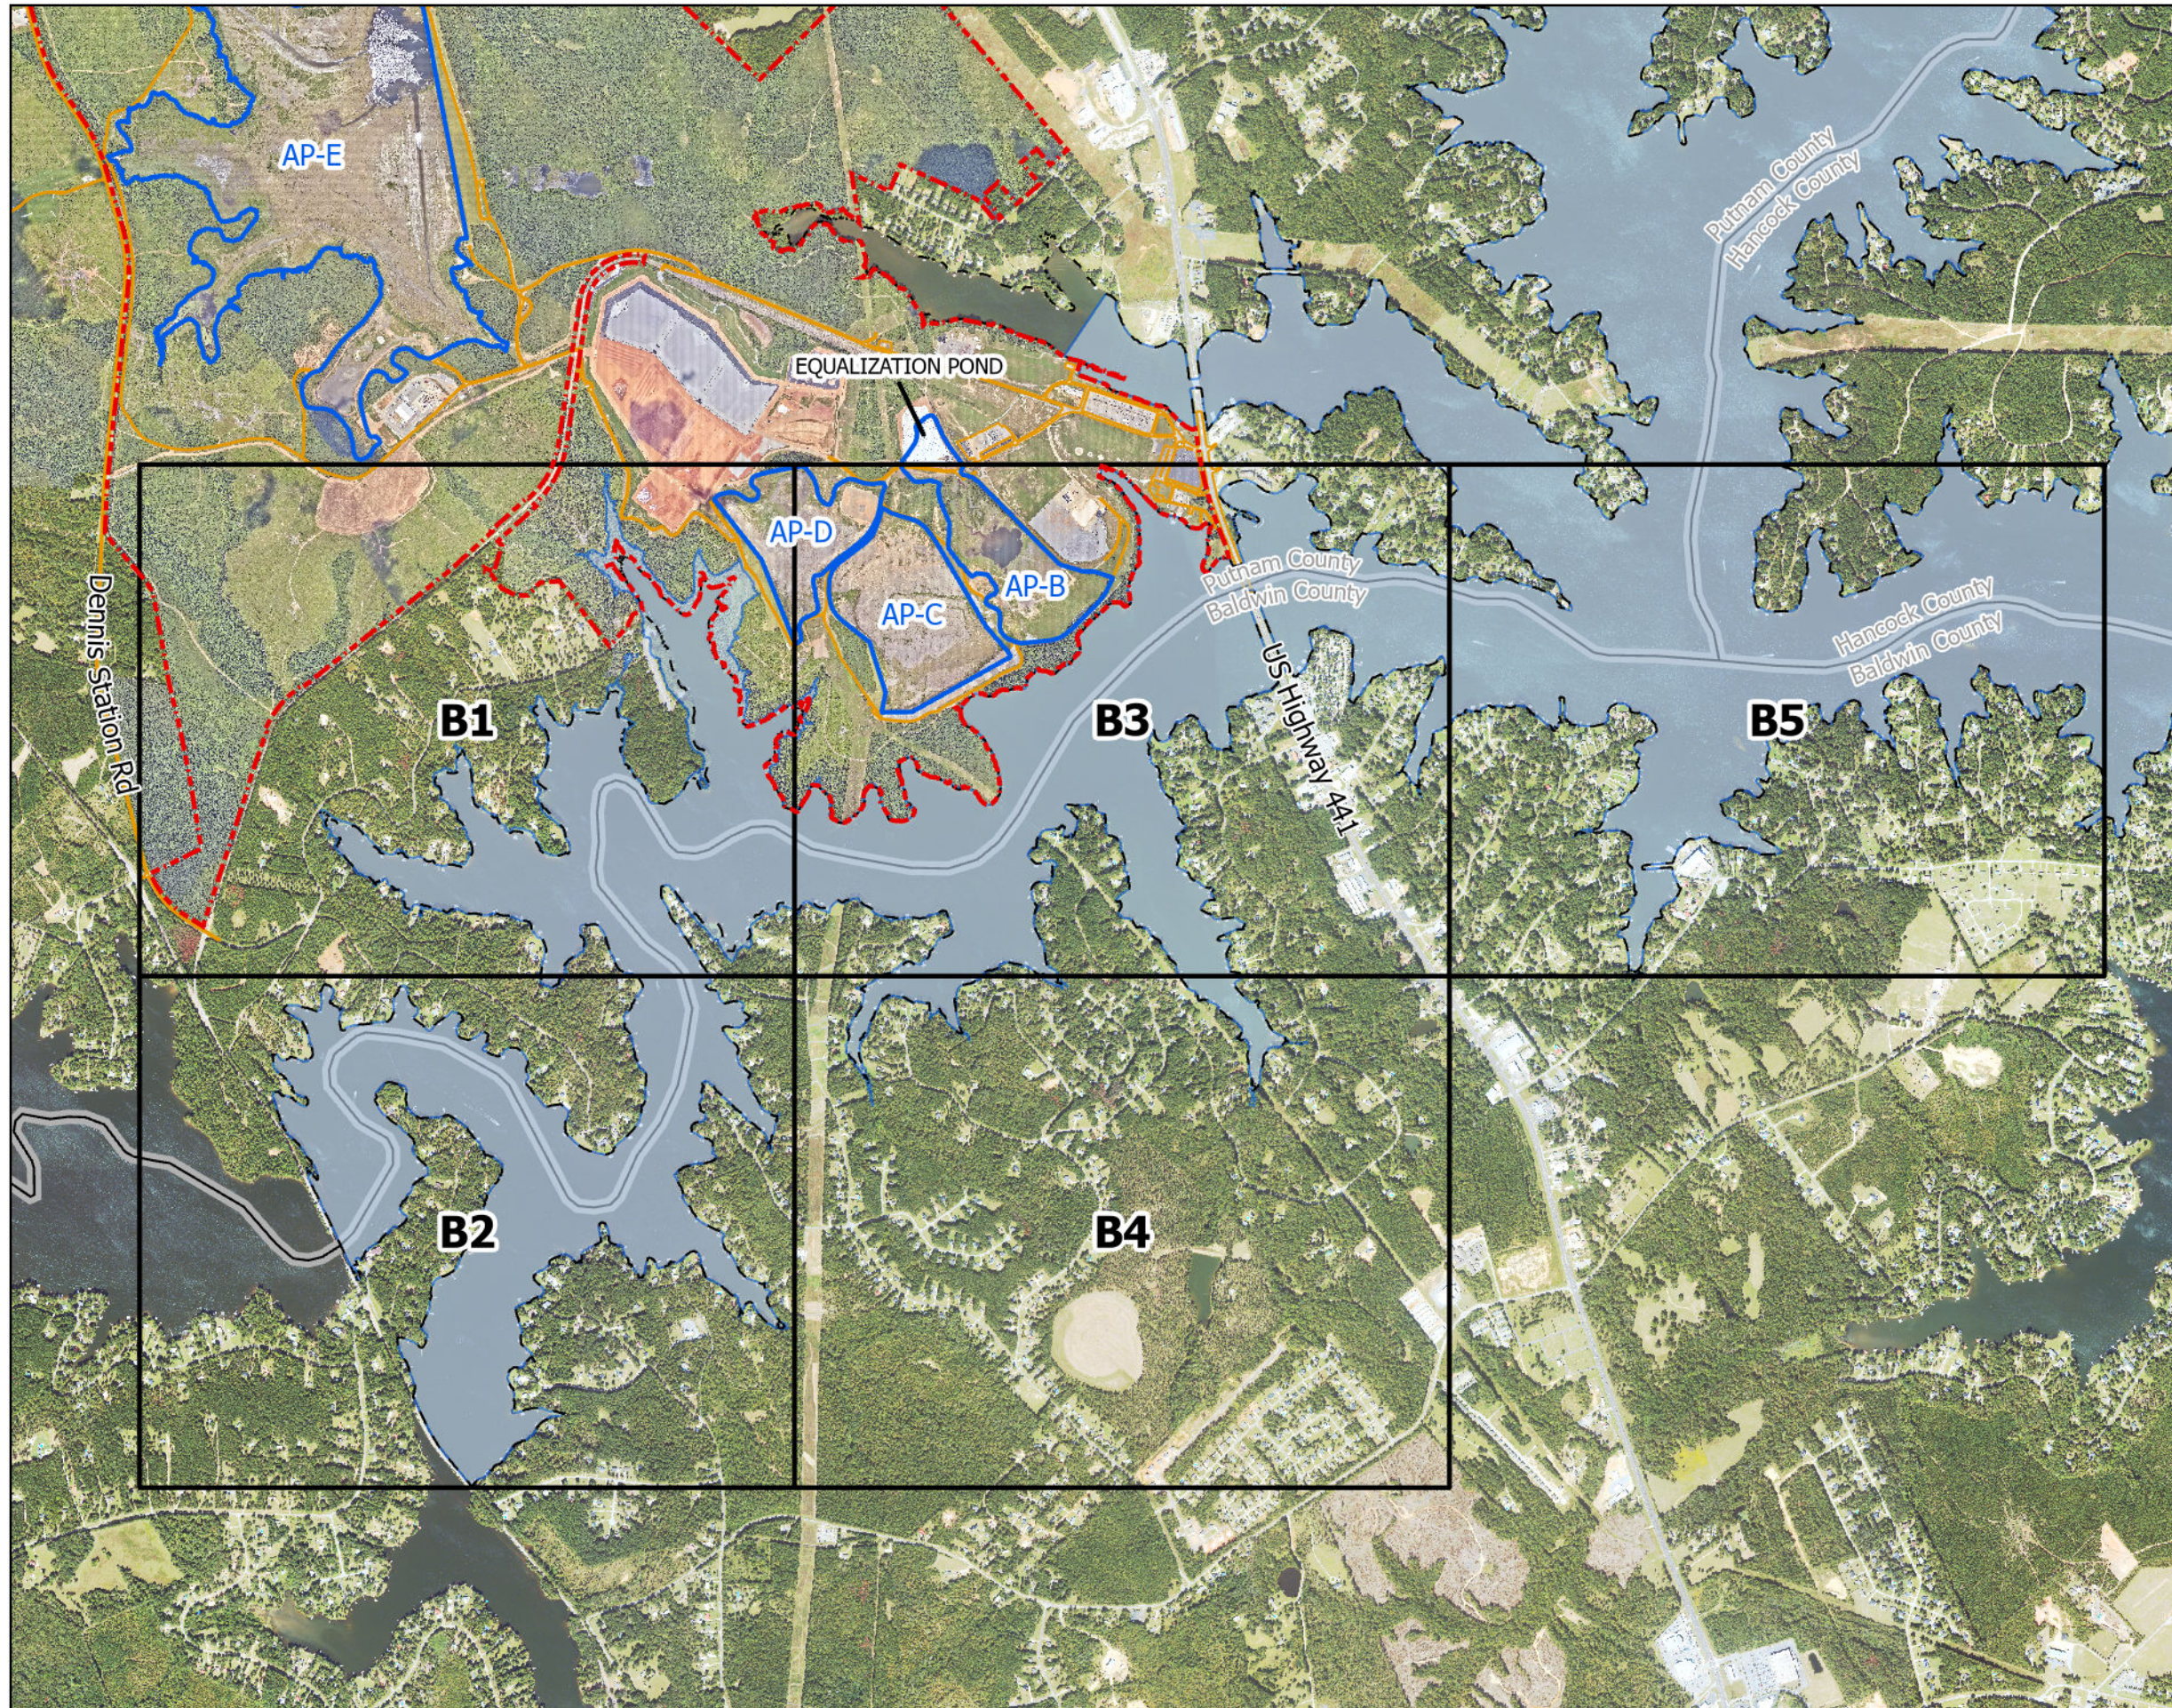
Prepared For:	FIGURE B-INDEX
Prepared By:	
KENNESAW, GA	APRIL 2026

Plant Branch	Sunny Day Inundation
Property Boundary	Ash Pond Boundaries
Sheet Index	Access Roads
Lake Sinclair Boundary	County Boundaries

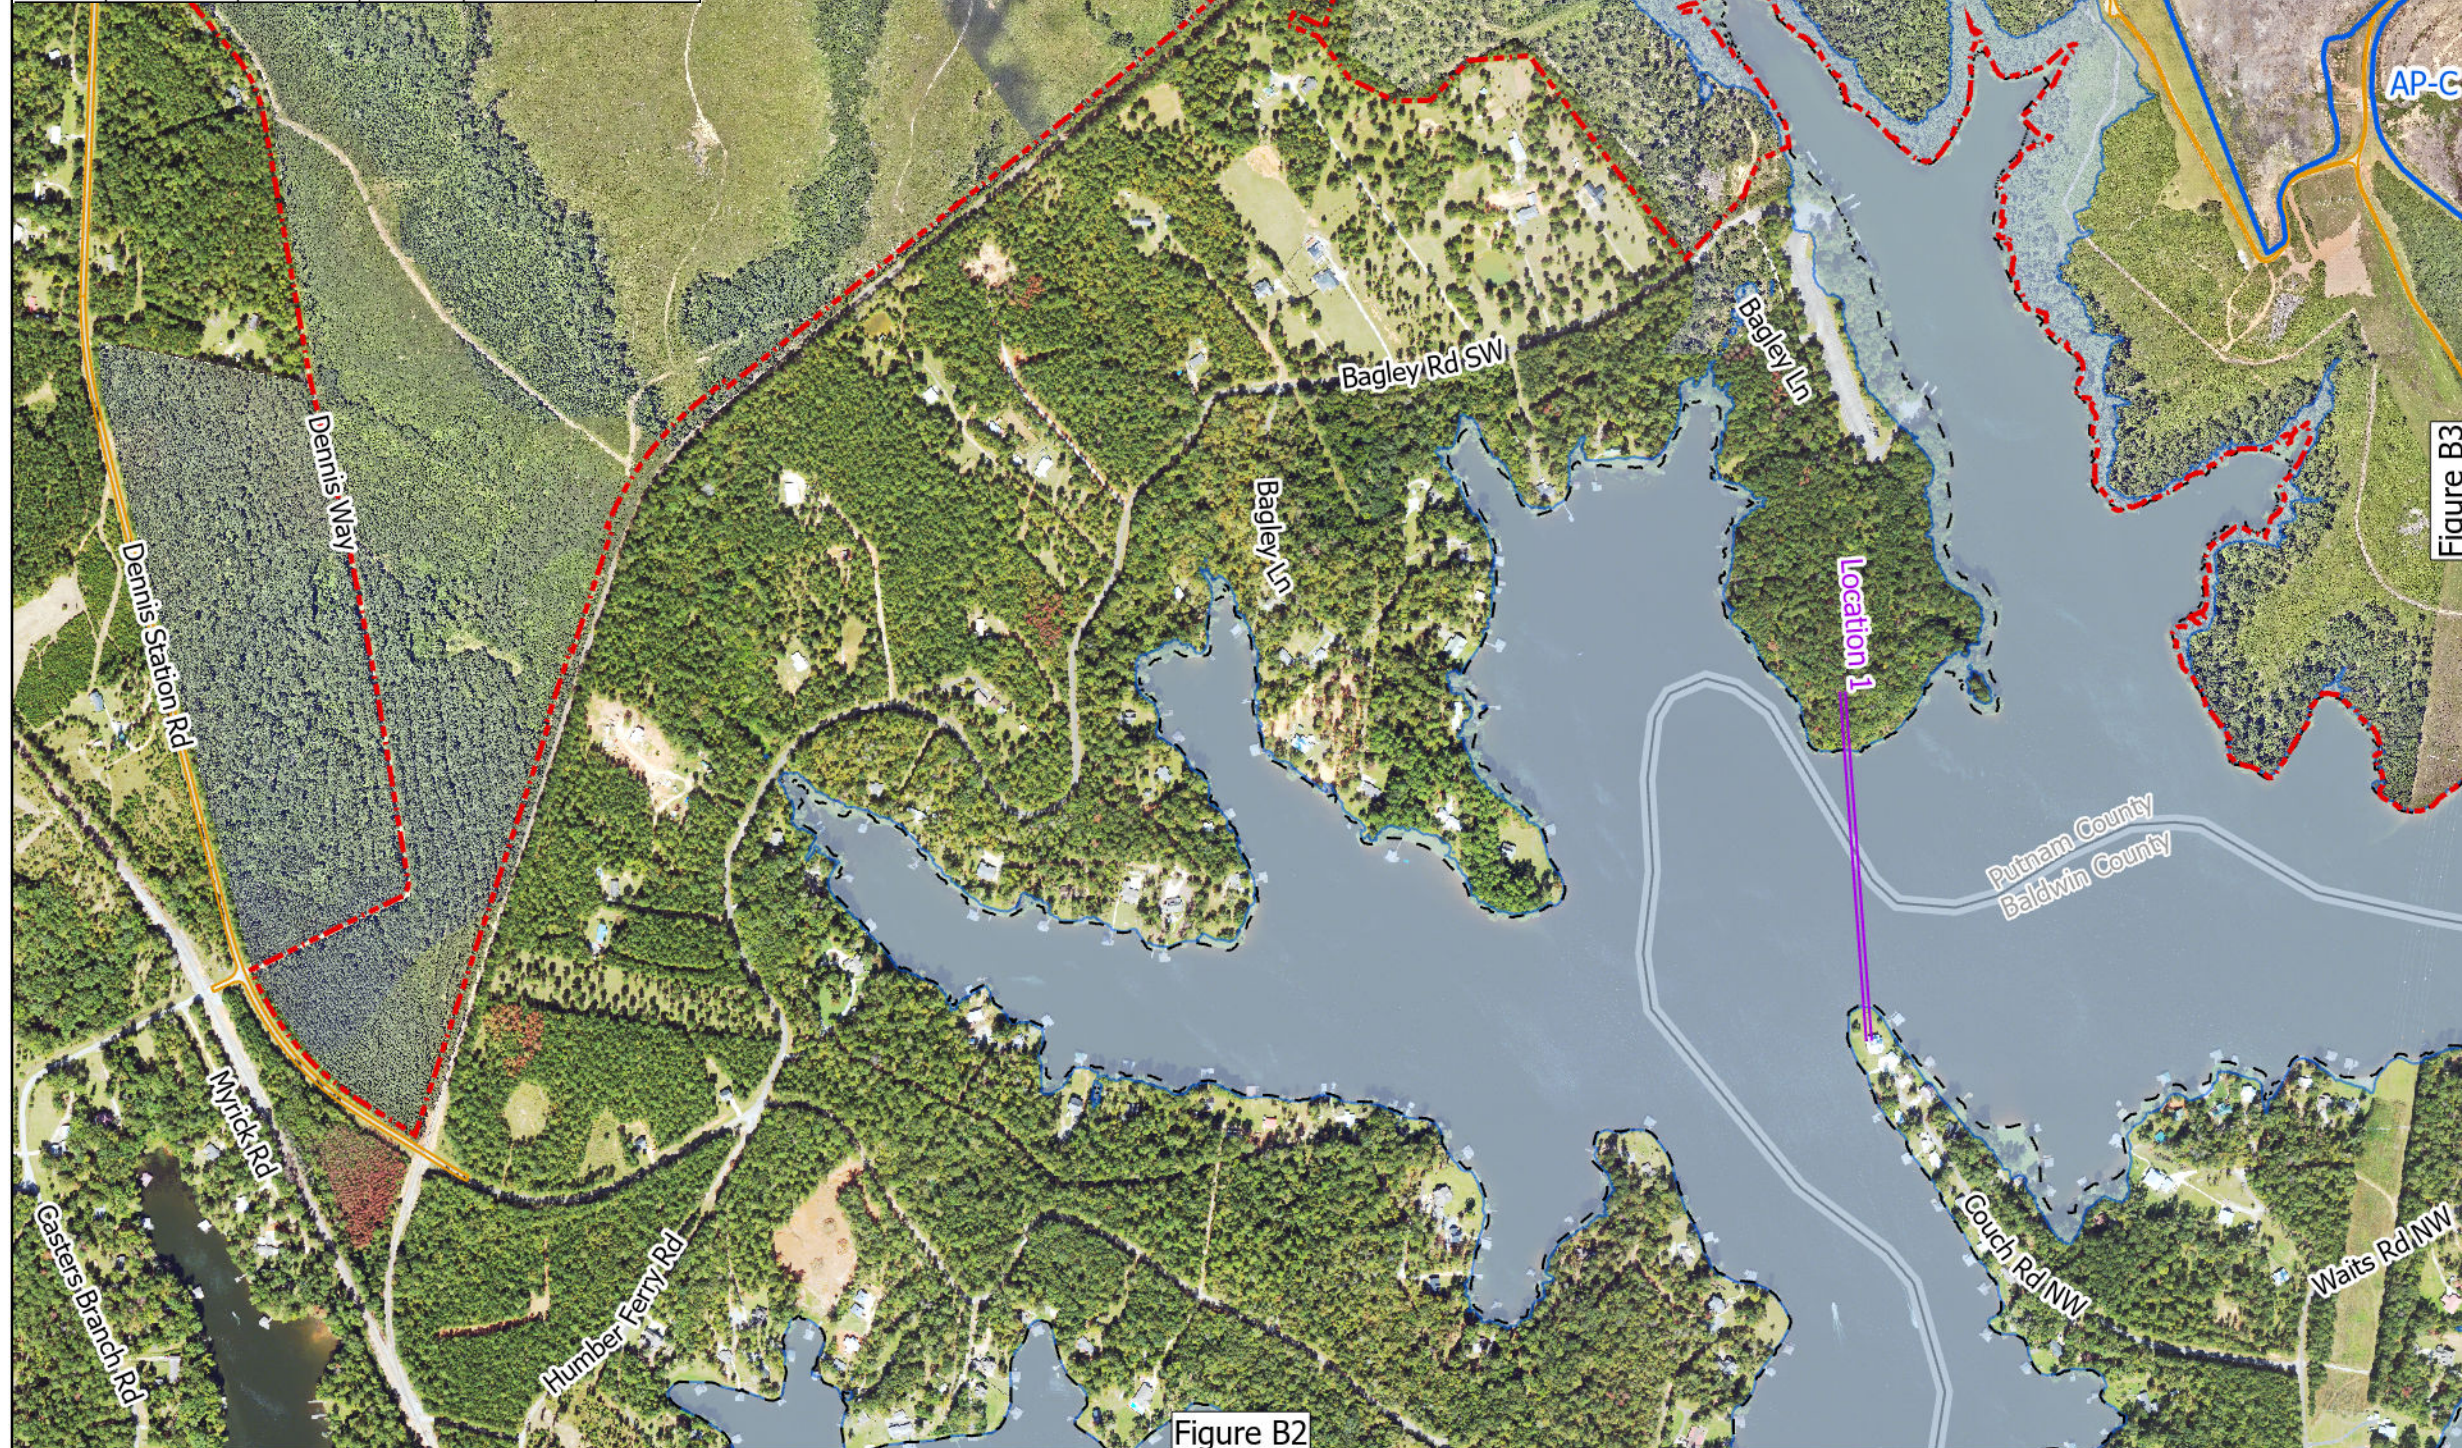
FIGURE B1

Location	River Miles Downstream of AP-D	Time from Breach to Initial Wave (h:mm)	Time from Breach to Maximum Wave (h:mm)	Maximum Water Surface Elevation (ft-NAVD88)	Peak Discharge (cfs)
1	0.91	0:05	0:13	340.9	25,700
2	1.75	0:12	0:28	339.3	4,400
3	2.94	0:20	0:46	338.8	1,650
4	2.61	0:19	0:43	338.8	2,250
5	1.39	0:10	0:19	339.8	8,250
6	1.89	0:14	0:23	339.5	1,900
7	2.15	0:18	0:47	339.4	3,600
8	2.88	0:25	0:57	338.8	1,750
9	3.45	0:30	1:12	338.8	700

- Locations (Purple line)
- Plant Branch Property Boundary (Red dashed line)
- Lake Sinclair Boundary (Black dashed line)
- Sunny Day Inundation (Light blue area)
- Ash Pond Boundaries (Blue outline)
- Access Roads (Yellow line)
- County Boundaries (Grey line)

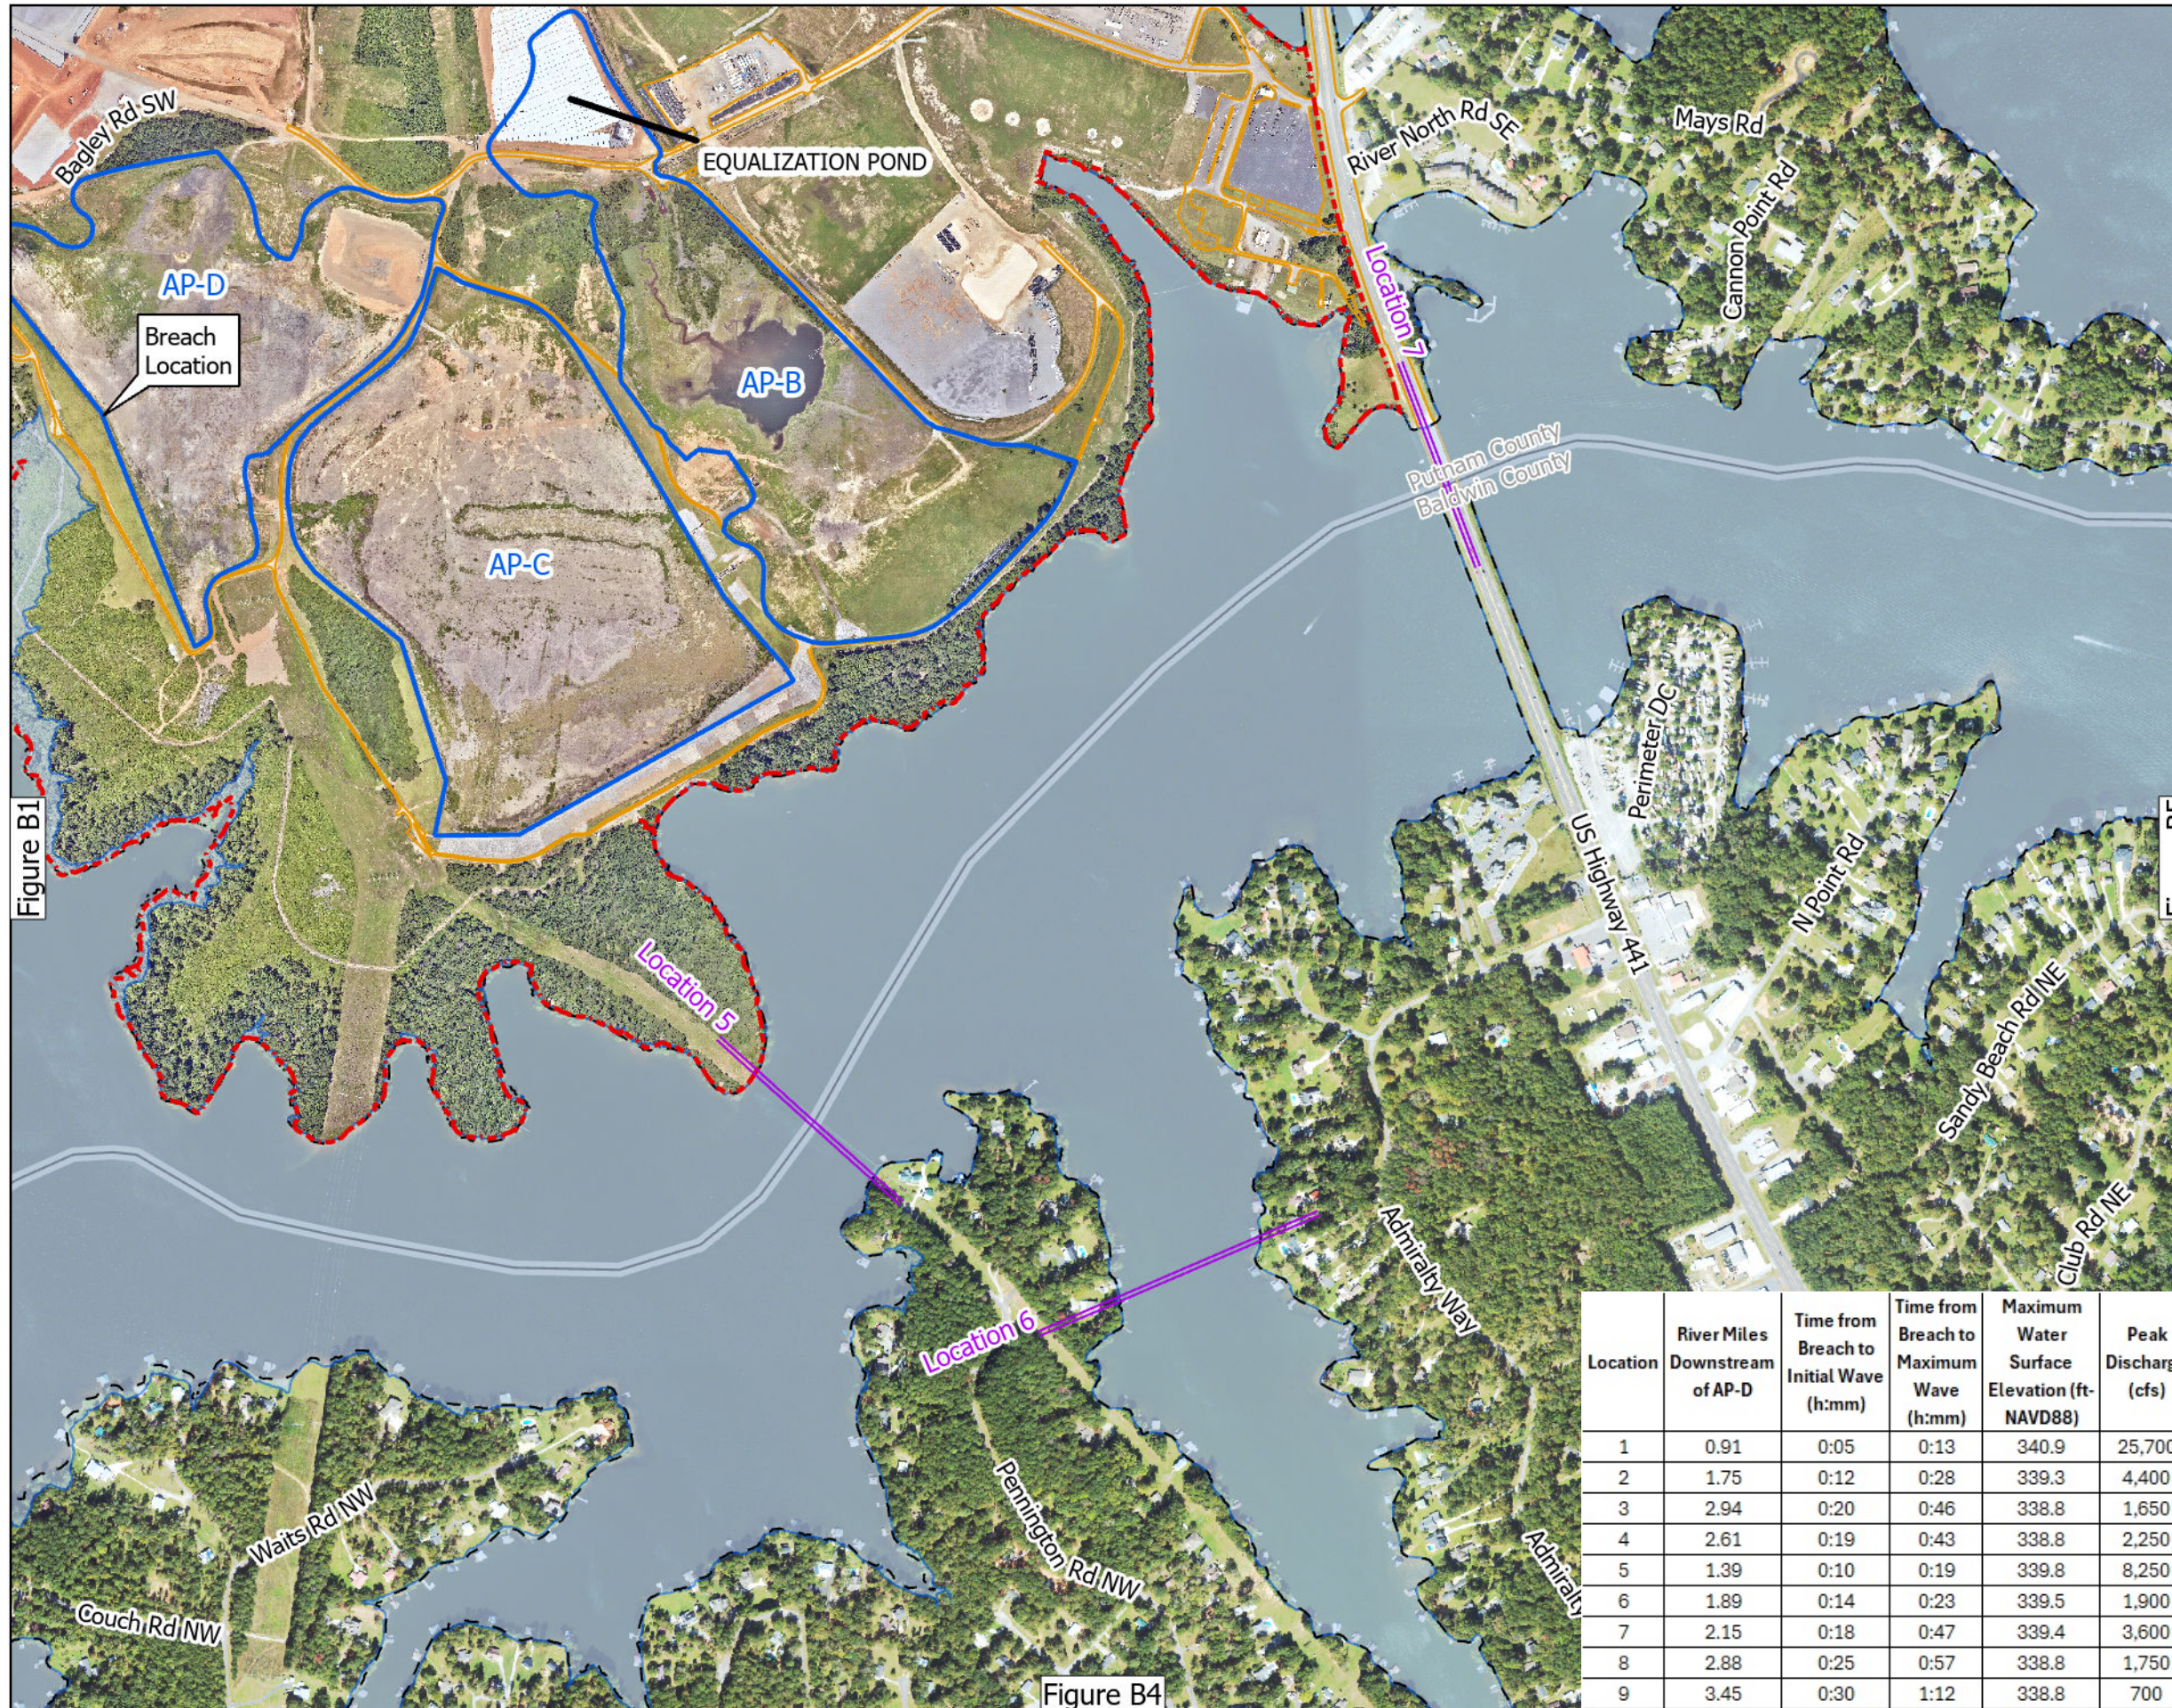
FIGURE B3

- Locations
- - - Plant Branch
- - - Property Boundary
- - - Lake Sinclair
- - - Boundary
- Sunny Day Inundation
- Ash Pond Boundaries
- Access Roads
- County Boundaries
