LEGACY CCR SURFACE IMPOUNDMENT EMERGENCY ACTION PLAN

Georgia Power Company
Plant Mitchell

Ash Pond 1 (AP-1)

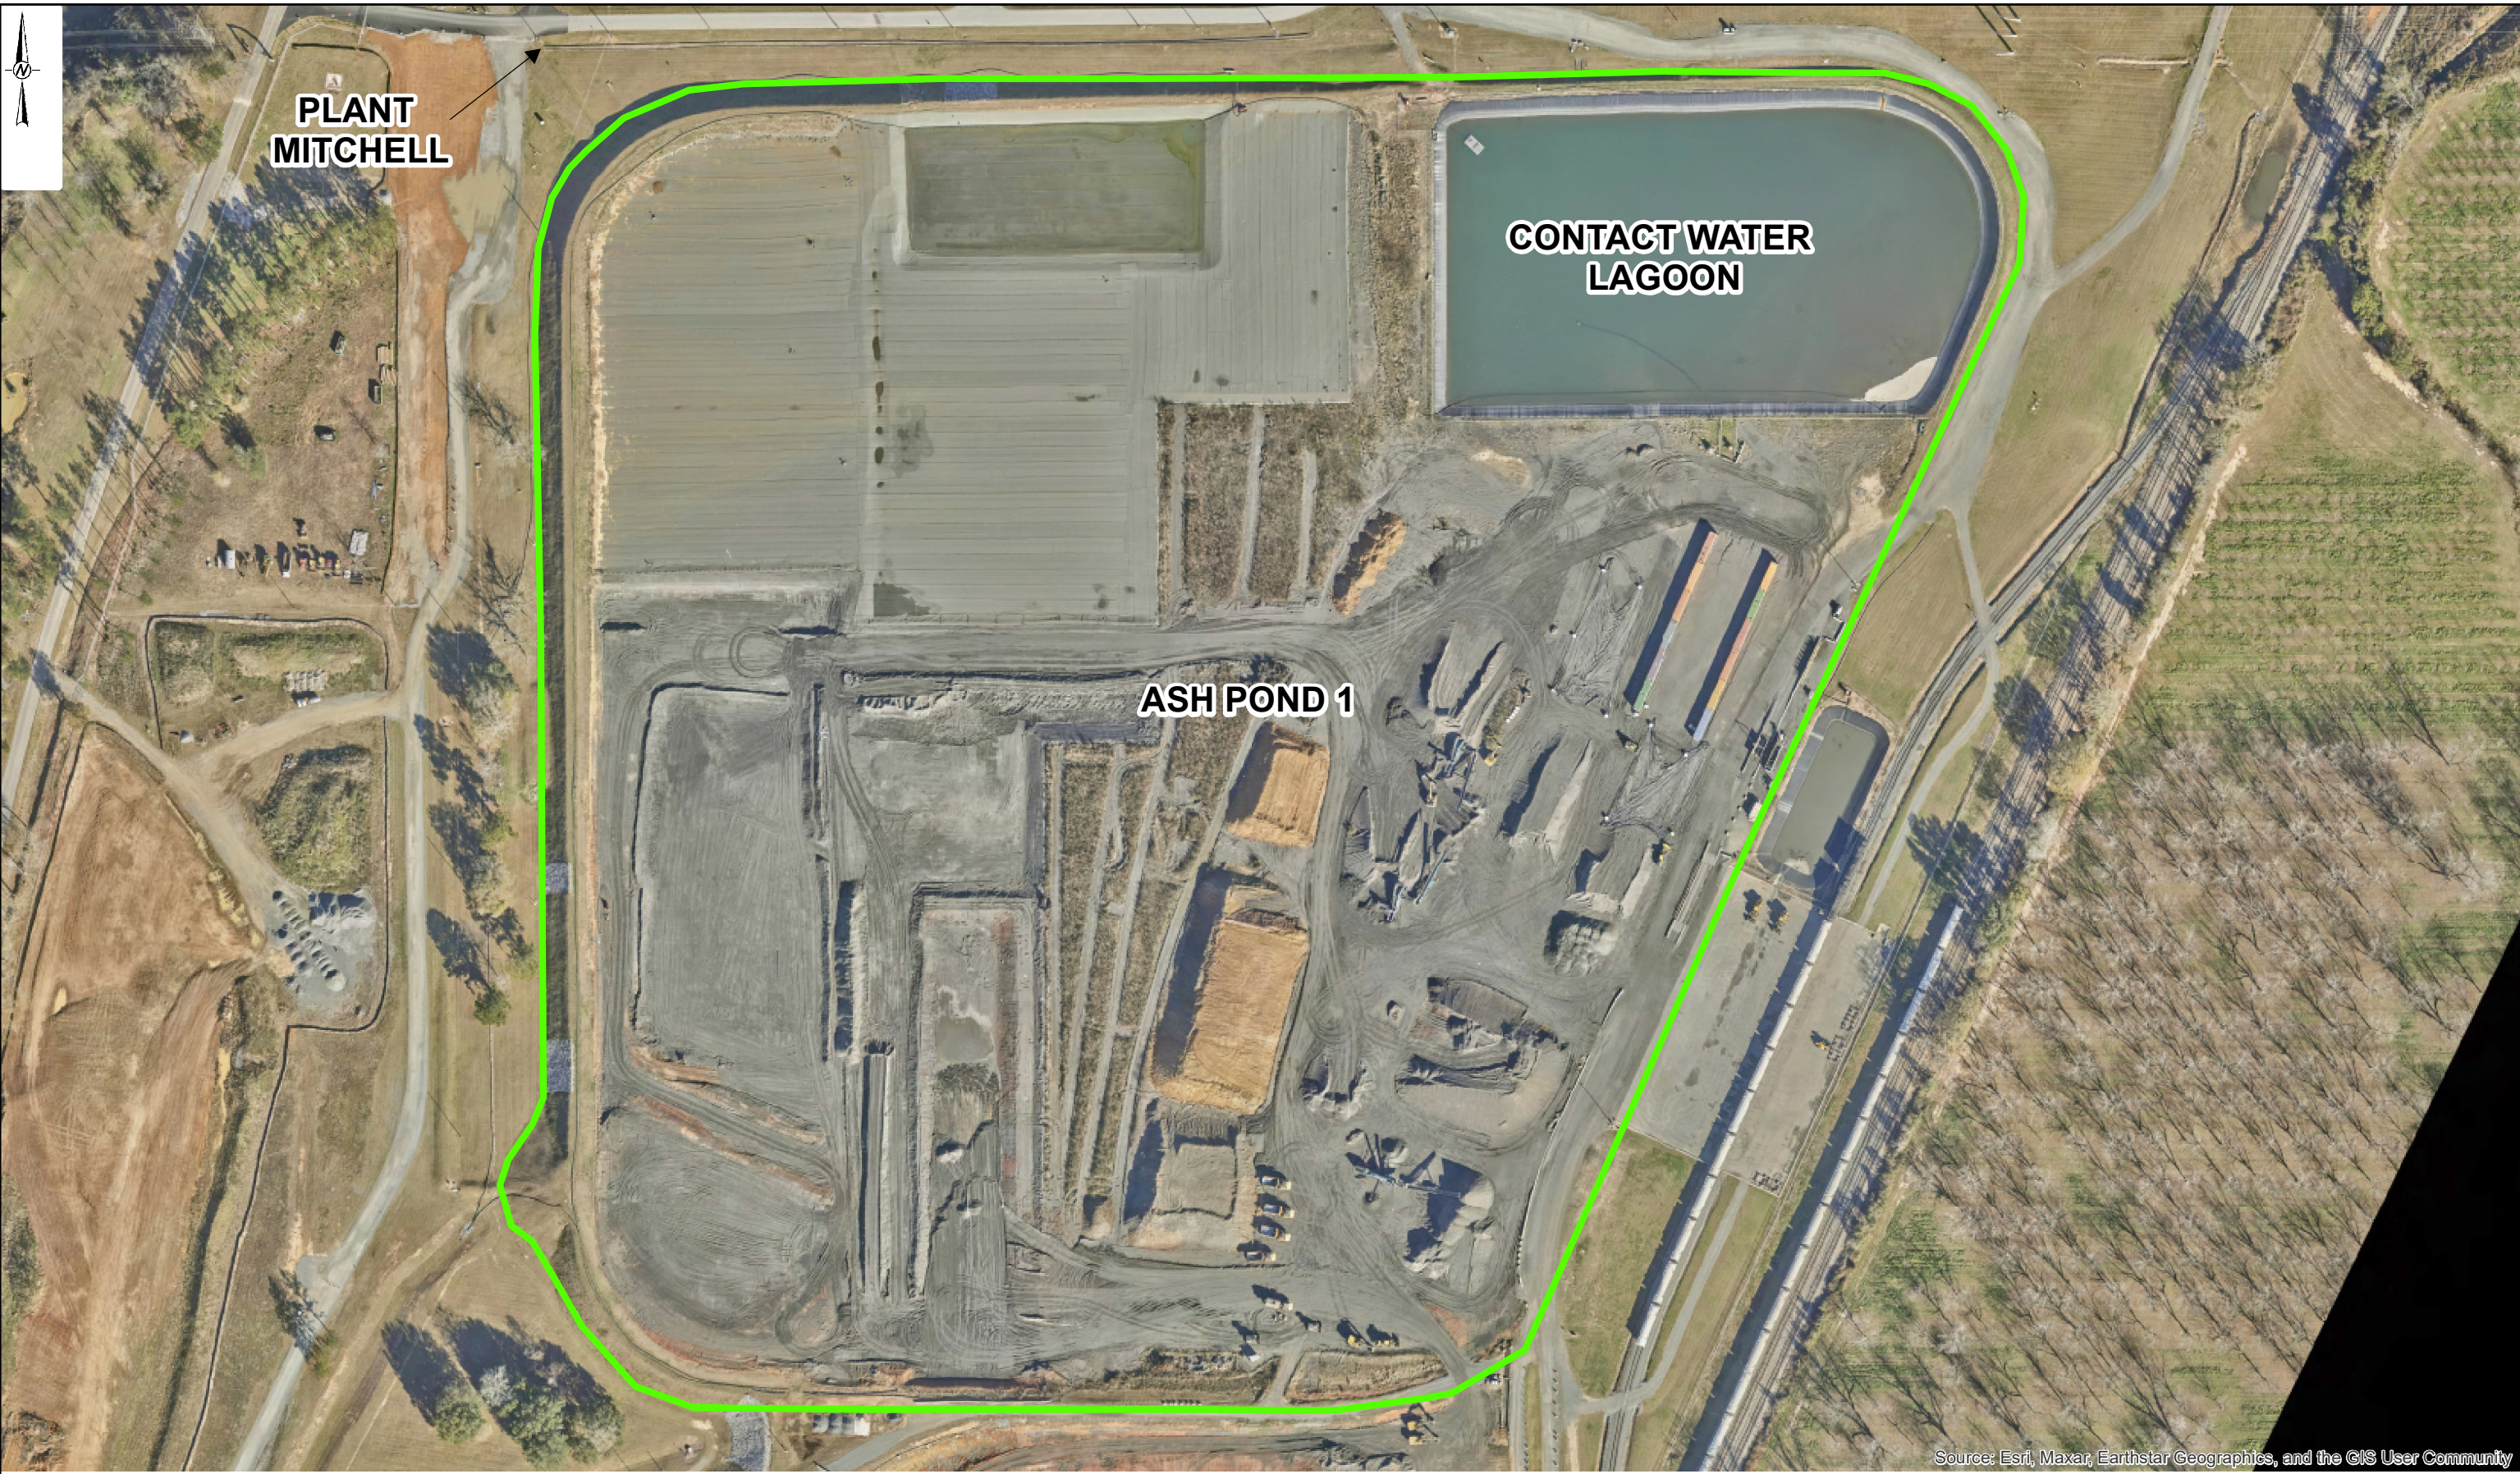
FIGURE
2

AP-1 Overview – Figure 2

AP-1 is approximately 53 acres in size at its normal pool elevation of 191 feet (Appendix A – Figure 2). AP-1 has earthen embankments (also referred to as dams) on its north, east, south, and west sides. The AP-1 dam has a maximum height of approximately 26 feet on the west side. Downstream slopes are predominately covered with grass with four areas of riprap protection (one on the northern dam, two on the western dam, and one on the southern dam adjacent to Ash Pond 2 (AP-2)). The outfall structure, formerly located at the southern end of the western dam, has been removed and the horizontal barrel has been abandoned in-place by grouting. A grass and a gravel drive provide access around the dam crest.

Plant and emergency personnel are able to access the dam by paved or gravel surfaced roadways from the Plant Mitchell access/entrance road. Figures 1 and 2 in Appendix A show the location of AP-1 within the Plant property.
