# Final Sediment Quality Study Report

**LANGDALE PROJECT (FERC No. 2341)  
AND  
RIVERVIEW PROJECT (FERC No. 2350)**

Prepared for:  
**Georgia Power Company**

Prepared by:  
**Kleinschmidt Associates**

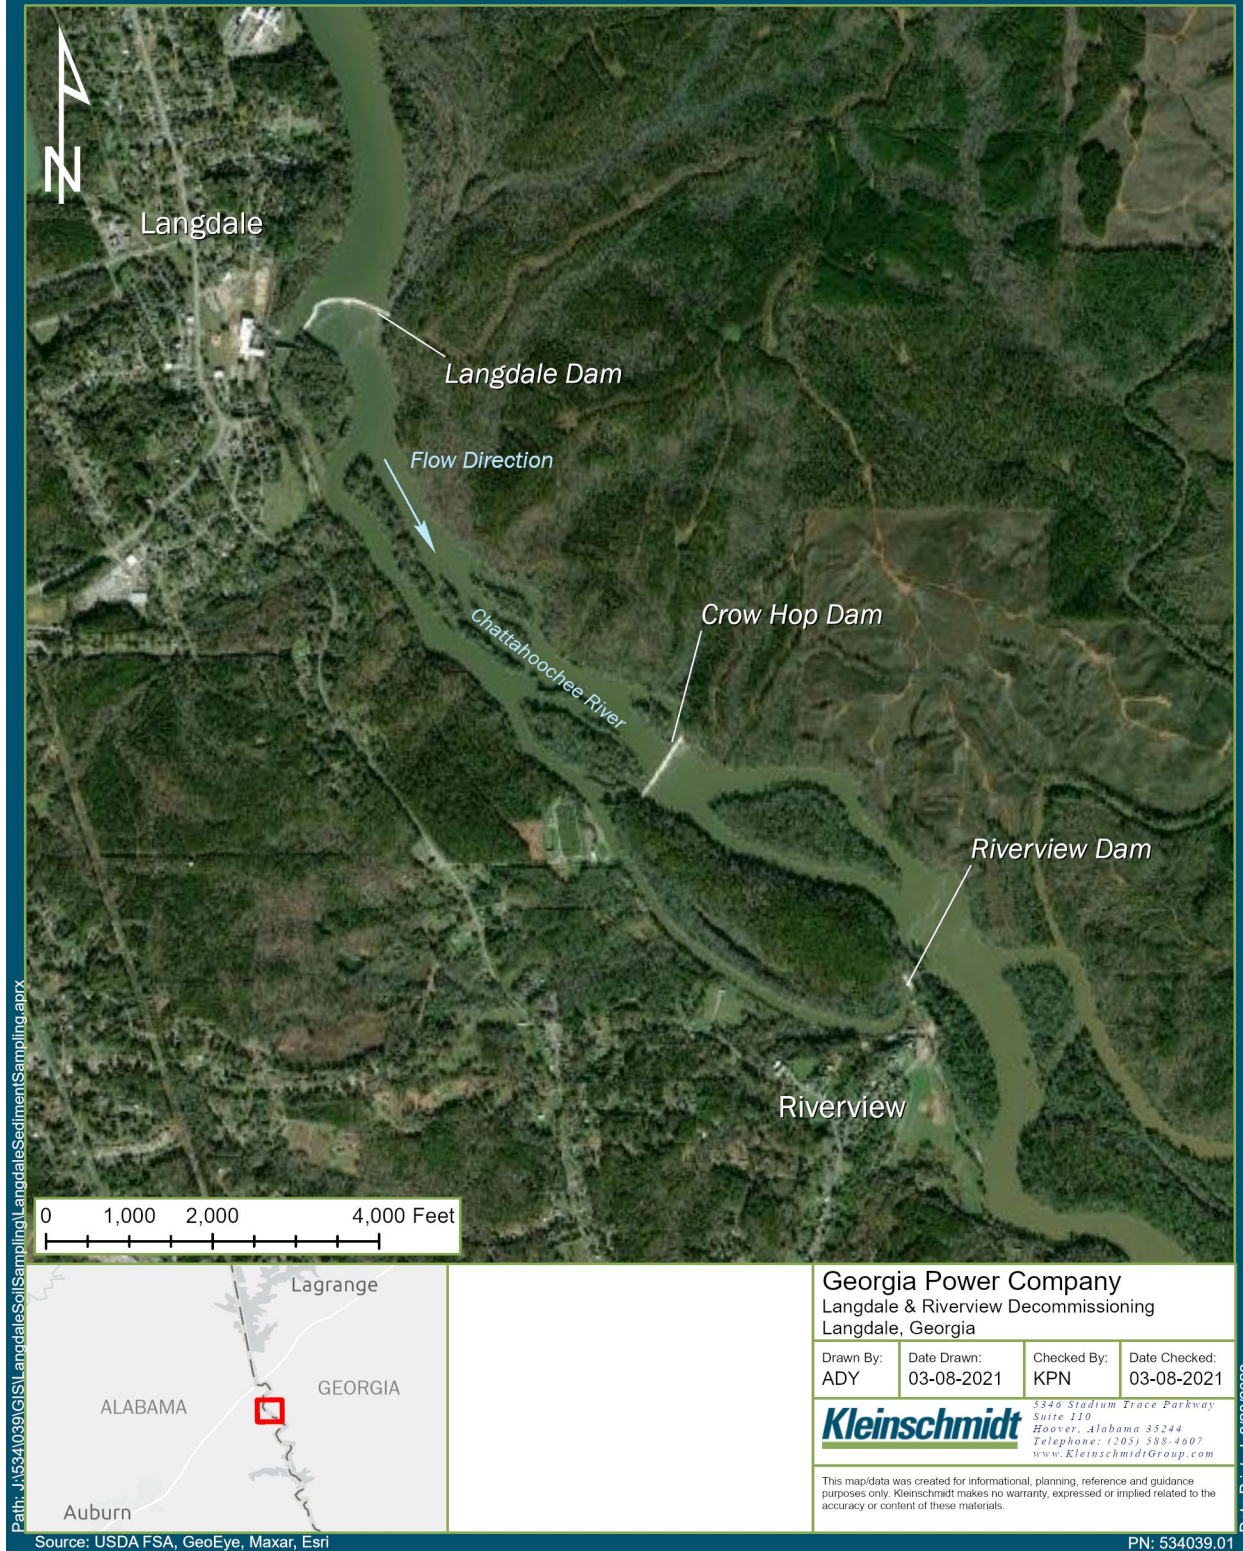
**Figure 1-2 Langdale and Riverview Project Locations**

The Project powerhouse is located on the western abutment of Riverview Dam (Figure 1-2). Crow Hop Dam is the upstream dam and is situated across the main river, diverting flow into a headrace channel between an island and the western bank. The headrace channel is approximately 1-mile-long. Riverview Dam (approximately 205-foot long, 12-foot tall) and the powerhouse are located at the lower end of this headrace channel. The Project was constructed in several phases. The smaller downstream dam was constructed in 1906 for West Point Manufacturing Company. Originally, the dam diverted water into the adjacent mill building to provide power for mill operation. The existing powerhouse was built in 1918 and houses two 240 kW generating units. Crow Hop Dam was constructed in 1920. Georgia Power purchased the Riverview Project from West Point Manufacturing Company in 1930 and began operating the two generating units. Over time, the units developed maintenance problems, and eventually were no longer operable or repairable. Georgia Power stopped operating the units in 2009. The Riverview Project previously operated as a run of river project that created an approximately 0.6-mile-long impoundment upstream of the approximately 950-foot long, 9-foot tall Crow Hop Dam.

The study reach encompasses the mainstem of Chattahoochee River at the Projects from the impoundment behind Langdale Dam downstream to the head of Lake Harding near Johnson Island (approximately RM 199.5 to RM 190.0; Figure 1-2). Previous sampling of the river bottom indicated that the dominant sediment load is composed of a tan-brown,

The Langdale Project was constructed between 1904 and 1908 and purchased by Georgia Power from West Point Manufacturing Company in 1930. The Project operated as a run of river hydroelectric plant. The powerhouse included two vertical and four horizontal generating units. Over time, the four horizontal generating units developed maintenance problems, and eventually were no longer operable. Generation records suggest that Georgia Power stopped operating the horizontal units in approximately 1954. The horizontal units were officially retired in 1960, leaving only the two 520 kilowatt (kW) vertical units operating at the Langdale Project; these two units remain in place in the powerhouse but have not operated since 2009. The run of river project creates an approximately 4.4-mile long impoundment behind the approximately 1,300-foot long, 15-foot tall dam (Figure 1-2).

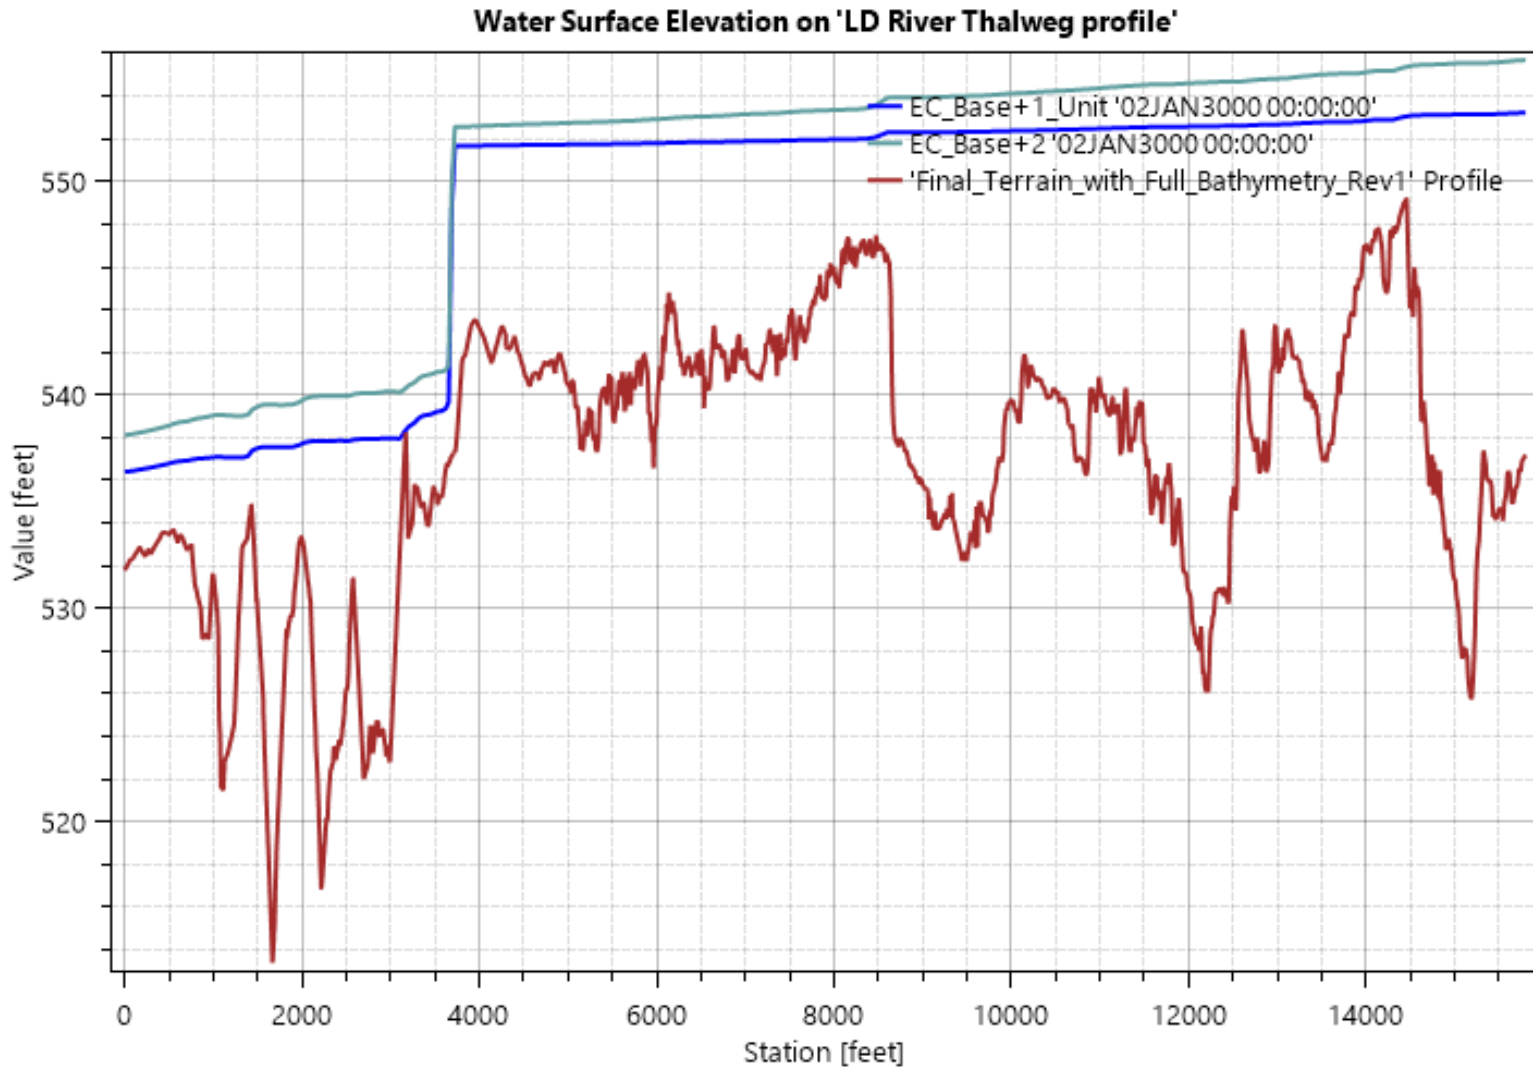
**Figure 2-1 Stream Profile above Langdale Dam Showing Variability in Existing Terrain**

silty, fine to coarse sand with a grain size distribution D50 equal to approximately 1 mm (2019 Boring Logs). The river appears to mobilize this sediment readily and transport it through the study reach without extensive deposition. This inference is based on the 1936 report that essentially called these impoundments “full” and a review of the river reach longitudinal elevation profile, which shows a highly irregular thalweg elevation interspersed with exposed bedrock controls upstream of each dam and intervening deep pools (Figure 2-1). Finer grain size distributions have been found in quieter areas affected by backwater and in floodplain deposits, including in samples collected at locations immediately upstream of each Project dam. The profile and grain size distributions from 2019 samples indicate that the area between the dam and the first bedrock control upstream are most likely to have the greatest potential to accumulate sediments; therefore, sampling of sediment for potential constituent testing occurred in the immediate vicinity of each Project dam. The volume and physical characteristics of the sediment are characterized in the *Final Sediment Transport Assessment Study Report*. Additionally, Georgia Power conducted a Hydraulics and Hydrology Study (Kleinschmidt 2022b; 2023b) to inform potential changes in water velocity, depth, and extents post-dam removal.

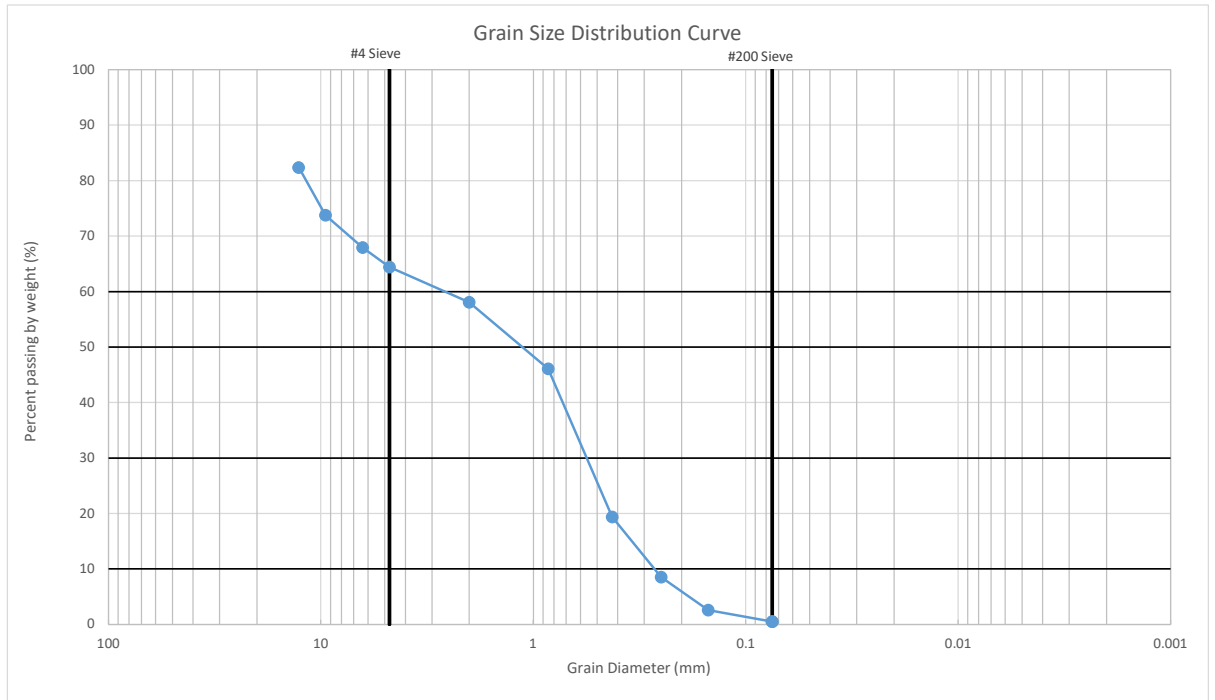
US Standard Sieve Size	Opening Size (mm)	Percent Passing by Weight
0.5"	12.7	99.73
0.375"	9.5	99.07
0.25"	6.35	98.02
4	4.75	96.73
10	2.0	90.31
20	0.85	54.64
40	0.425	11.20
60	0.250	2.38
100	0.150	0.87
200	0.075	0.26
Minus 200	0.075	0.24

Solutions	
D <sub>60</sub>	1.0228
D <sub>50</sub>	0.8046
D <sub>30</sub>	0.6089
D <sub>10</sub>	0.4012
C <sub>u</sub>	2.55
C <sub>c</sub>	0.90
Gravel	3%
Sand	97%
Silt/Clay	0%

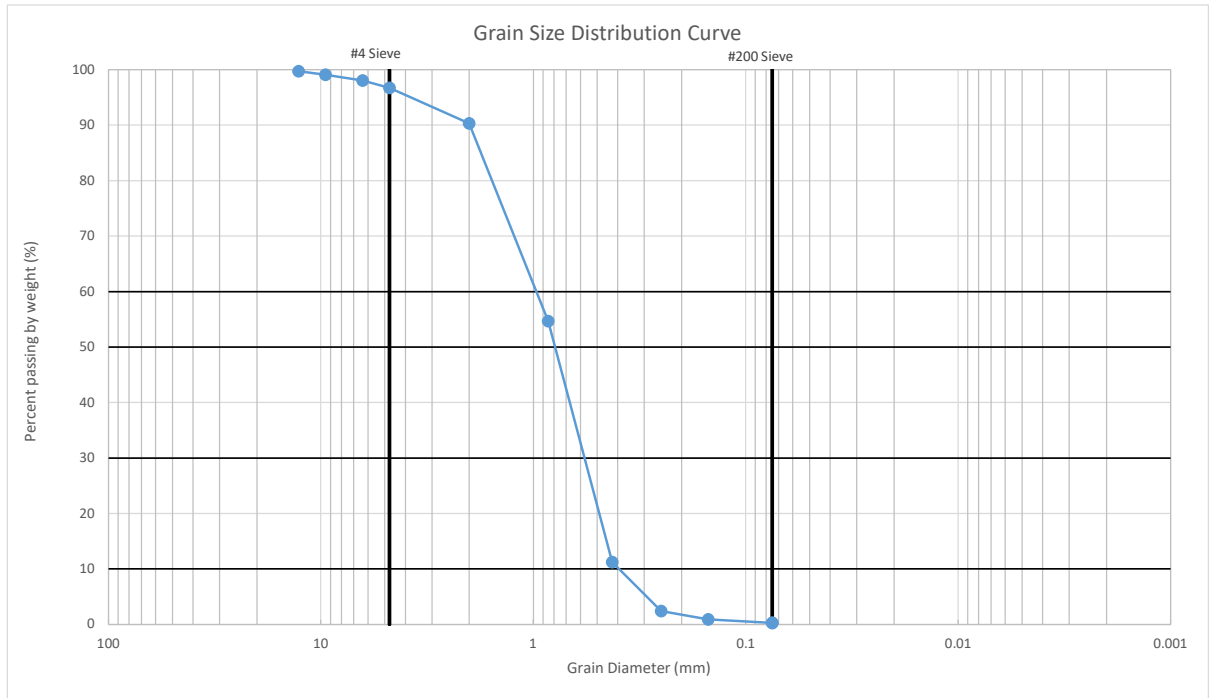
US Standard Sieve Size	Opening Size (mm)	Percent Passing by Weight
0.5"	12.7	99.62
0.375"	9.5	99.53
0.25"	6.35	98.87
4	4.75	98.51
10	2.0	95.32
20	0.85	59.60
40	0.425	8.49
60	0.250	0.87
100	0.150	0.39
200	0.075	0.19
Minus 200	0.075	0.16

Solutions	
D <sub>60</sub>	0.8629
D <sub>50</sub>	0.7702
D <sub>30</sub>	0.6039
D <sub>10</sub>	0.4376
C <sub>u</sub>	1.97
C <sub>c</sub>	0.97
Gravel	1%
Sand	99%
Silt/Clay	0%

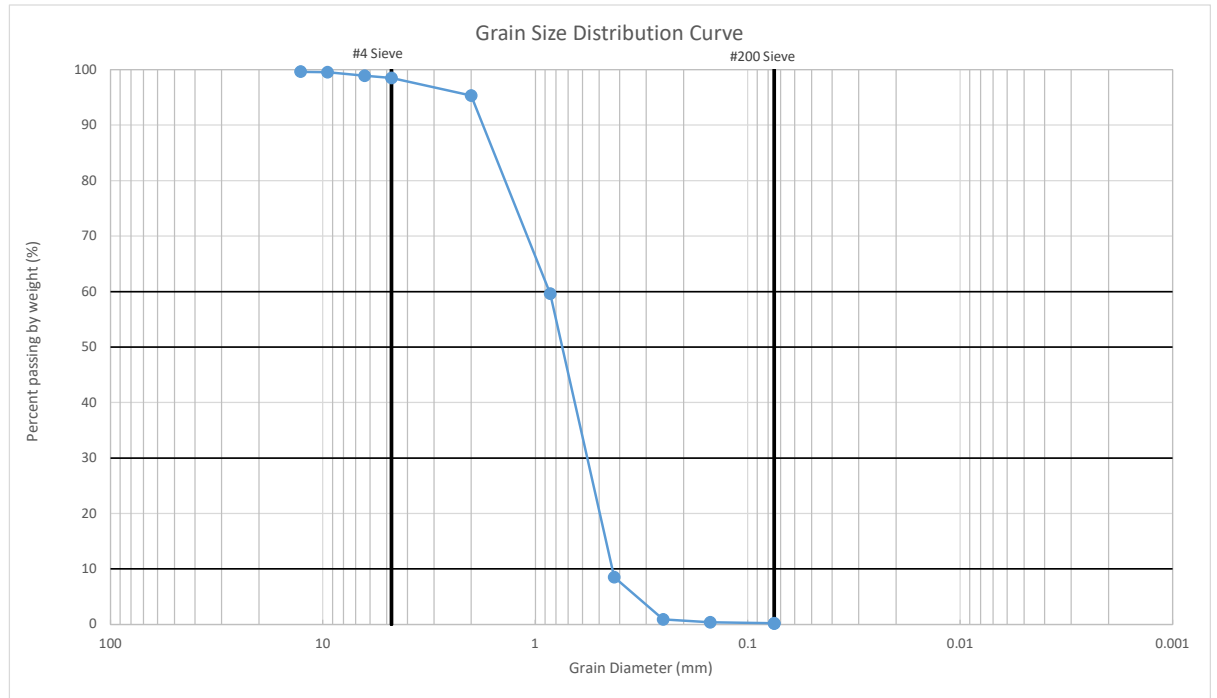
US Standard Sieve Size	Opening Size (mm)	Percent Passing by Weight
0.5"	12.7	100.00
0.375"	9.5	100.00
0.25"	6.35	100.00
4	4.75	99.92
10	2.0	99.22
20	0.85	93.41
40	0.425	81.84
60	0.250	73.73
100	0.150	63.06
200	0.075	55.52
Minus 200	0.075	55.30

Solutions	
D <sub>60</sub>	0.1196
D <sub>50</sub>	N/A
D <sub>30</sub>	N/A
D <sub>10</sub>	N/A
C <sub>u</sub>	N/A
C <sub>c</sub>	N/A
Gravel	0%
Sand	44%
Silt/Clay	56%

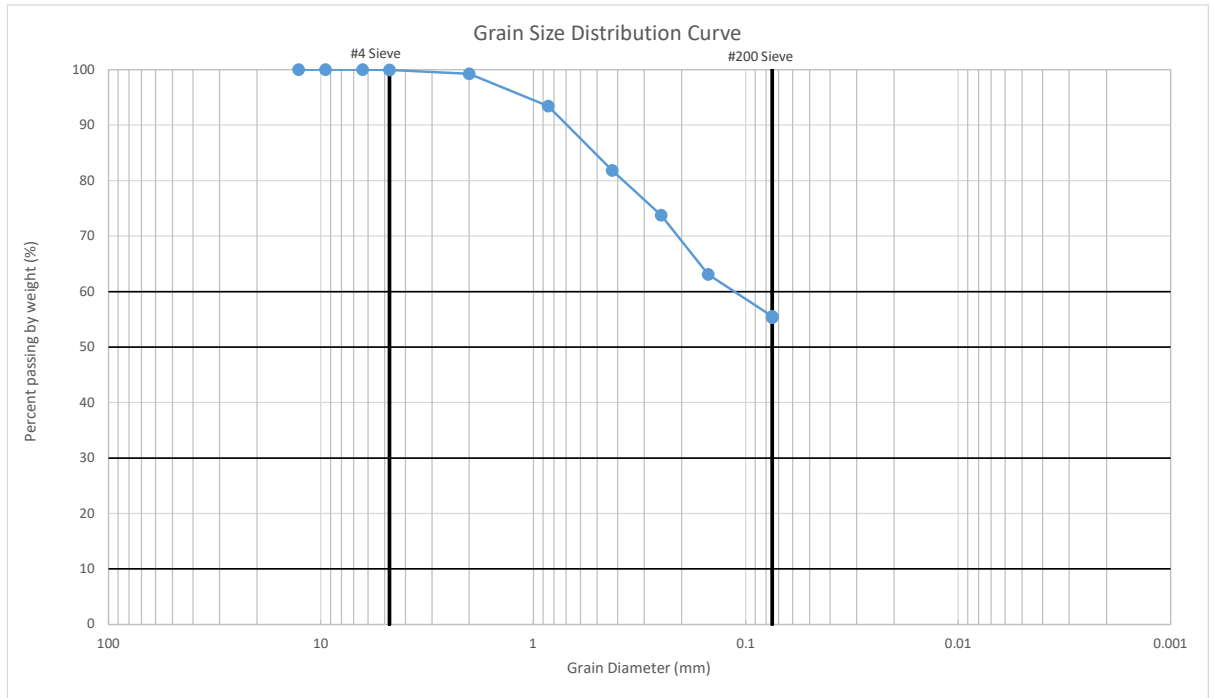
US Standard Sieve Size	Opening Size (mm)	Percent Passing by Weight
0.5"	12.7	100.00
0.375"	9.5	100.00
0.25"	6.35	99.65
4	4.75	99.46
10	2.0	96.68
20	0.85	83.59
40	0.425	60.95
60	0.250	52.29
100	0.150	50.93
200	0.075	48.82
Minus 200	0.075	48.71

Solutions	
D <sub>60</sub>	0.4058
D <sub>50</sub>	0.1169
D <sub>30</sub>	N/A
D <sub>10</sub>	N/A
C <sub>u</sub>	N/A
C <sub>c</sub>	N/A
Gravel	1%
Sand	51%
Silt/Clay	49%

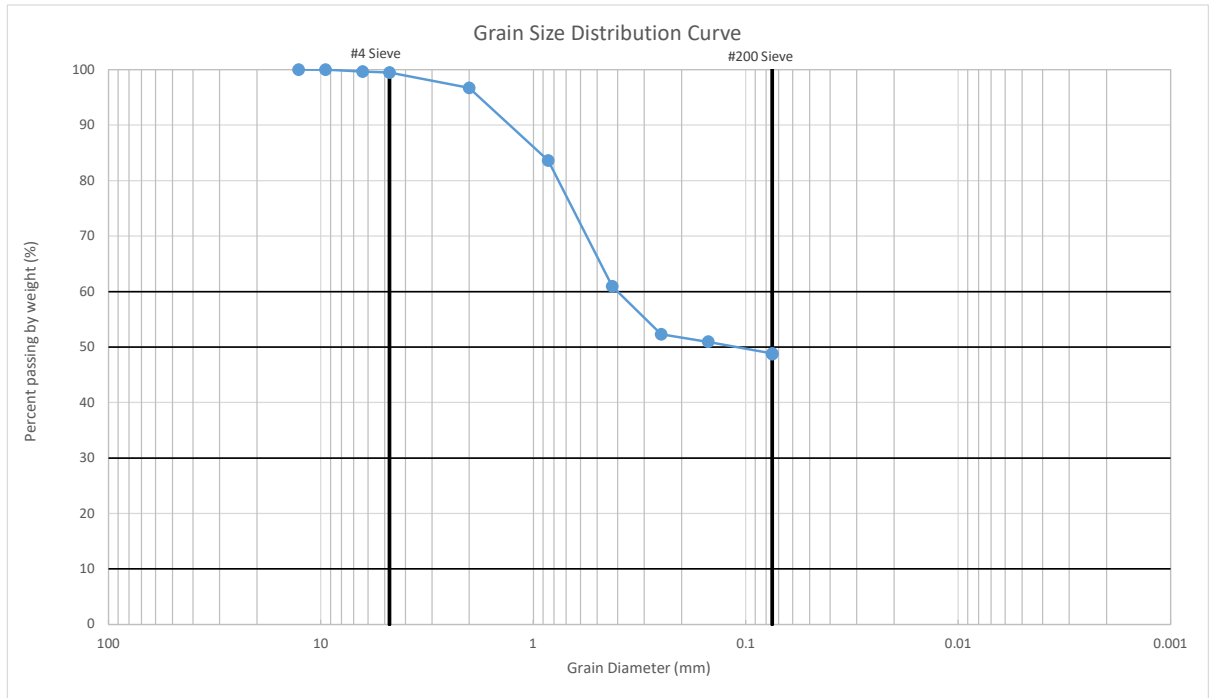
US Standard Sieve Size	Opening Size (mm)	Percent Passing by Weight
0.5"	12.7	81.76
0.375"	9.5	78.77
0.25"	6.35	74.49
4	4.75	72.35
10	2.0	67.40
20	0.85	51.29
40	0.425	21.02
60	0.250	7.52
100	0.150	3.38
200	0.075	2.08
Minus 200	0.075	2.01

Solutions	
D <sub>60</sub>	1.4718
D <sub>50</sub>	0.8319
D <sub>30</sub>	0.5511
D <sub>10</sub>	0.2821
C <sub>u</sub>	5.22
C <sub>c</sub>	0.73
Gravel	9%
Sand	89%
Silt/Clay	2%

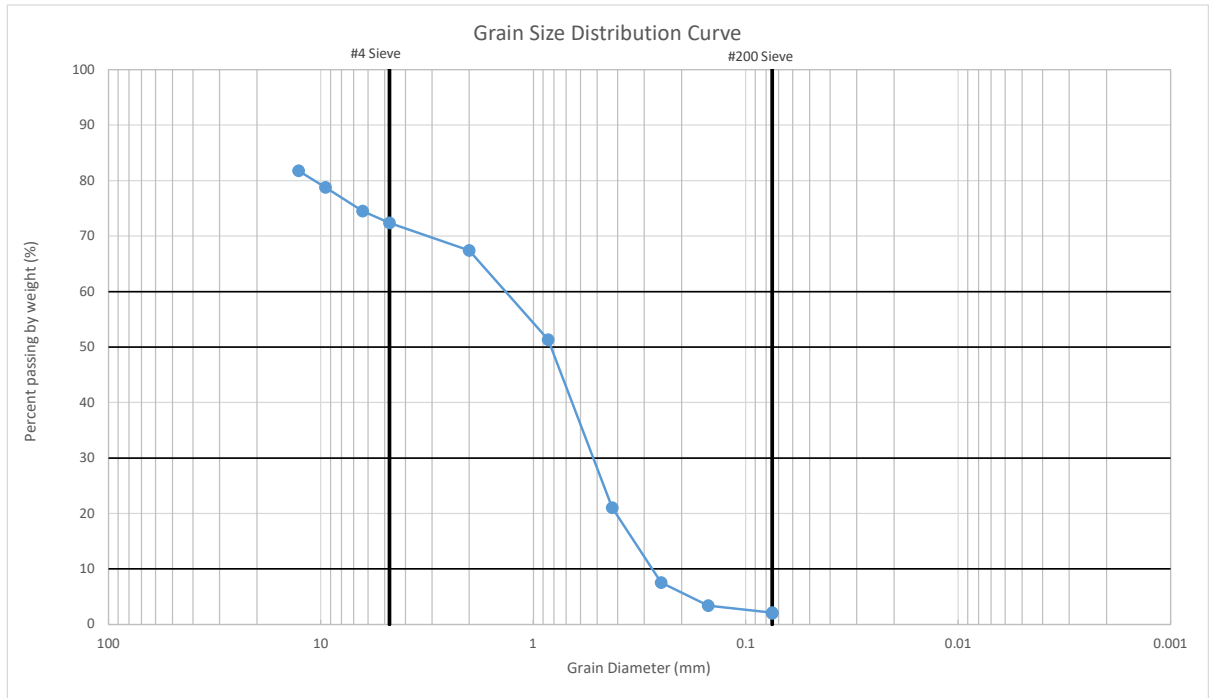
US Standard Sieve Size	Opening Size (mm)	Percent Passing by Weight
0.5"	12.7	100.00
0.375"	9.5	100.00
0.25"	6.35	99.87
4	4.75	99.39
10	2.0	92.60
20	0.85	49.12
40	0.425	6.38
60	0.250	0.86
100	0.150	0.40
200	0.075	0.23
Minus 200	0.075	0.20

Solutions	
D <sub>60</sub>	1.1378
D <sub>50</sub>	0.8733
D <sub>30</sub>	0.6599
D <sub>10</sub>	0.4610
C <sub>u</sub>	2.47
C <sub>c</sub>	0.83
Gravel	1%
Sand	99%
Silt/Clay	0%

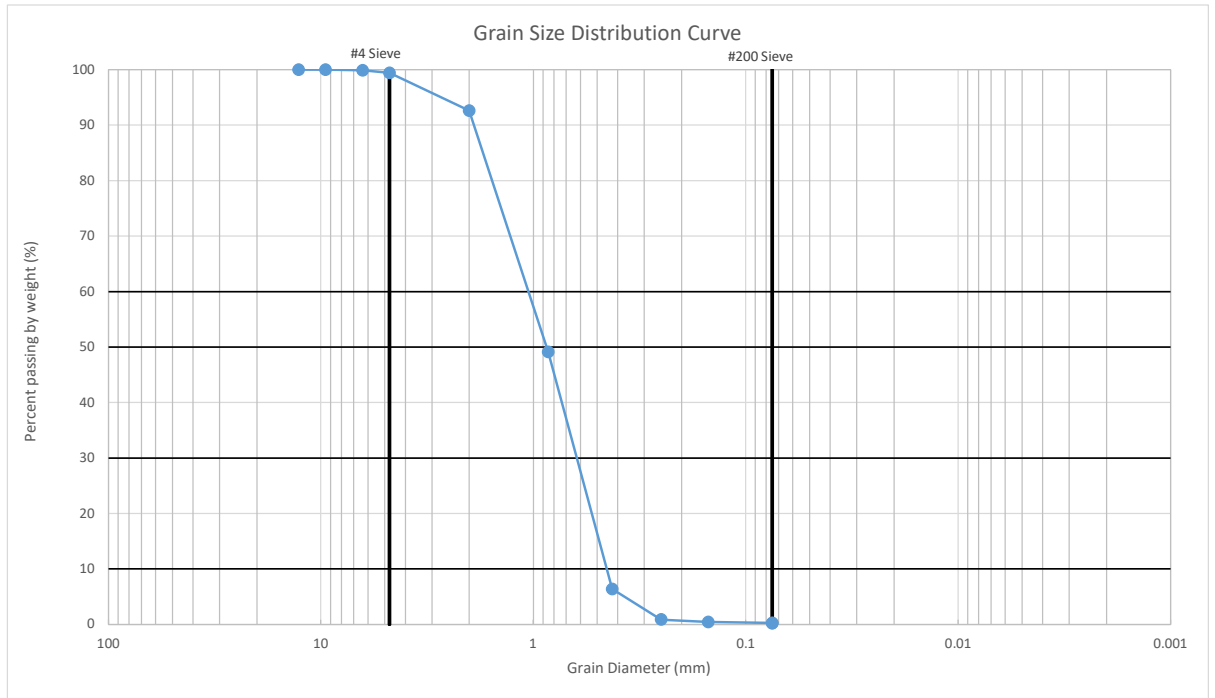
Calculations				
D	60	50	30	10
Nearest Large to D	93	93	49	49
Nearest Small to D	49	49	6	6
Fraction D from Nearest Small to Nearest Large	0.25	0.02	0.55	0.08
Opening Size Range	2	2	0.85	0.85
	0.85	0.85	0.425	0.425
Extrapolated Grain Diameter (mm)	1.138	0.873	0.660	0.461

Graphing	
60% Passing	60
100	60
0.001	60
50% Passing	50
100	50
0.001	50
30% Passing	30
100	30
0.001	30
10% Passing	10
100	10
0.001	10
# 4 Sieve	0
4.75	100
#200 Sieve	0
0.075	100
0.075	100
