257.83 (b) (2)	REPORT OF ANNUAL INSPECTION OF CCR SURFACE IMPOUNDMENT		
	FACILITY NAME: Plant McDonough Ash Pond 4 (AP-4)		
	OWNER/OPERATOR OF FACILITY: Georgia Power Company		
	INSPECTION DATE: May 17, 2022		
	INSPECTING ENGINEER: Patrick B. Rhodes, P.E. (Georgia P.E. License # 24586) Southern Company Services Fossil Dam Safety		
	Based on the results of the inspection and review of the data provided by a qualified Professional Engineer, it is my professional opinion that the report has been completed in accordance with 40 CFR 257.83(b).

INSTRUMENTATION LOCATION PLANT MCDONOUGH AP-4

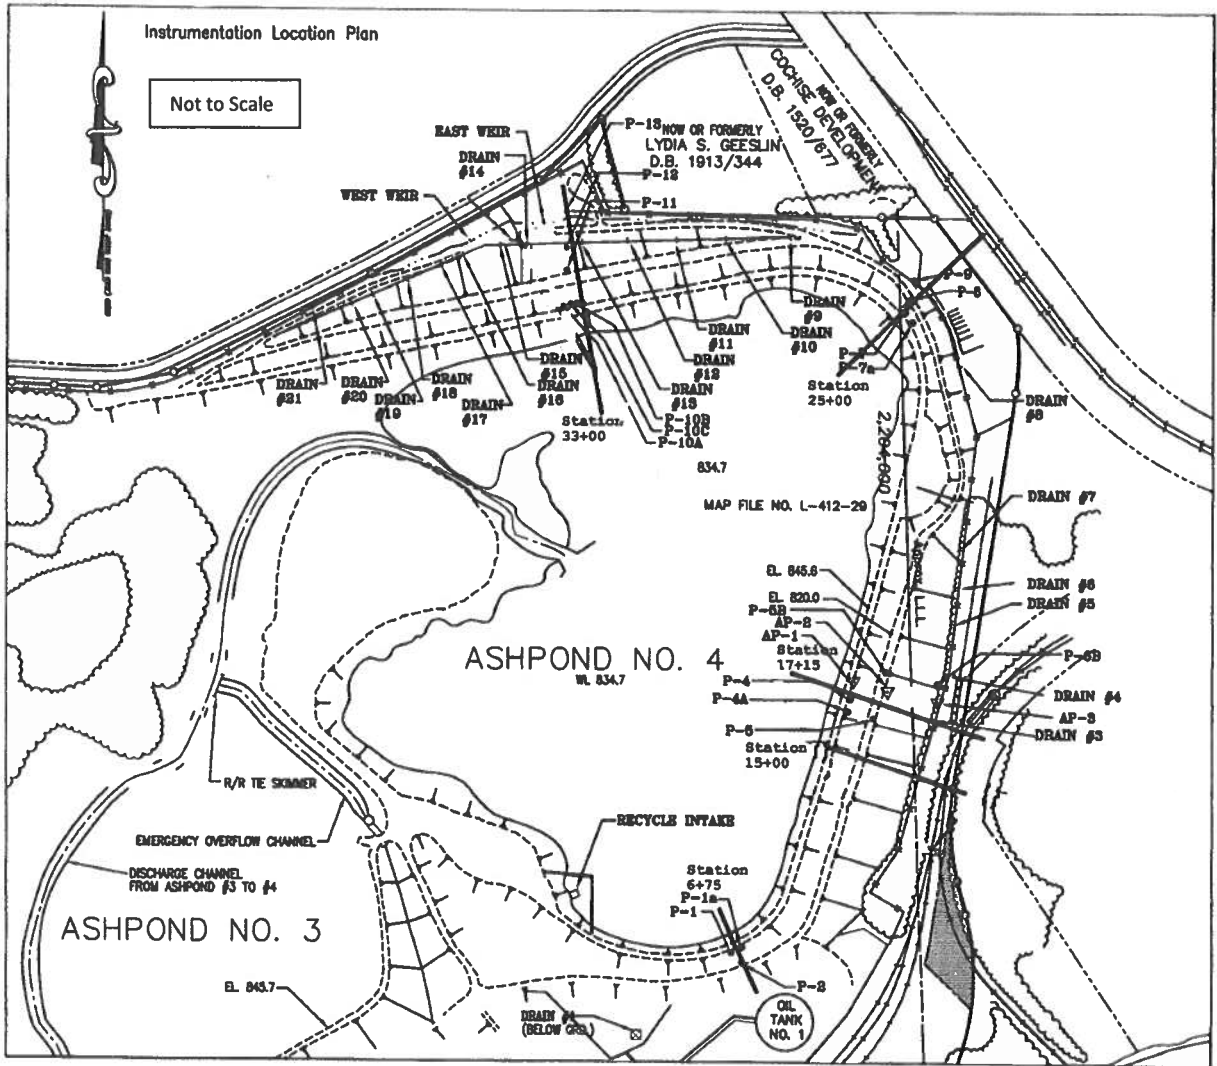
(i)	ANY CHANGES IN GEOMETRY OF THE IMPOUNDING STRUCTURE SINCE THE PREVIOUS ANNUAL INSPECTION (YES OR NO)?	Yes	
	(IF YES, DESCRIBE): The embankment is being lowered as a part of the closure construction.		
(ii)	LOCATION AND TYPE OF EXISTING INSTRUMENTATION	See Attached Figure	
(ii)	MAXIMUM RECORDED READING OF EACH INSTRUMENT SINCE PREVIOUS ANNUAL INSPECTION	See Attached Chart	
(iii)	APPROXIMATE MINIMUM, MAXIMUM AND PRESENT DEPTH AND ELEVATION OF THE IMPOUNDED WATER SINCE PREVIOUS ANNUAL INSPECTION		
	MIN. DEPTH: 2 ft*	MAX. DEPTH: 6 ft*	PRESENT DEPTH: 3 ft*
	MIN. ELEVATION: EL 832 ft*	MAX. ELEVATION: EL 839 ft*	PRESENT ELEVATION: EL 836 ft*
(iii)	APPROXIMATE MINIMUM, MAXIMUM AND PRESENT DEPTH AND ELEVATION OF CCR SINCE PREVIOUS ANNUAL INSPECTION.		
	MIN. DEPTH: 0 ft	MAX. DEPTH: 102 ft	PRESENT DEPTH: Up to 102 ft
	MIN. ELEVATION: EL 762 ft	MAX. ELEVATION: EL 900 ft	PRESENT ELEVATION: Up to EL 900 ft
(iv)	APPROXIMATE STORAGE CAPACITY OF IMPOUNDING STRUCTURE AT TIME OF INSPECTION.	0 yd ³ *
